HISTORIC STRUCTURES REPORT
for
LITTLE SABLE POINT LIGHT STATION
(PETITE POINTE au SABLE)
Golden Township (Oceana County), Michigan

Prepared by:
Sanders & Czapski Associates, PLLC
109 S. Front Street
Suite #210
Marquette, Michigan 49855

FINAL REPORT
July 15, 2015

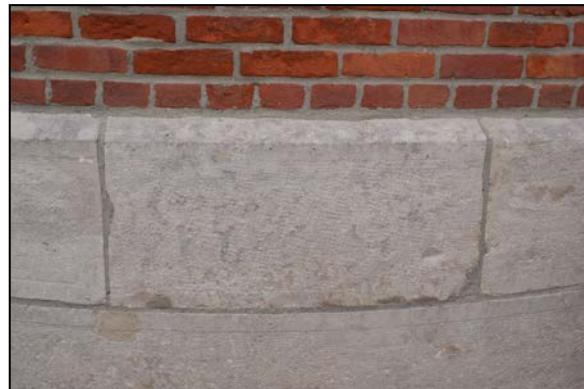
PHOTO III-B-7

The light tower is a brick masonry structure constructed on a limestone base. Original drawings indicate a series of wood piles of unknown depth sunk into the ground that provide support for the masonry tower. Historic documents indicate one hundred nine (109) twelve inch diameter wood piles were driven to a termination point nine feet below the surface. The brick and stone masonry is in exceptionally good condition throughout. The cut stone base is exposed on the west side of the tower where the grade drops, as seen in Photos III-B-2 and III-B-3. Where the sand is washed away, an area of the rough stone foundation is exposed, as seen in Photos III-B-4, III-B-5 and III-B-6. The exposed uncut stone has been coated with a cement wash. All stone and mortar joints are in very good condition. Refer to Photo III-B-7.

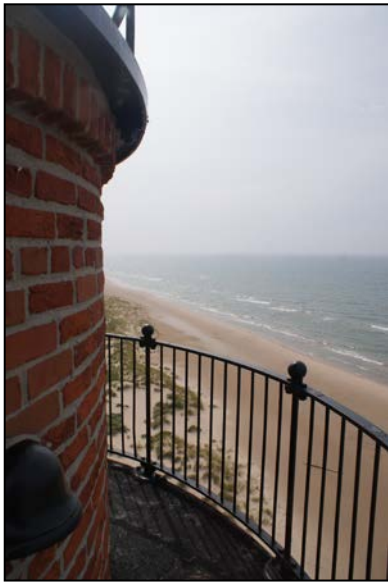
PHOTO III-B-18

The exterior tower walls at the Watch Deck level are also brick masonry, as seen in Photo III-B-18. The upper most brick course is corbelled where it transitions to the underside of the metal lantern deck, as seen in Photo III-B-19. The brick and mortar joints are in very good condition at this upper level with some minor areas of deterioration near the deck surface, shown in Photo III-B-20, and some cracking above the door, Photo III-B-21. Five metal vents, Photo III-B-22, are set in the masonry at this level.

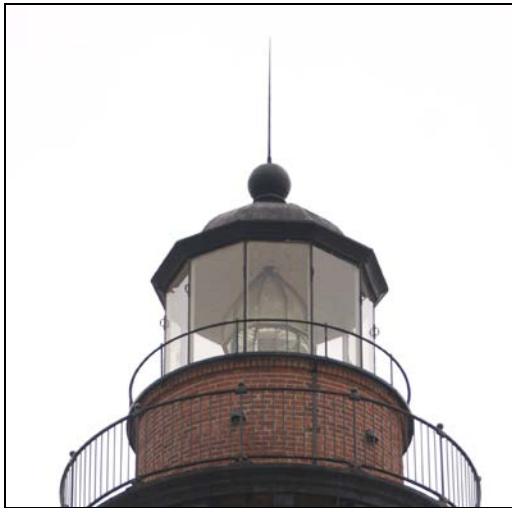
PHOTO III-B-30

The ten-sided lantern, Photo III-B-30, has large glass panels measuring 2'-8 ½" wide x 5'-10" high. All glass panels are in good condition providing protection for the Fresnel Lens, Photo III-B-31. Vertical glazing bars include safety handles, as seen in Photo III-B-32. All exterior glazing bars are in good condition, however, as with other exterior lantern components, the paint finish is in poor condition. The metal roof of the lantern is capped with a ventilation ball and lightning rod. The lantern roof has built-in gutters with drainage tubes that penetrate the simple metal cornice. These are also seen in Photo III-B-32. All metal components are in good condition, however, the paint finish is in poor condition.

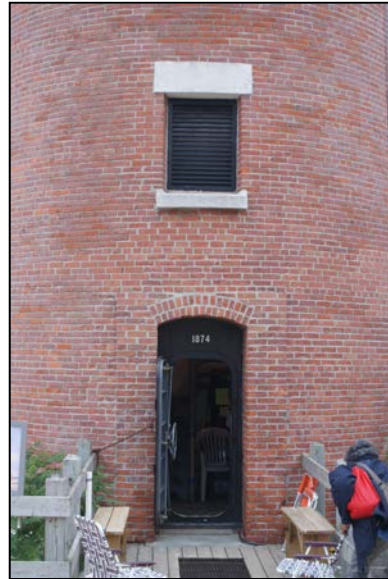
PHOTO III-B-42

At Level Two of the tower directly above the entry door, Photo III-B-42, there is another former window opening that has been modified. At this masonry opening, which measures 2'-8" wide x 3'-6" high, the former wood window sash have been removed and replaced with a modern fixed metal ventilation louver, as seen in Photo III-B-43. This metal louver, with 5" metal blades, is covered with a removable metal insect screen on the interior face, as seen in Photo III-B-44, and allows for continuous ventilation in the tower. Some wood trim and window frame components remain on the interior. The metal louver is in good condition.

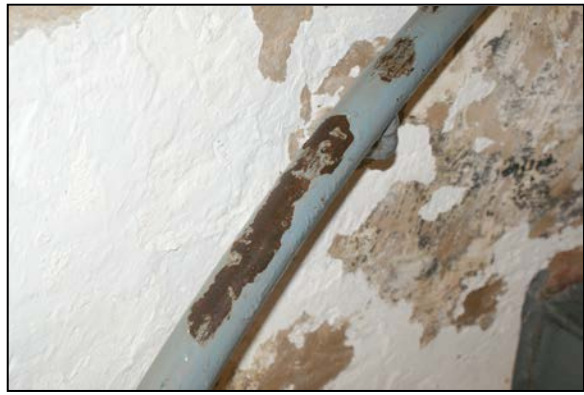
PHOTO III-B-69

Conditions are similar throughout all levels of the tower with plaster walls and the circular metal stair. Plaster and paint finish on the walls is in poor condition in many areas. Views of the interior tower are shown in Photos III-B-63, III-B-64, III-B-65 and III-B-66. The vertical rise between the landings at Levels Two through Six is a consistent 16'-9 1/2". A 1 5/8" diameter metal pipe handrail follows the curvature of the stair and terminates at each landing, as seen in Photo III-B-67. The metal handrail is mounted to the masonry wall with metal brackets, Photo III-B-68, and is solid throughout. The paint finish on the handrail is deteriorated in some areas, as seen in Photo III-B-69.

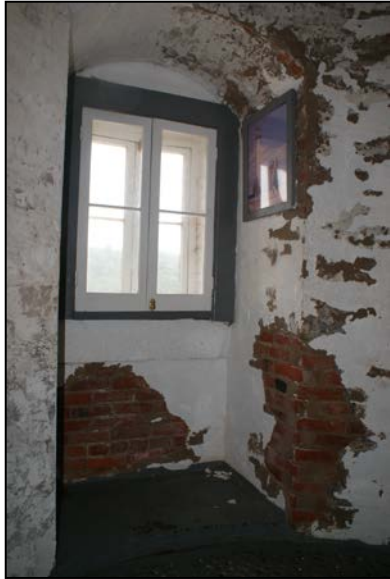
PHOTO III-B-72

As seen in many of the previous photos, there is damaged wall plaster and paint throughout the tower. There is some severe plaster deterioration at the window recess at Level Four, as seen in Photos III-B-72 and III-B-73. At Level Three a masonry crack is located at the apex of the arch above the window recess, as seen in Photo III-B-74.

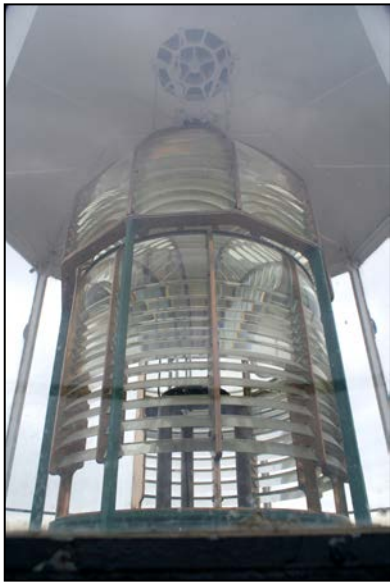
PHOTO III-B-103

The Third Order Fresnel Lens, Photo III-B-103, is housed in a ten-sided lantern with glass panels measuring 2'-8 1/2" wide x 5'-10" high. The 2'-0" wide interior lantern floor deck is located 6'-10 1/4" above the Watch Room floor and surrounds the navigation light. An interior view of the glazing is shown in Photo III-B-104. The lower edge of the glass, condensation gutter and checkered floor deck are shown in Photo III-B-105. All components are in good condition, however, paint finish is in poor condition on most surfaces, as seen in Photo III-B-106. Some "J" hooks remain at the bottom edge of the ceiling, once used to support curtains that protected the lens. The Lantern ceiling is metal with a paint finish, all of which are in good condition, as seen in Photo III-B-107. The ventilation opening at the top appears unrestricted.

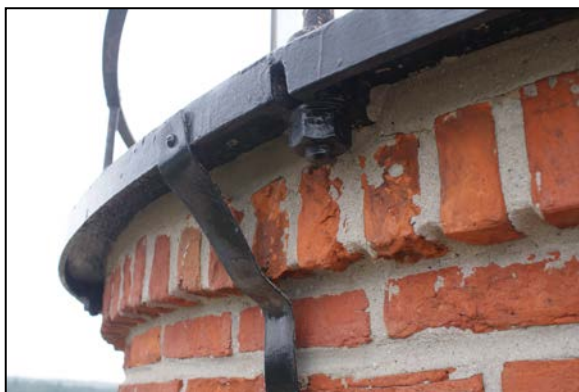
PHOTO III-B-113

A lightning grounding bar runs from the Lantern down the exterior face of the tower on the north wall. Refer to Photos III-B-113, III-B-114 and III-B-115. This grounding bar appears in good condition, however, the continuity is not known.
