TABLE OF CONTENTS

Management Summary

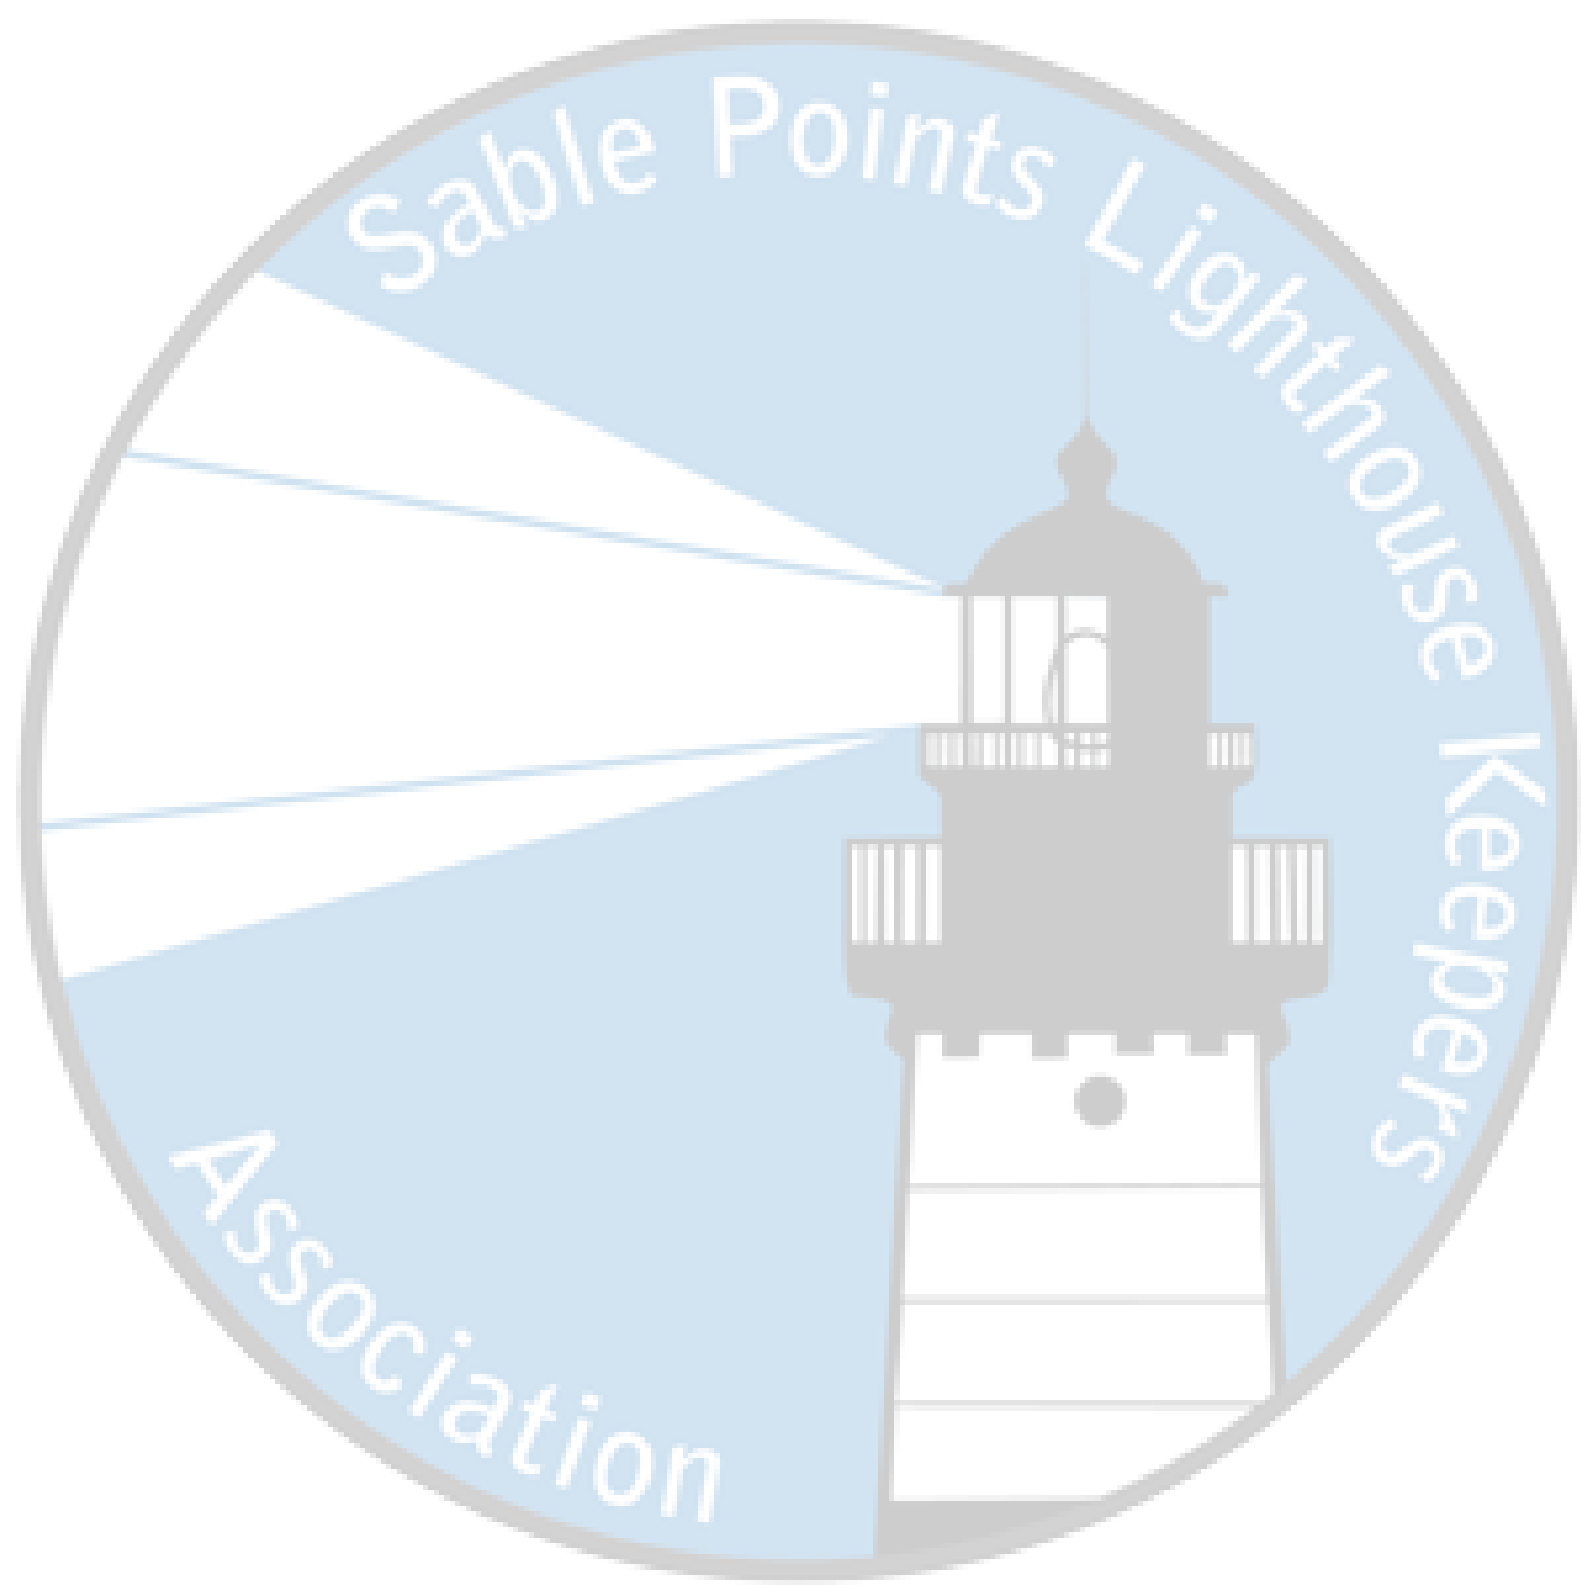
Sable Points Lighthouse Keepers

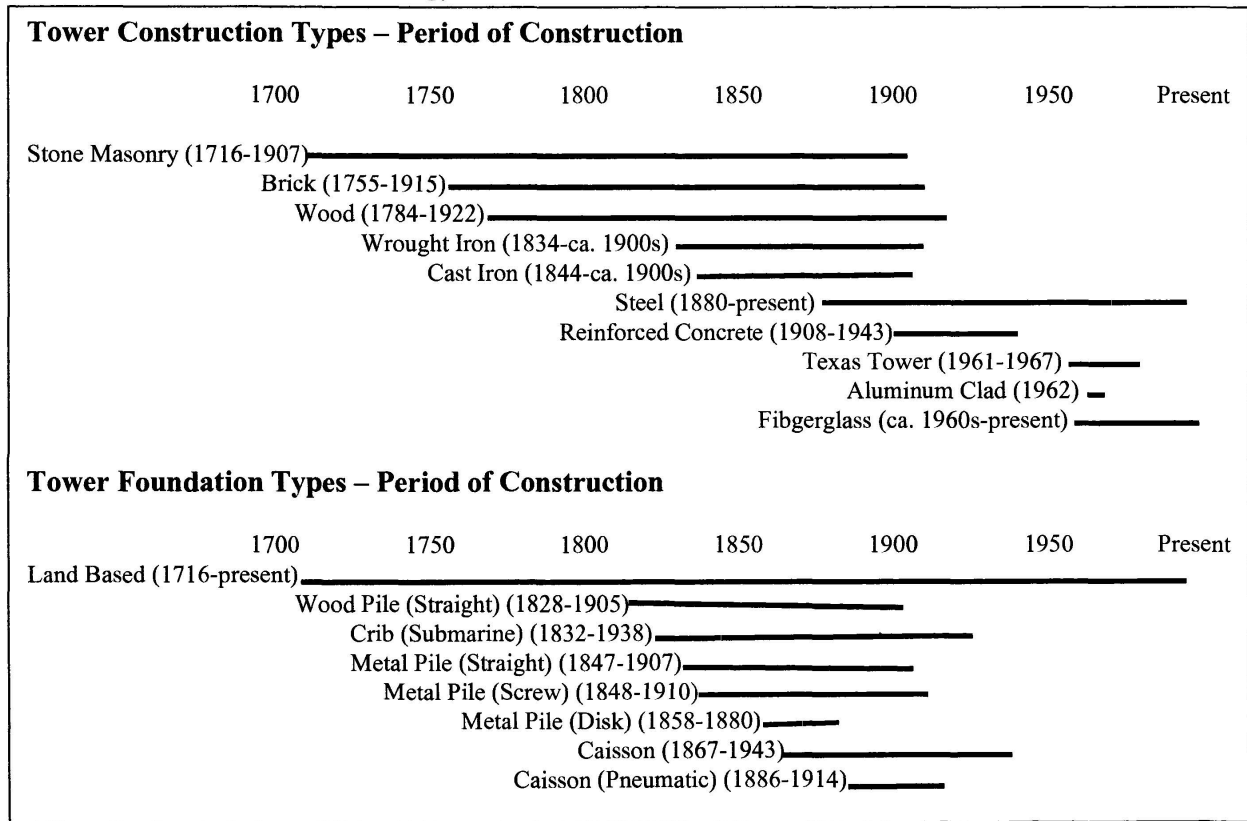
²⁴ This timeline is for United States lighthouses; tower and foundation construction types were sometimes used earlier or later in other countries. The dates are meant only to give relative time, not absolute first and last use of this construction type.

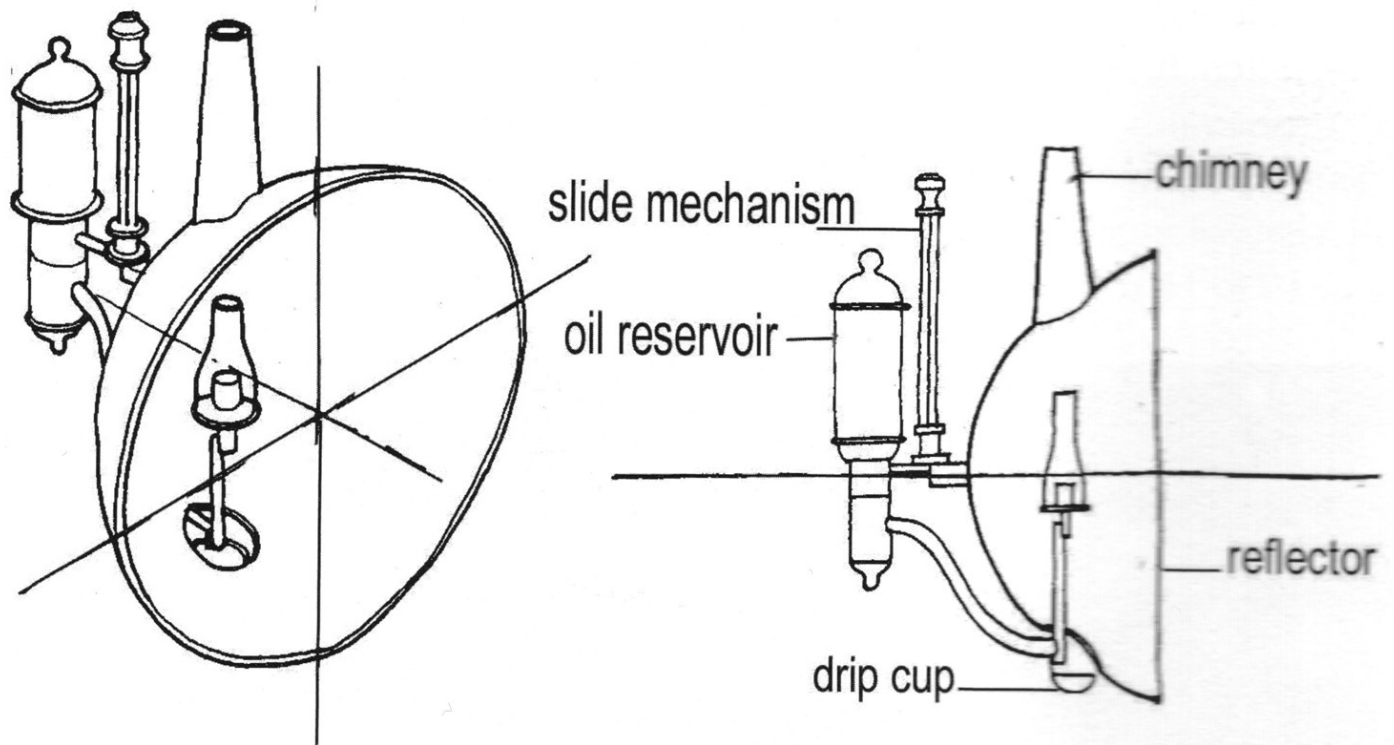
Figure 1A-03: Drawing of the Argand/Lewis lamp system with parabolic reflector used in U.S. lighthouses prior to the introduction of the Fresnel lens.

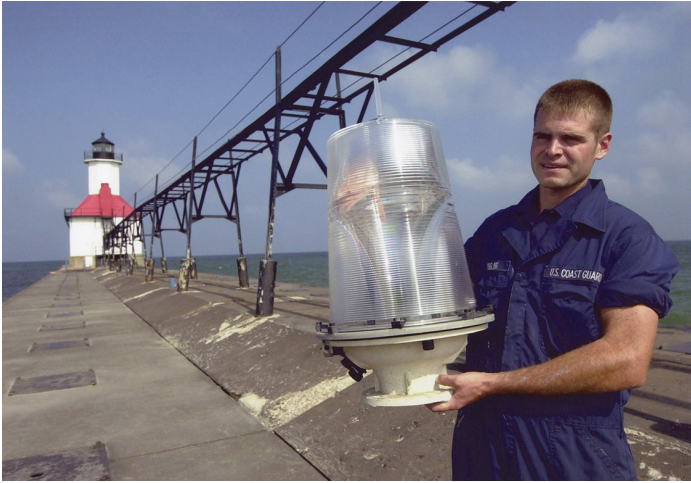
Figure 1A-05: 2003 photo of Coastguardsmen holding the replacement optic for the St. Joseph Outer Light.

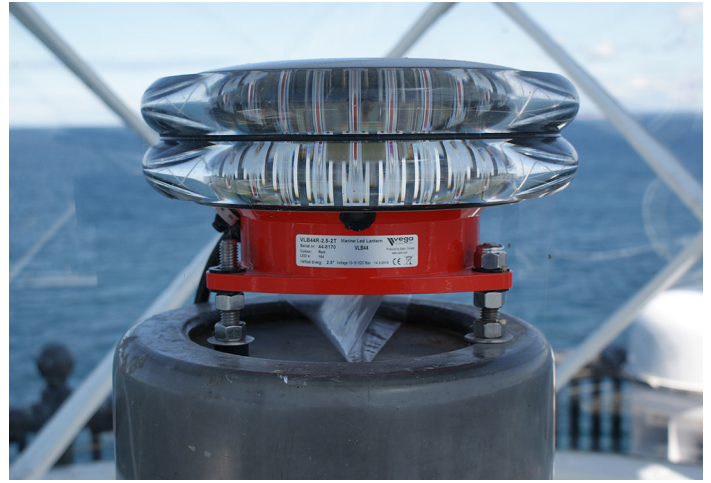
Figure 1A-07: Photo of the VLB44R-2.5-2T light by Vega Industries currently installed in the North Manitou Shoal Light Station.

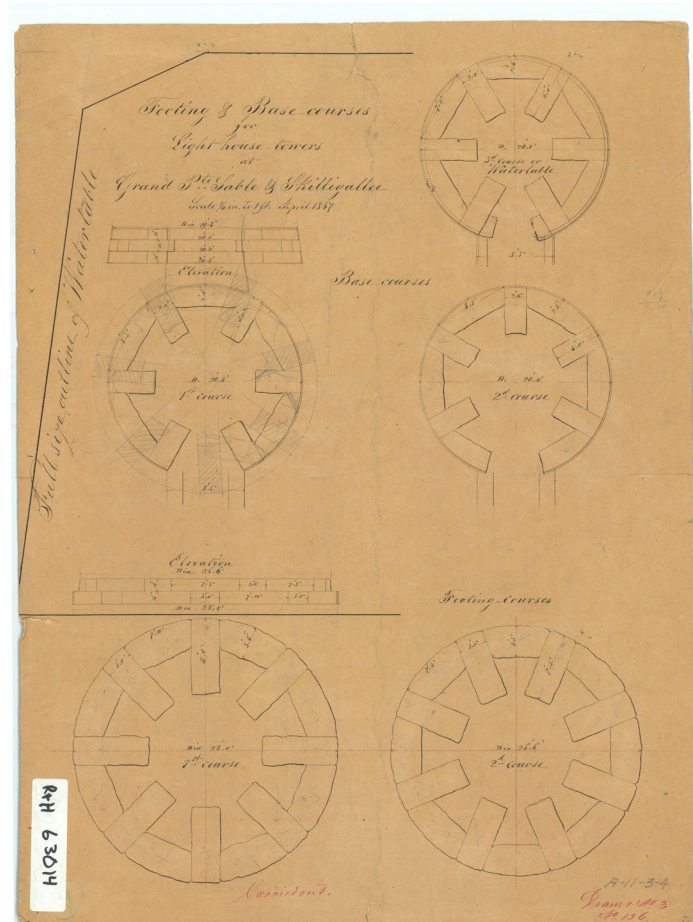
Figure 1B-02: April 1867 drawing for the “Footings & Base-courses for Lighthouse-towers at Grand Pte. Sable & Skilligallee.”

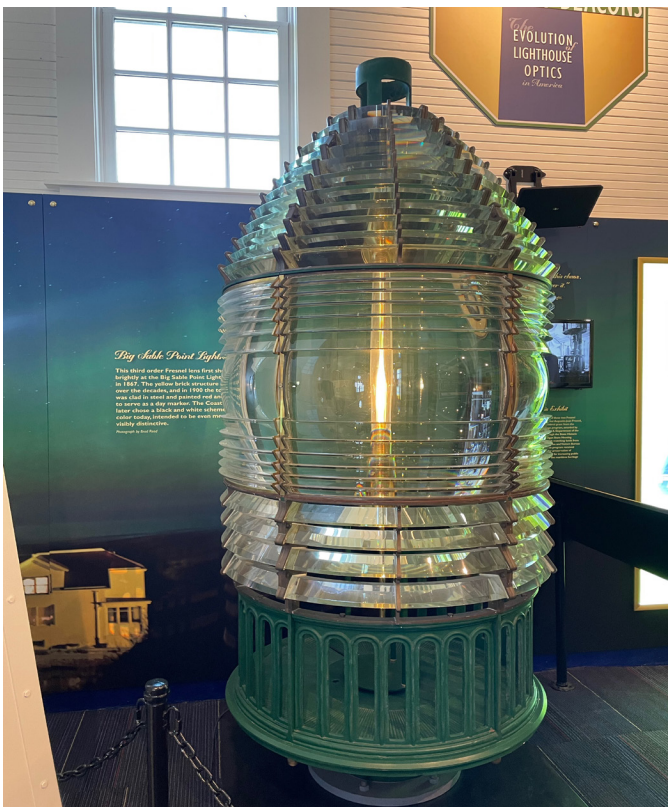
Figure 1B-08: 2023 photo of the restored, Big Sable third-order Fresnel lens, located at The Port of Ludington Maritime Museum.

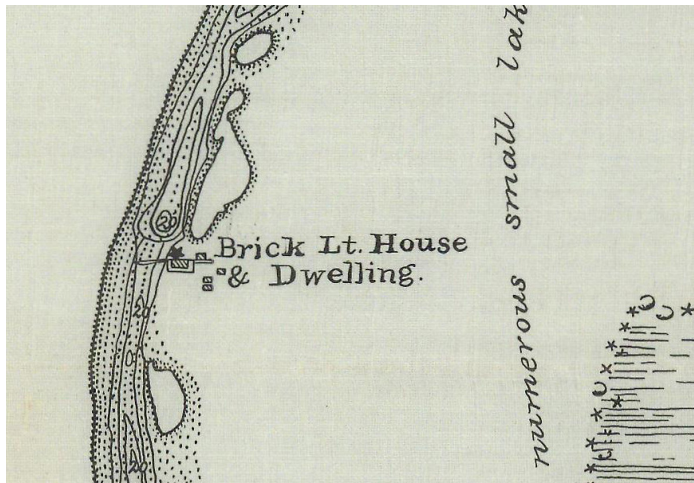
Figure 1B-10: Detail of the 1883 survey drawing showing the buildings and wood walks at the station.

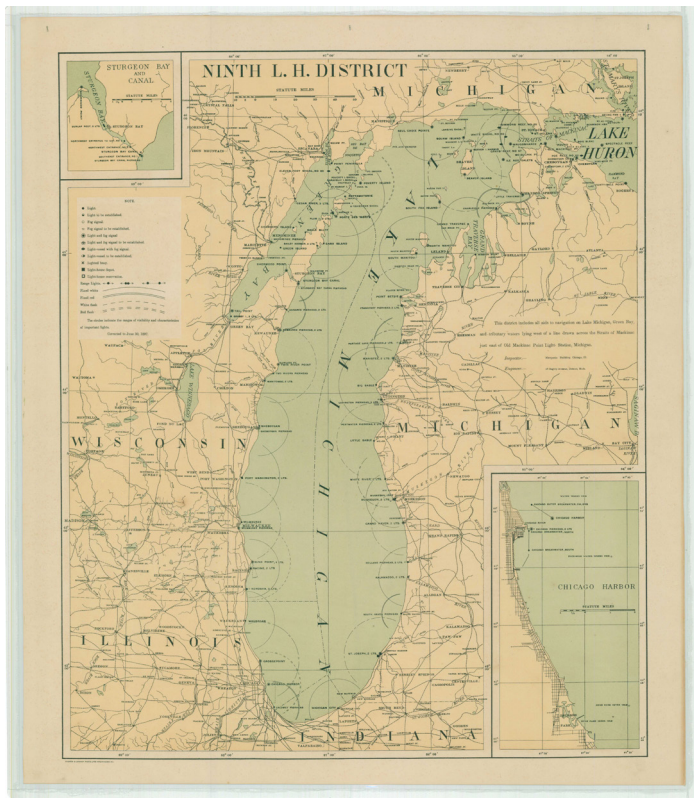
Figure 1B-11: 1897 map of the navigational aids in the Ninth Lighthouse District.

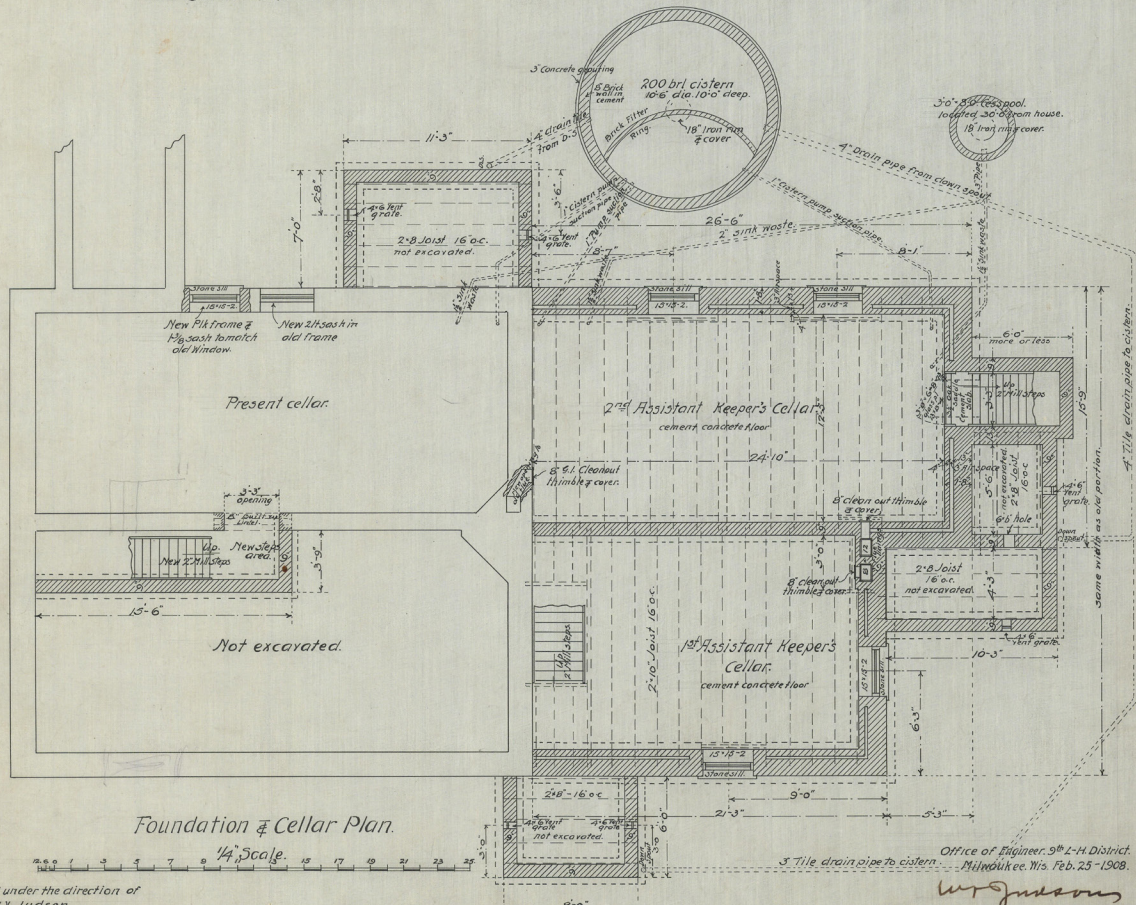
Foundation & Cellar Plan.

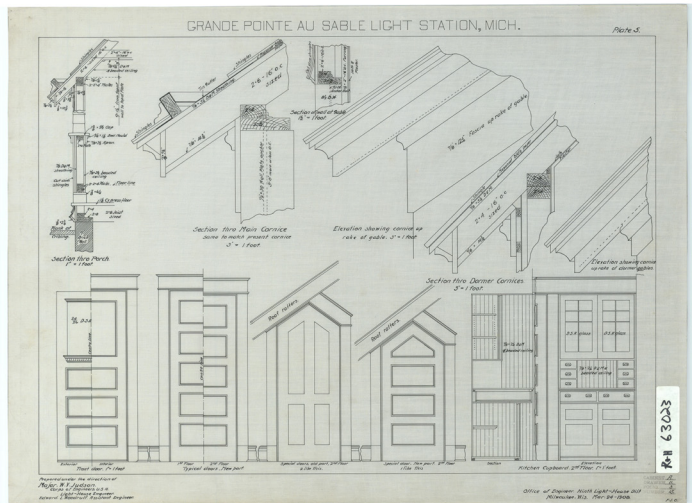
Figure 1B-24: 1908 drawing for the extension to and modifications of the keeper's dwelling. This drawing includes details for the porches, cornices, doors, and kitchen cupboards.

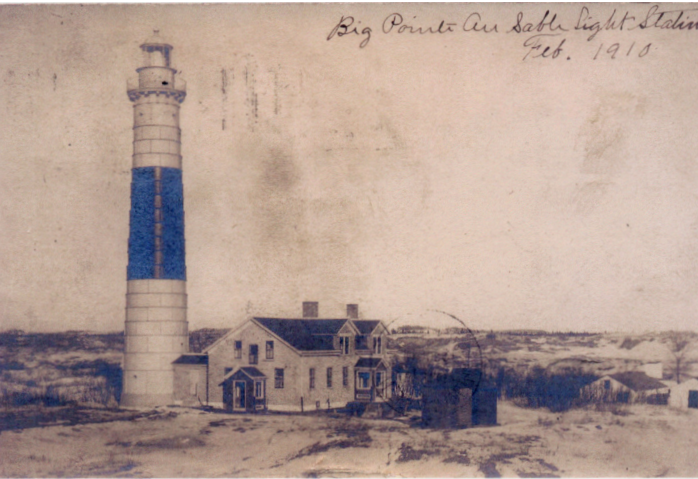
Figure 1B-25: 1910 photograph looking northeast toward the recently expanded keeper's dwelling.

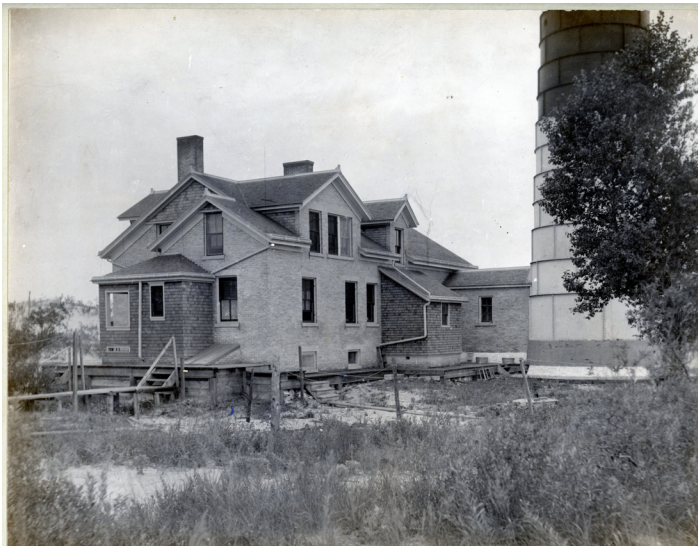
Figure 1B-26: 1910 photograph looking southwest toward the recently expanded keeper's dwelling.

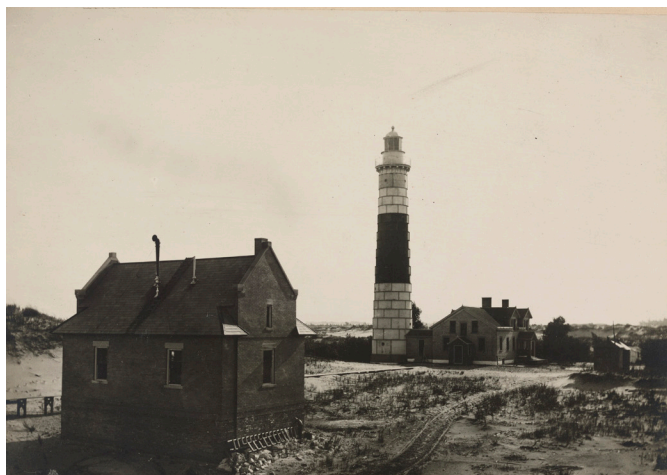
Figure 1B-29: 1914 photograph looking northeast at the station.

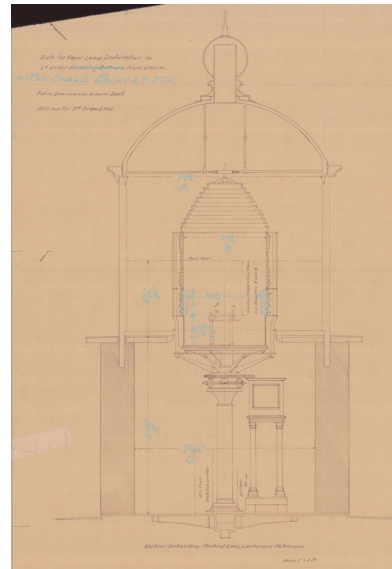
Figure 1B-30: April 1909 drawing for vapor lamp installation in third order fixed lenses with dimensions added for the lens at Big Sable.

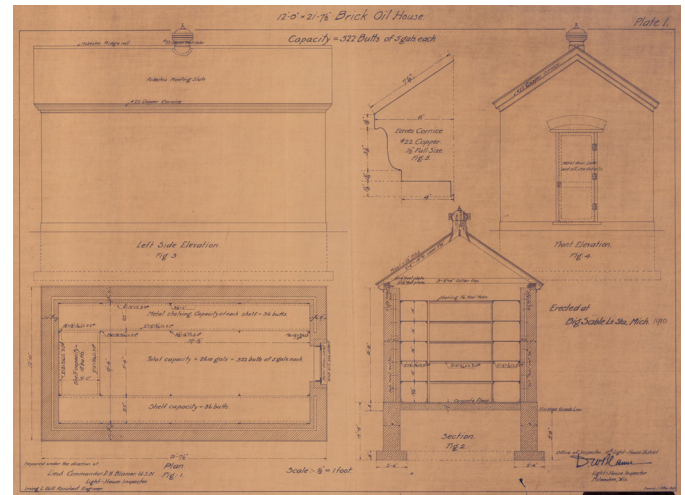
Figure 1B-31: Undated drawing for a large oil house, noted as erected at Big Sable Light Station in 1910.

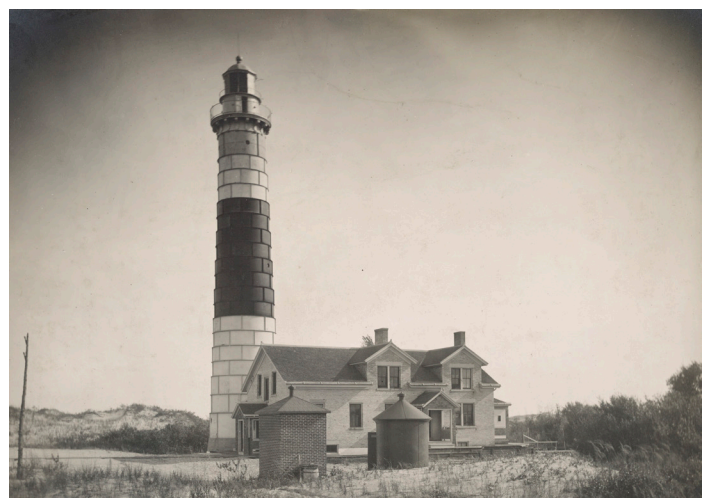
Figure 1B-32: 1914 photograph looking northeast toward the lighthouse and oil houses. The three barns east and southeast appear to have been removed from the site by this time.

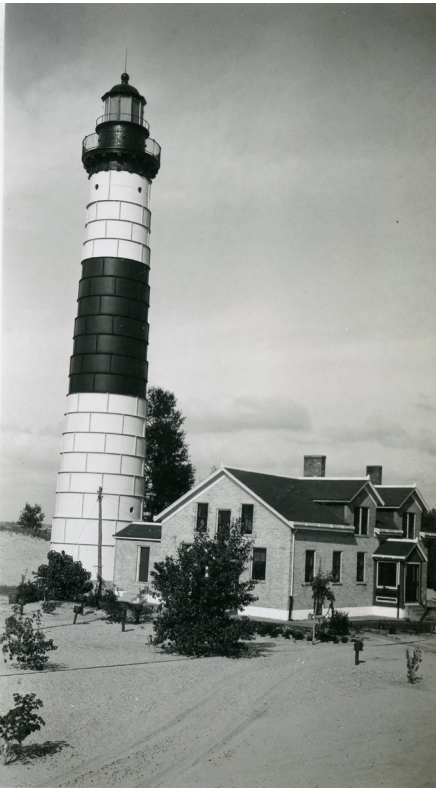
Figure 1B-36: Circa 1920s photograph looking northeast toward the lighthouse. Note the telephone pole west of the passageway.

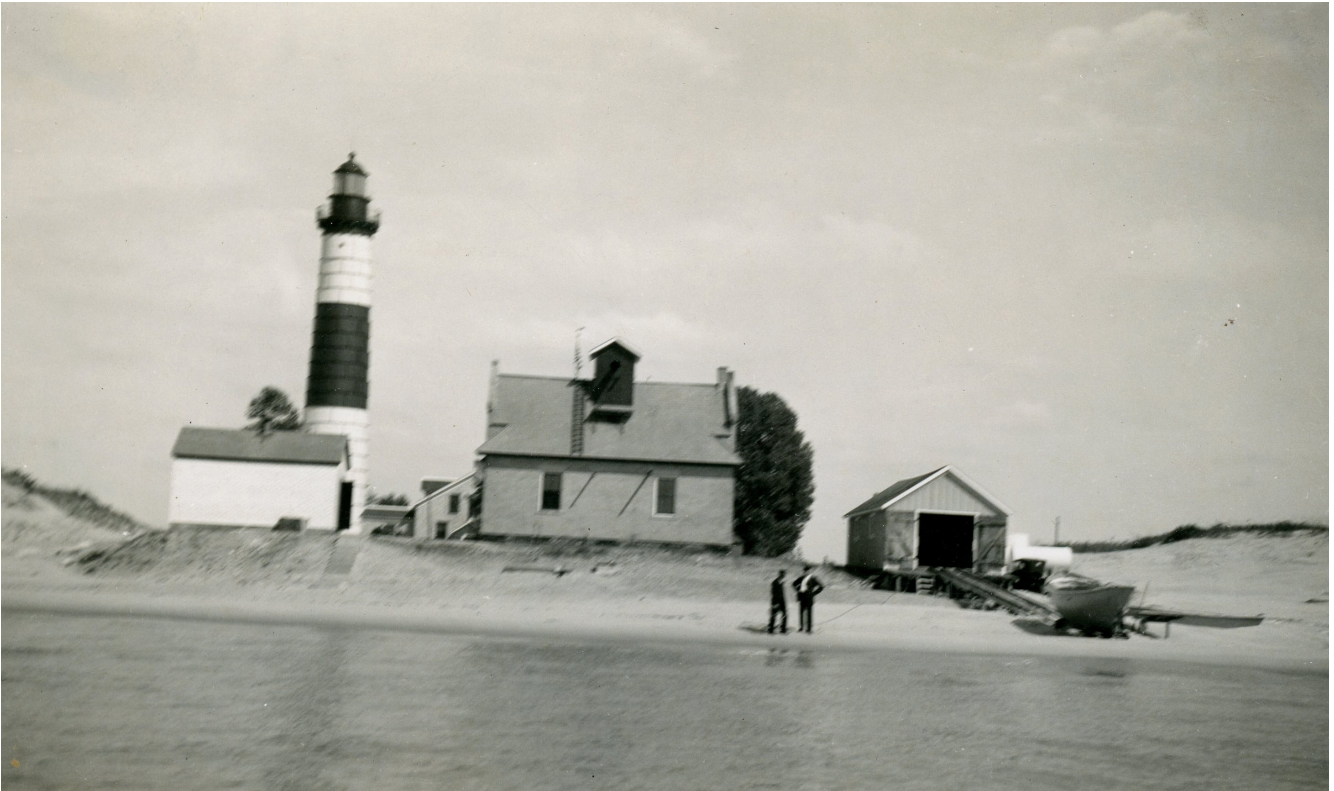
Figure 1B-39: Circa mid-late 1930s looking toward the station from the water.

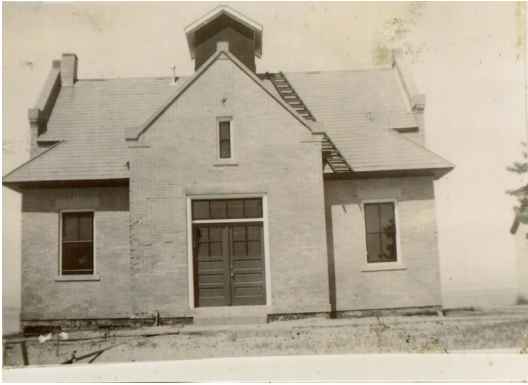
Figure 1B-40: Circa mid-late 1930s of the east side of the fog signal building.

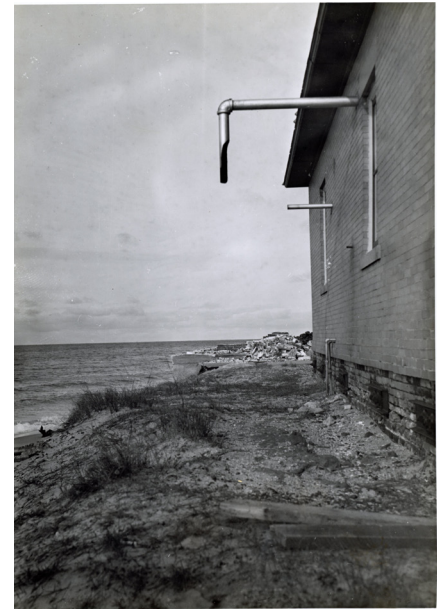
Figure 1B-45: November 1941 photo looking north, just west of the fog signal building. The foundation and debris from the oil house is in the background.

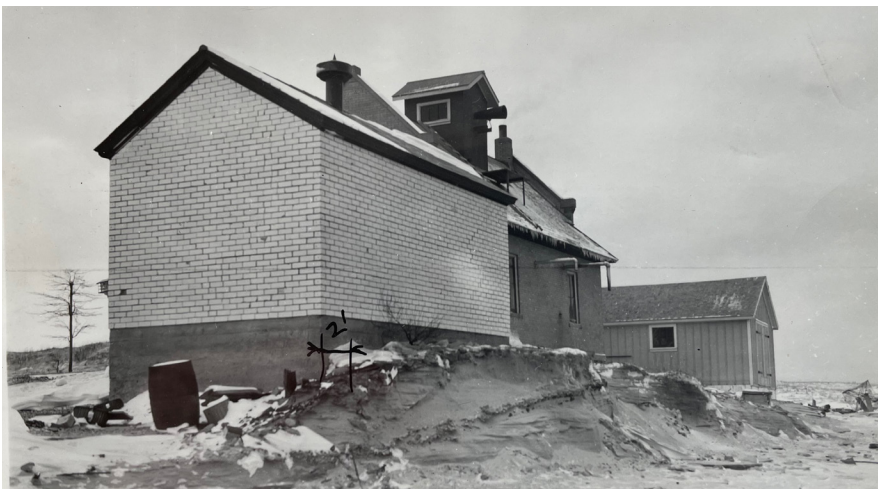
Figure 1B-44: January 1941 photo looking north toward the oil house, fog signal building, and boathouse.

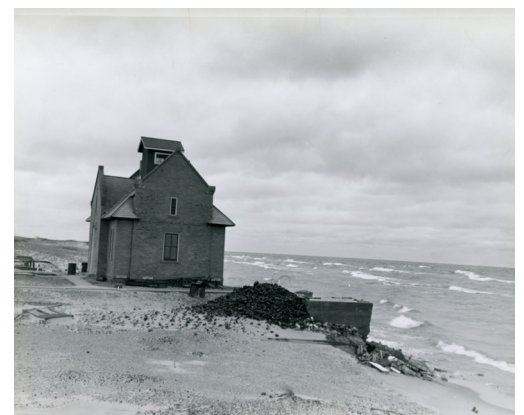
Figure 1B-46: November 1941 photo looking south toward the fog signal building. The foundation and debris from the oil house is in the foreground.

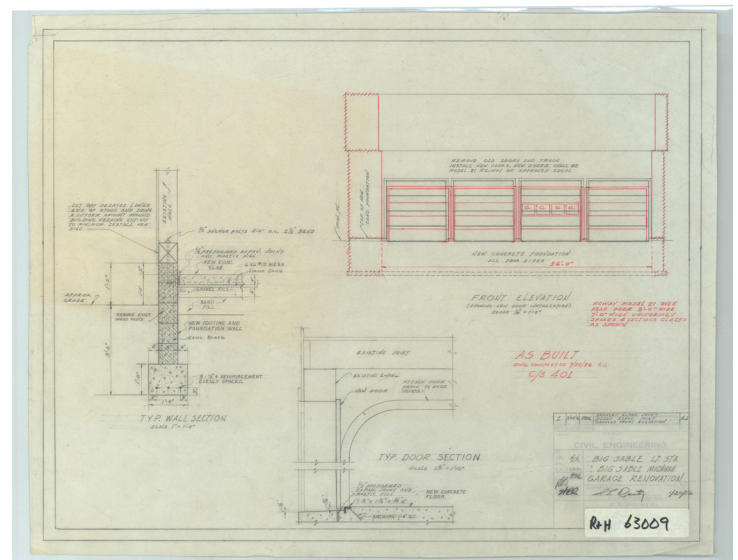
Figure 1B-72: Drawing for the garage update.

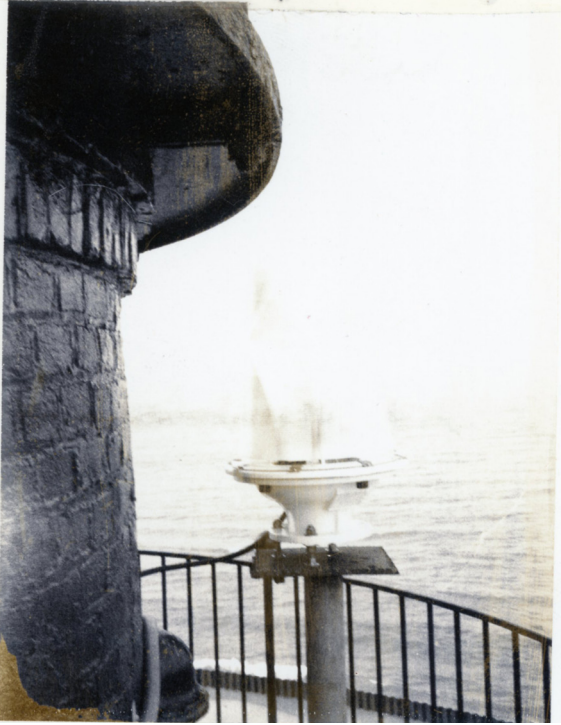
Figure 1B-75: Photo of the stand-by light installed on the lantern gallery in 1971

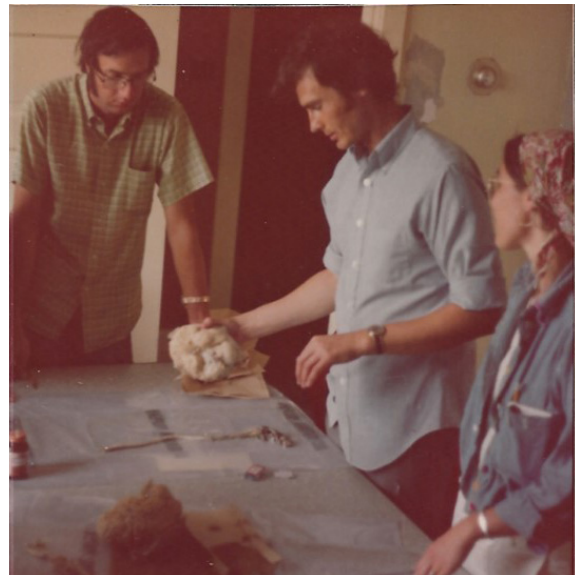
Figure 1B-76: The typed caption with this photo in the SPLKA archives states, "Summer 1974 - Students observe as Dr. Jon DeFrance gives lab demonstration on dissection of human brain during summer conference program." Dr. DeFrance's Curriculum Vitae listed on LinkedIn notes that he is from western Michigan, has degrees in psychology and physiology, and taught at Wayne State University from 1972 through 1976.

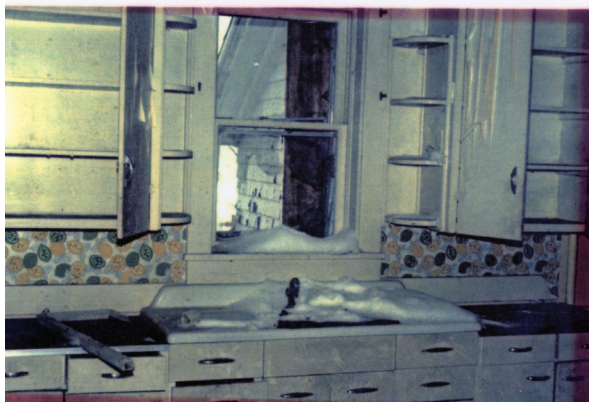
Figure 1B-78: Undated photo showing snow accumulating in the kitchen at a broken window.

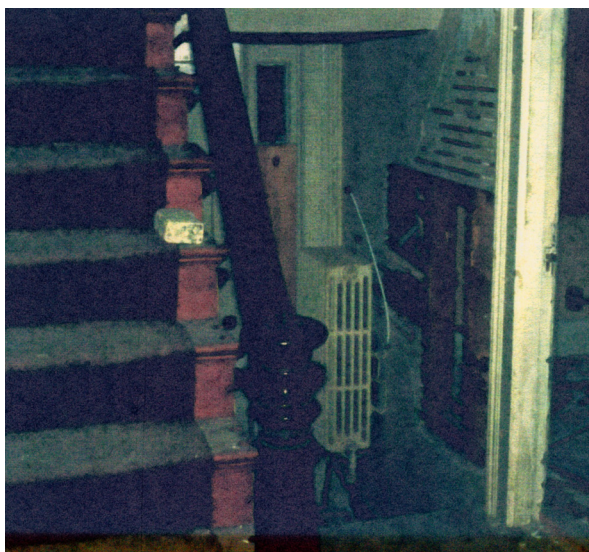
Figure 1B-79: Undated photo showing a section of wall that was removed and missing balusters on the stair.

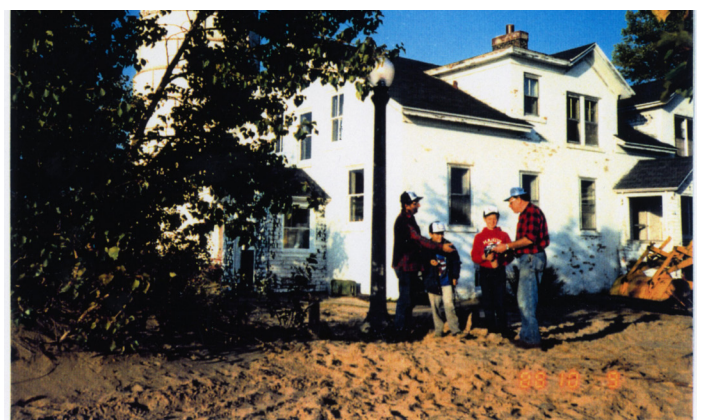
Wendall Putz (left) donates antique yard lighting Association.

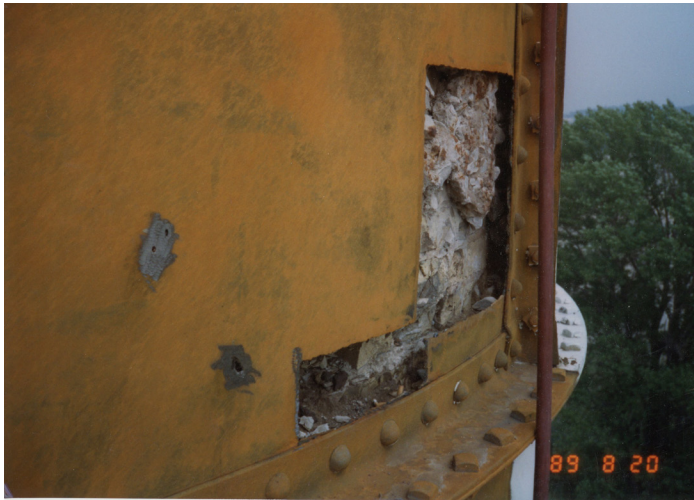
Figure 1B-93: 1989 photo taken during the 1989 tower repairs showing a section of the metal cladding that was removed for replacement.

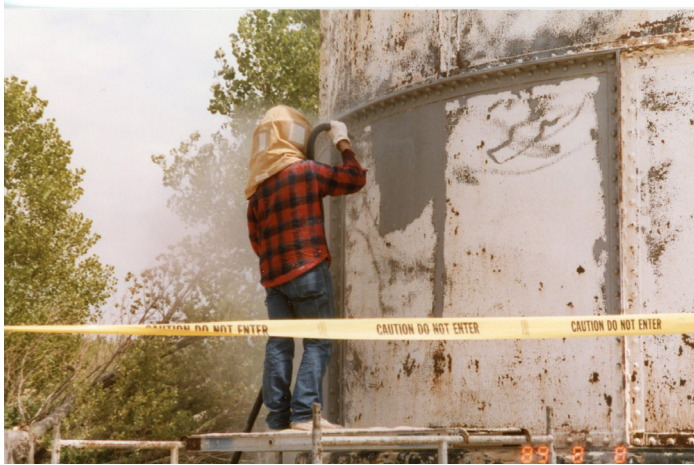
Figure 1B-94: 1989 photo taken during the 1989 tower repairs showing a section of the metal cladding being welded.

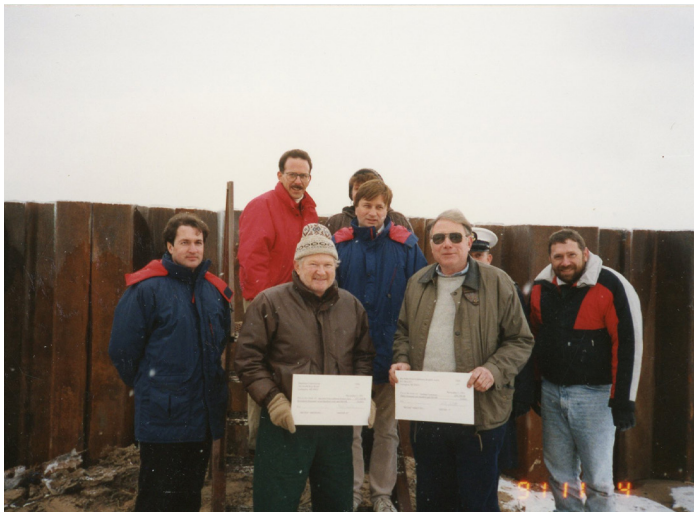
Figure 1B-95: 1989 photo of SPLKA members, State Historic Preservation Representative Brian Conway, and other stakeholders showing commemorative grant checks in front of the new steel piling shoreline protection..

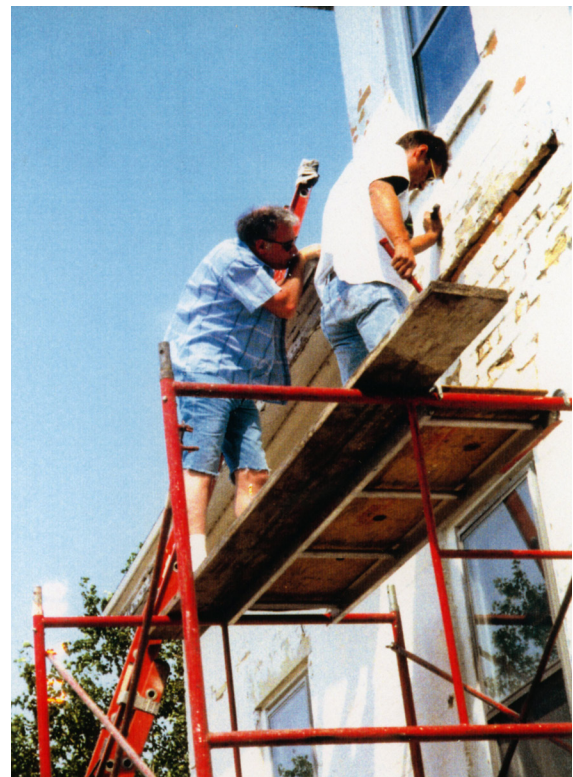
Figure 1B-96: Circa 1990s photo of SPLKA volunteers repointing the masonry wall of the Keepers' Dwelling.

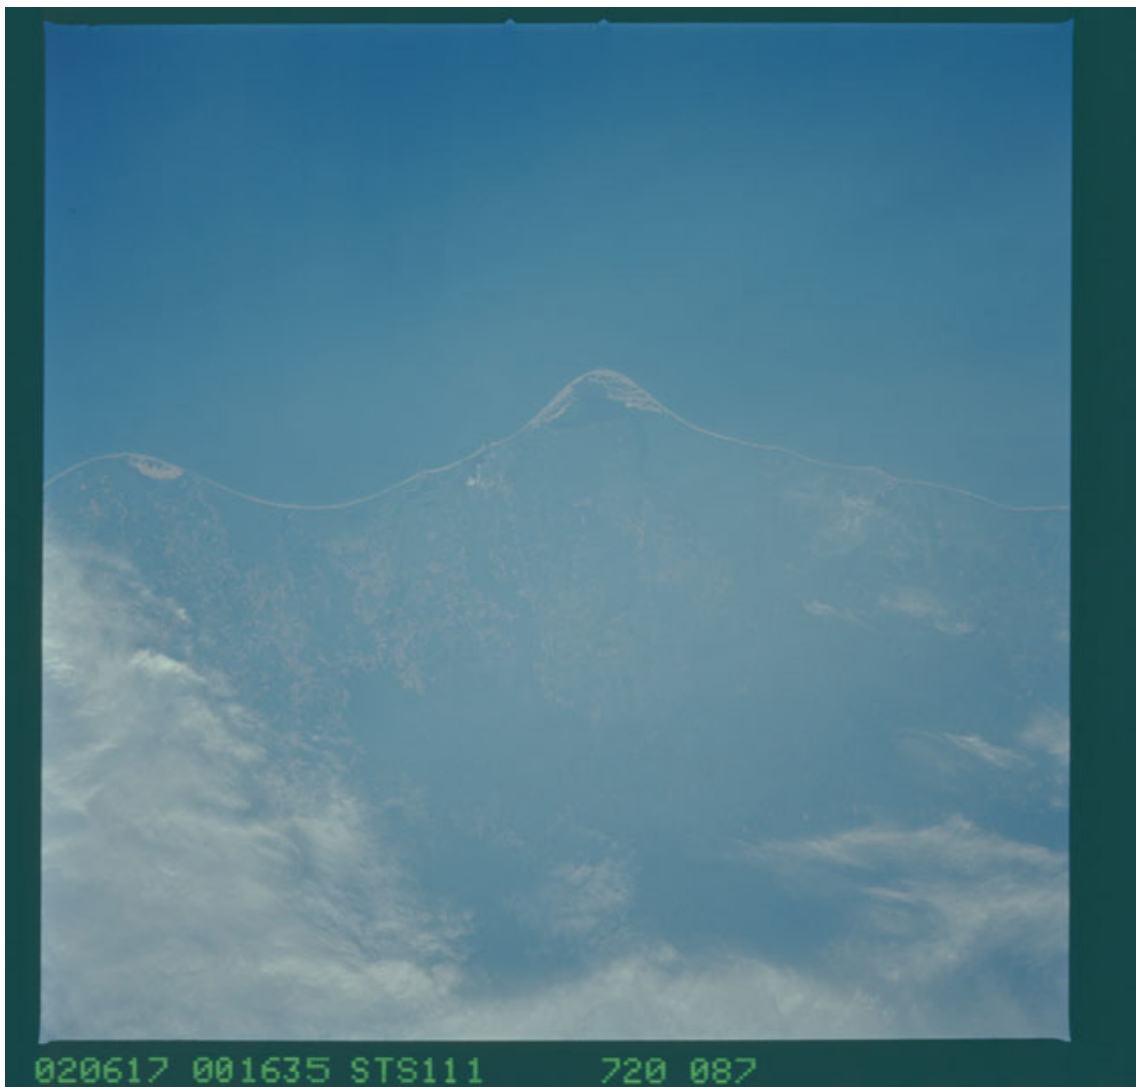
Figure 1B-103: 2002 photo of Big Sable Point in the SPLKA archives noted as being taken from the space shuttle.

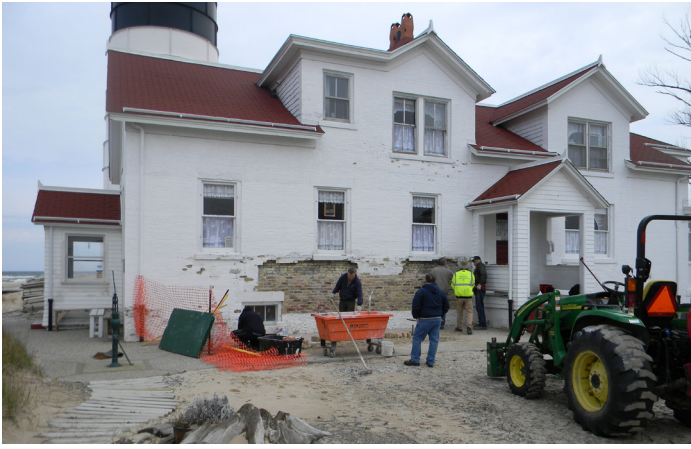
Figure 1B-106: Photo taken during the 2013 masonry workshop.

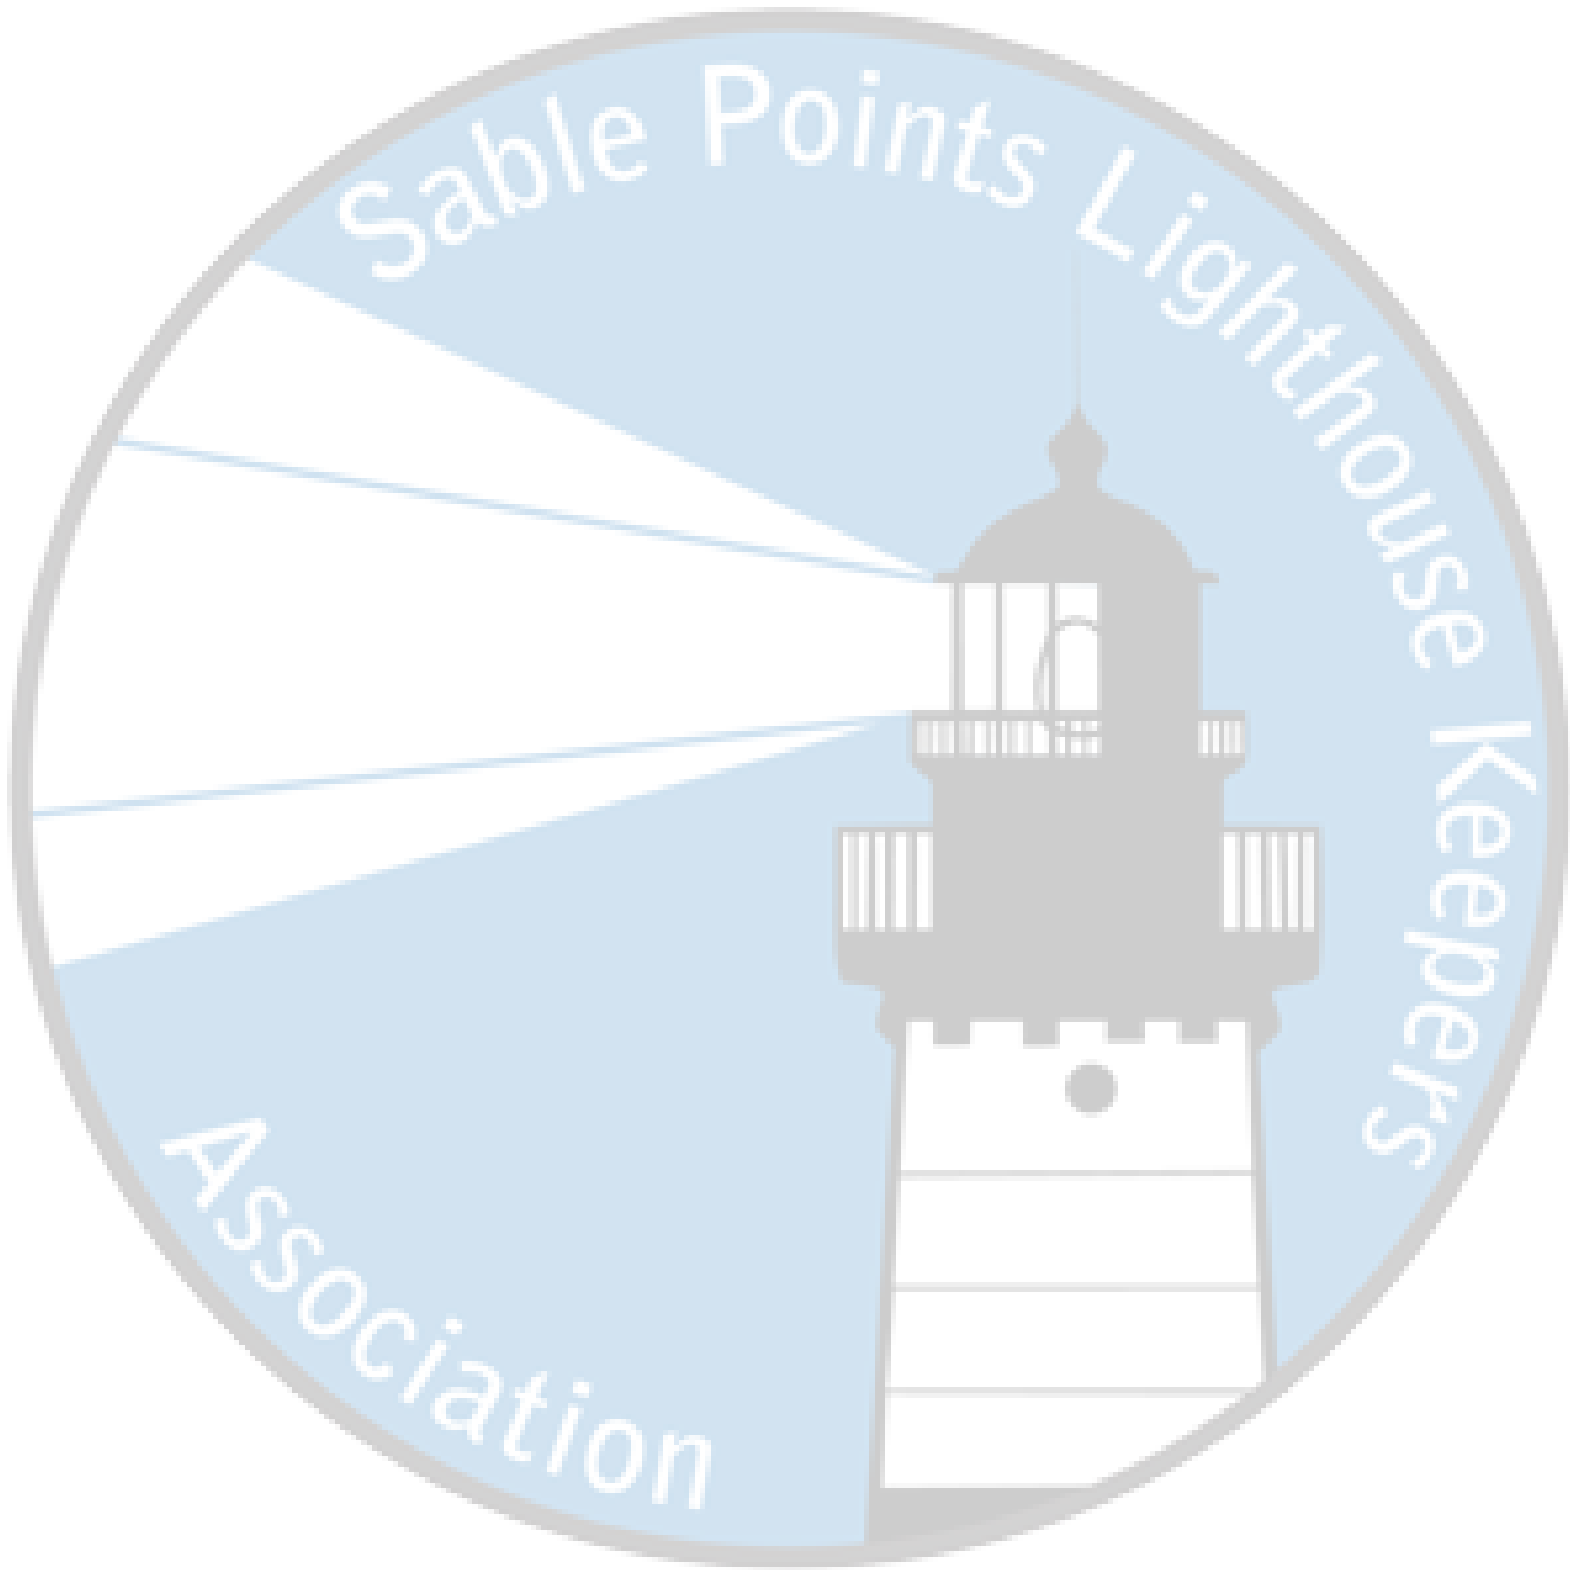
1C Chronology of Development + Use

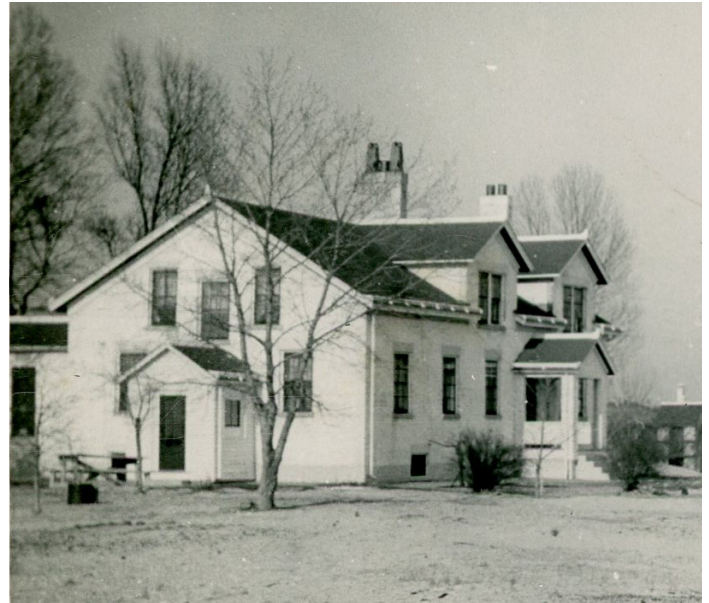
Figure 1C-03: Circa 1940s photo of the Keepers' Dwelling.

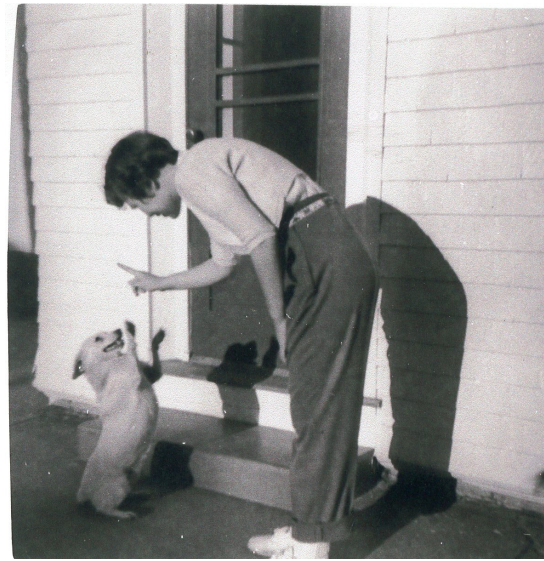
Figure 1C-07: Circa 1950s photo of a woman and dog at the west porch, after the Keepers' Dwelling was painted..

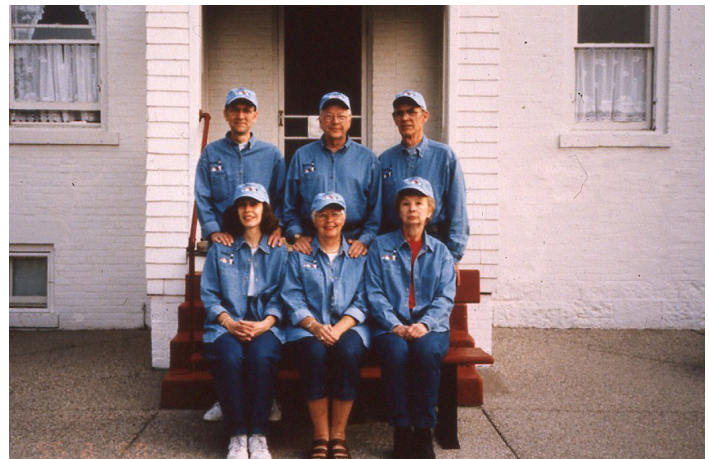
Figure 1C-08: Circa 1990s photo of SPLKA members at the west porch, after the Keepers' Dwelling windows were painted white..
