TABLE OF CONTENTS

Management Summary

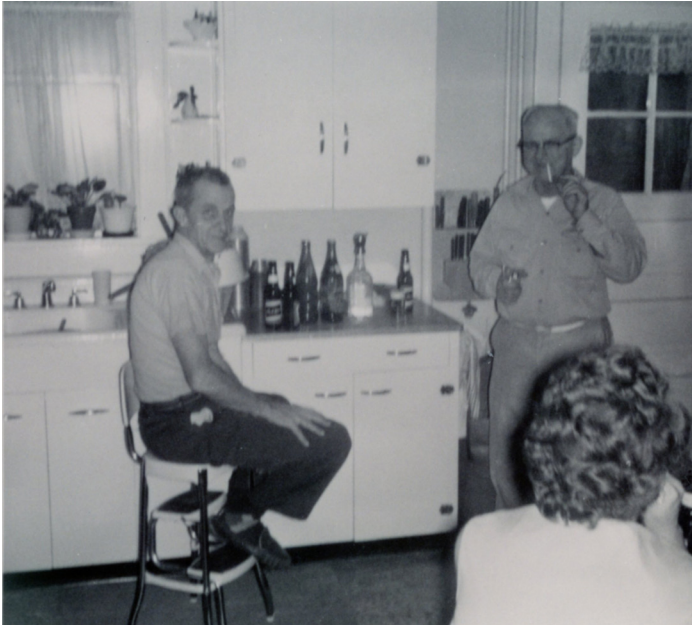
Figure 1C-09: Circa 1960s photo of Keeper Vavrina and others in the first floor, west kitchen..

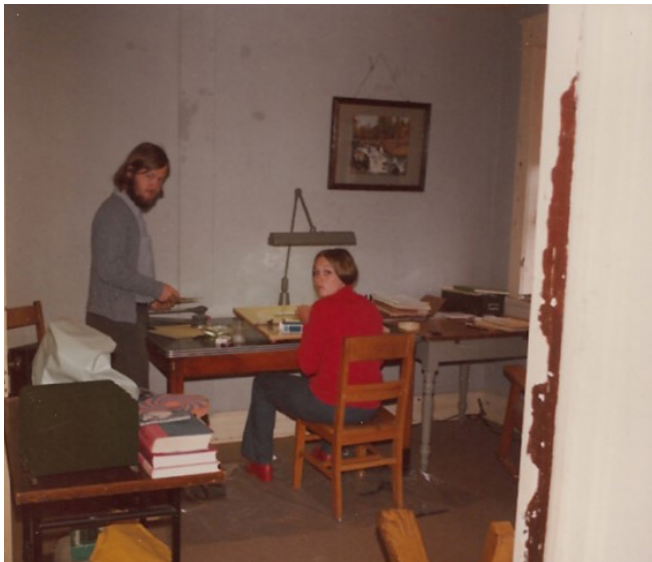
Figure 1C-15: 1974 photo of the students doing a project for the Foundation for Behavioral Research in one of the bedrooms..

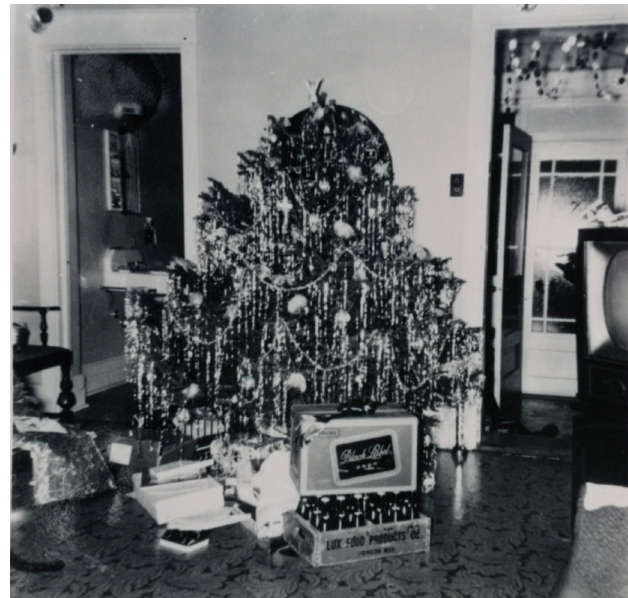
Figure 1C-16: 1963 photo of the Assistant Keeper's (east, first floor) living room..

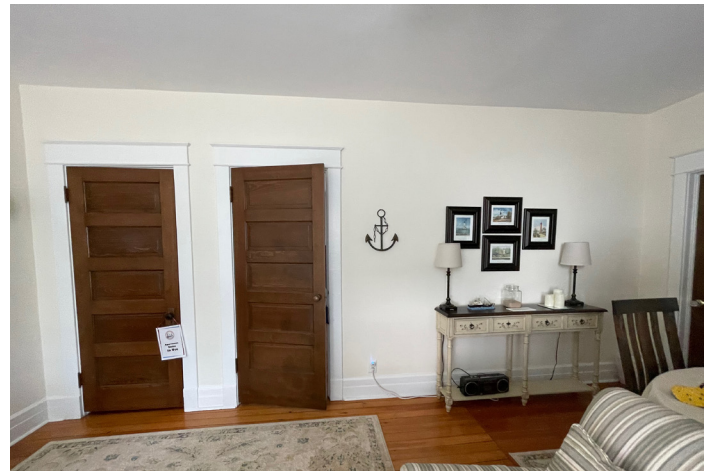
Figure 1C-18: 2023 photo of the Assistant Keeper's (east, first floor) living room..

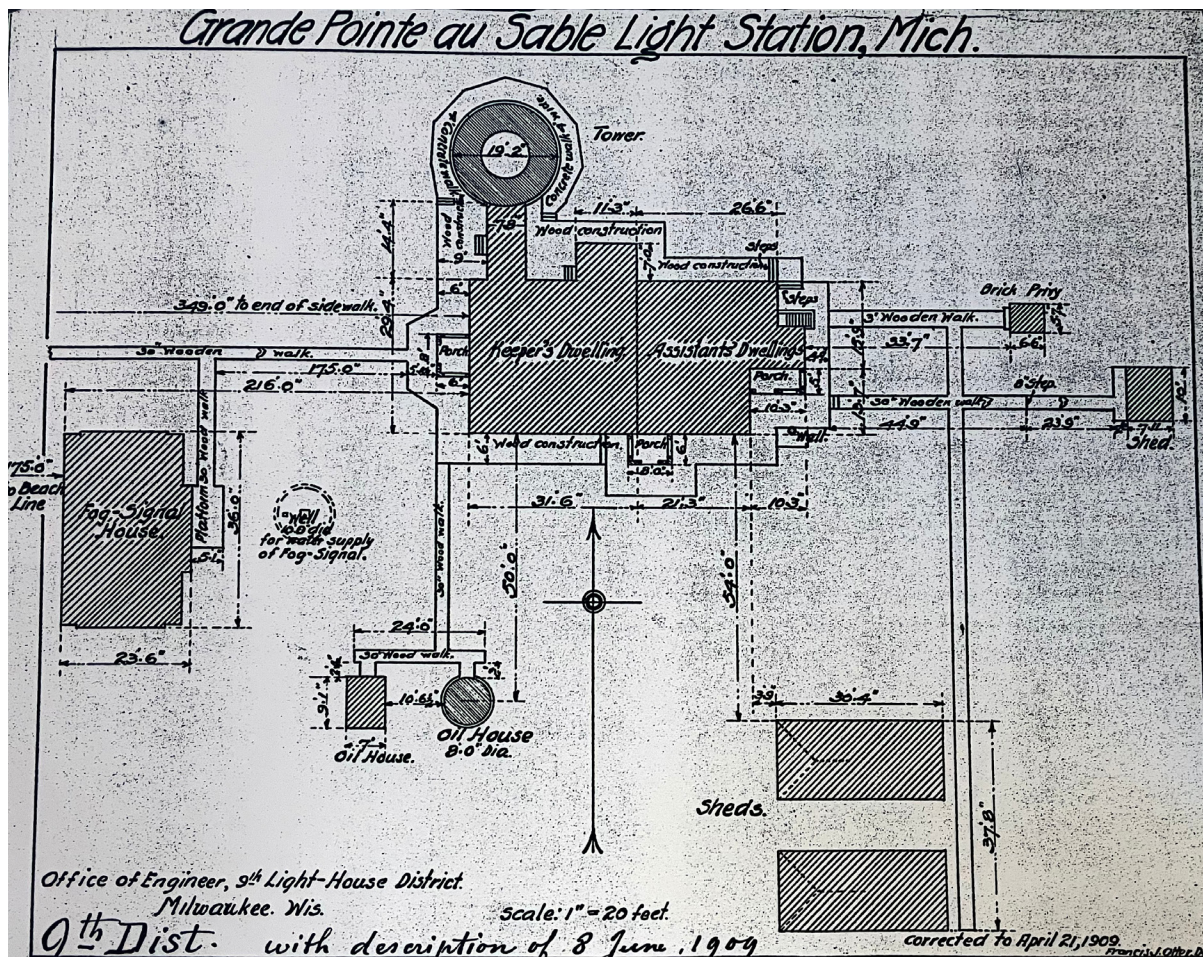
Figure 1C-26: 1909 plot plan of the light station.

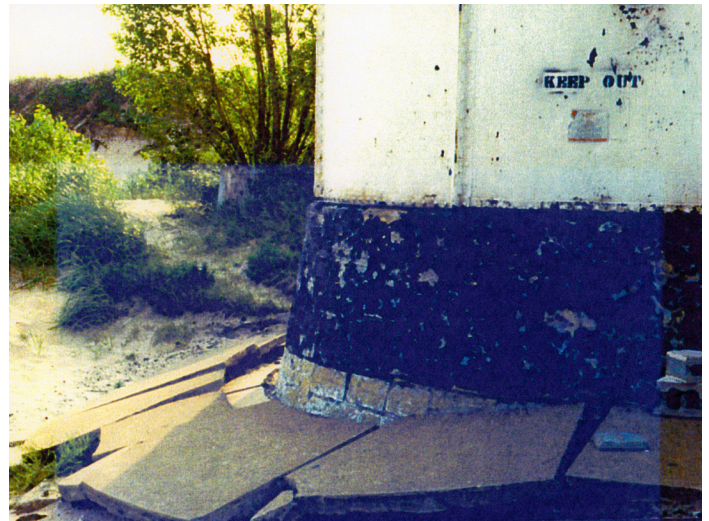
Figure 1C-28: Circa 1980s photo of the collapsed concrete walkway around the base of the tower.

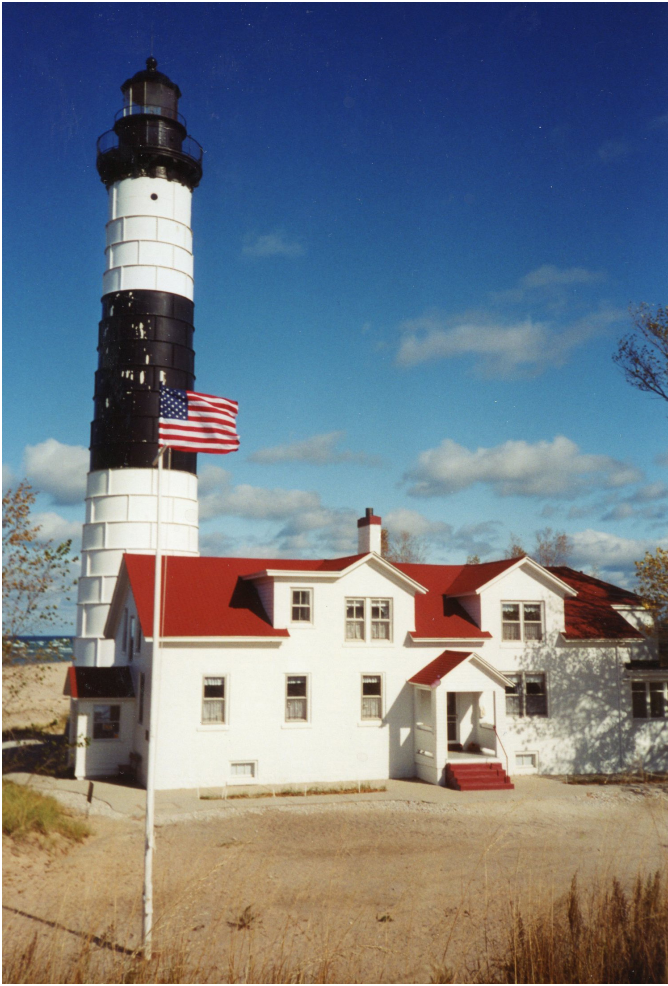
Figure 1C-30: Circa late 1990s photo looking northeast toward the Keepers' Dwelling showing the replacement concrete walkways.

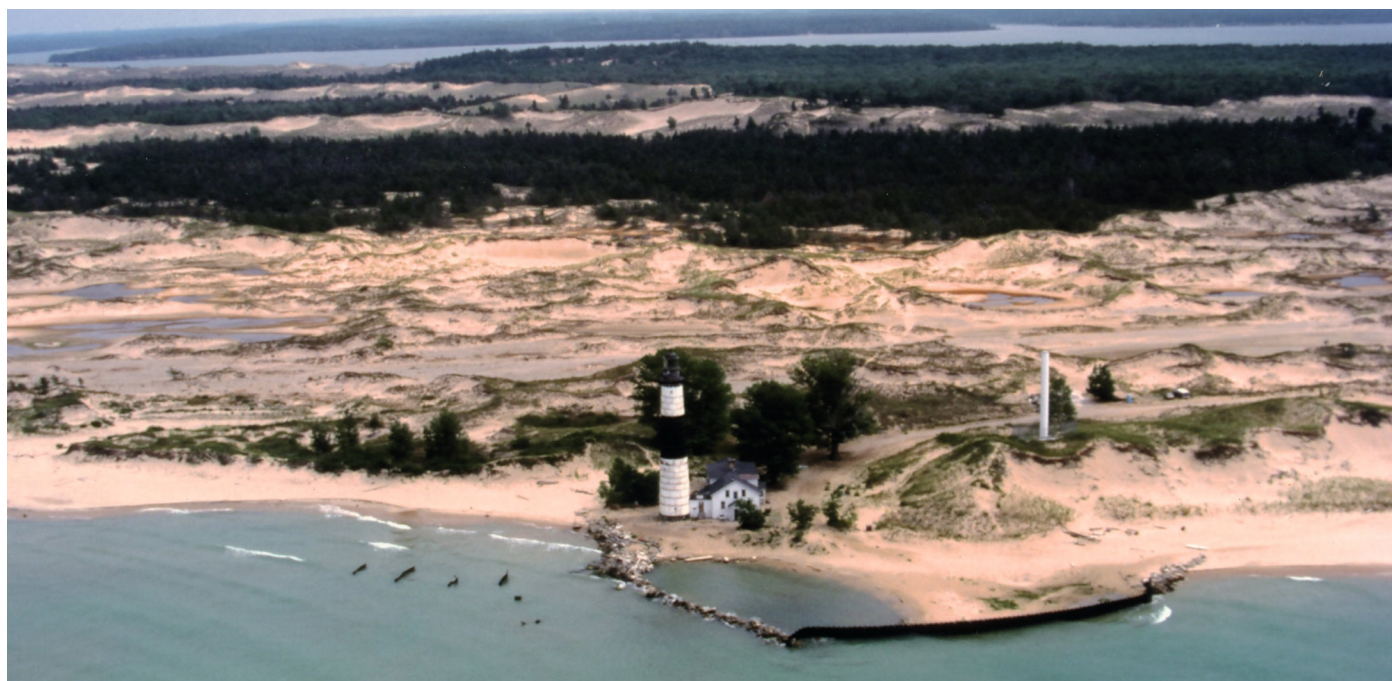
Figure 1C-34: Circa 1986 aerial photo showing the shore protection at that time.

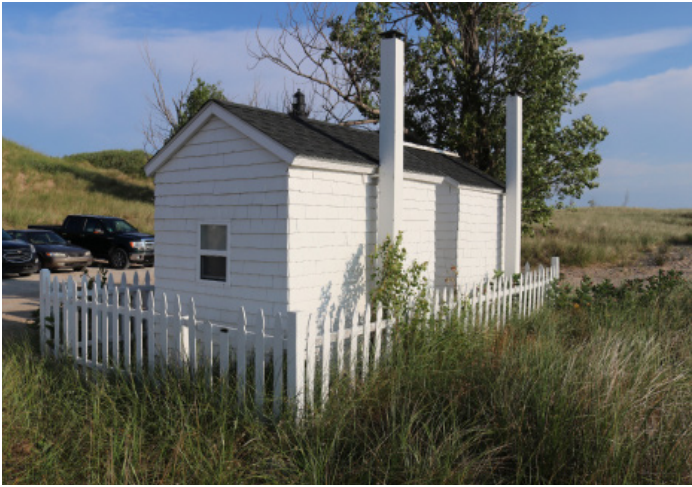
Figure 1D-11 South and east elevations of the public Vault Toilets.

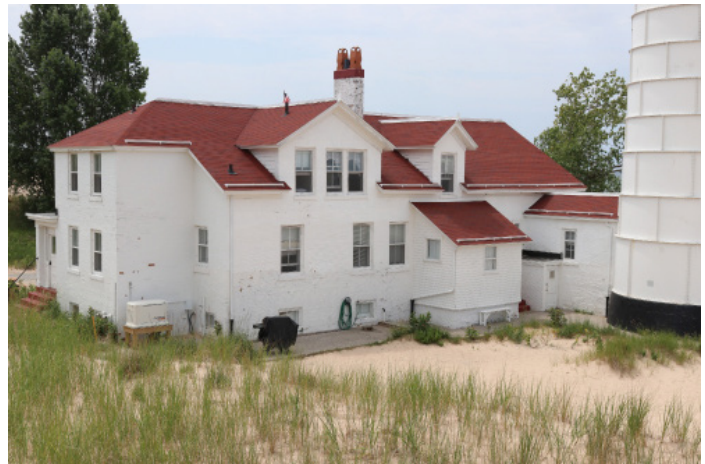
Figure 1D-34 North elevation of the Keepers' Dwelling.

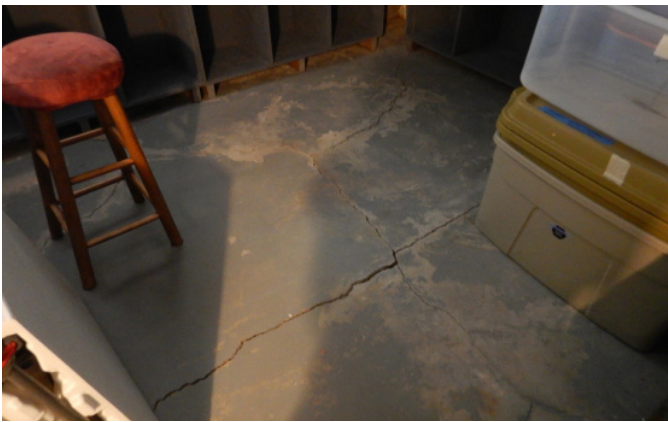
Figure 1D-38 Cracked and heaved slab on ground in southwest quadrant of basement of keepers dwelling

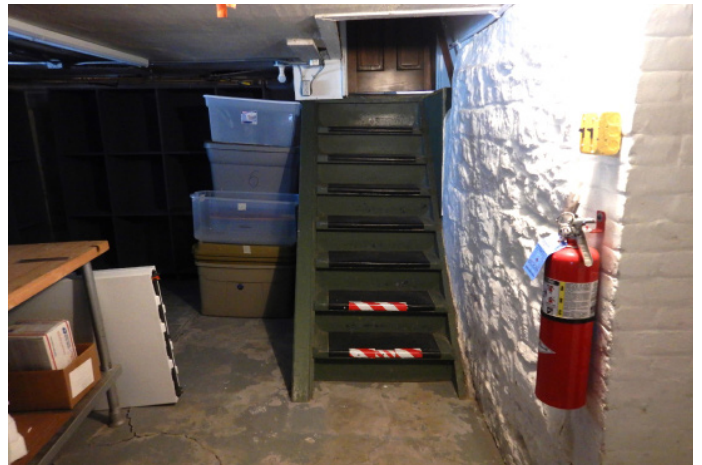
Figure 1D-39 Unlevel stair treads at basement stair in southwest quadrant of basement.

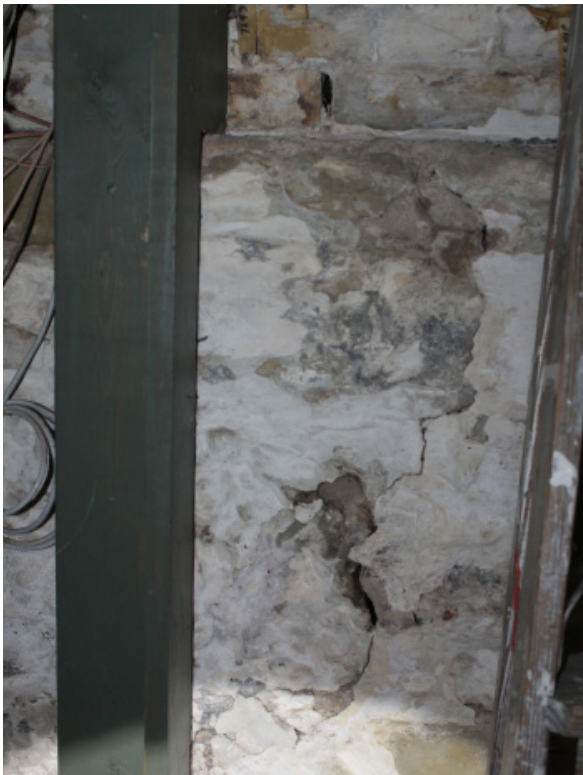
Figure 1D-40 Vertical cracking in upper courses of center stone masonry bearing wall.

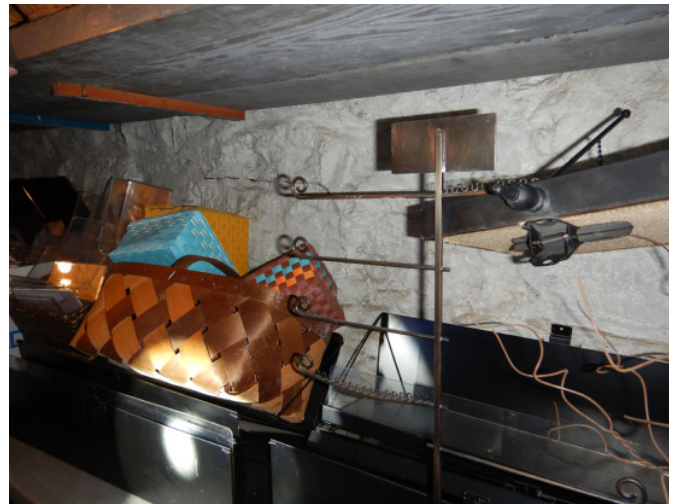
Figure 1D-41 Step cracking in center stone masonry bearing wall behind storage shelves.

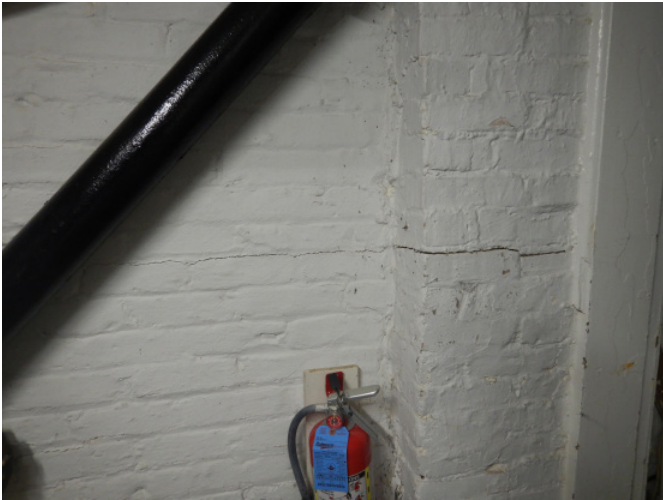
Figure 1D-43 Horizontal crack in south brick masonry foundation wall.

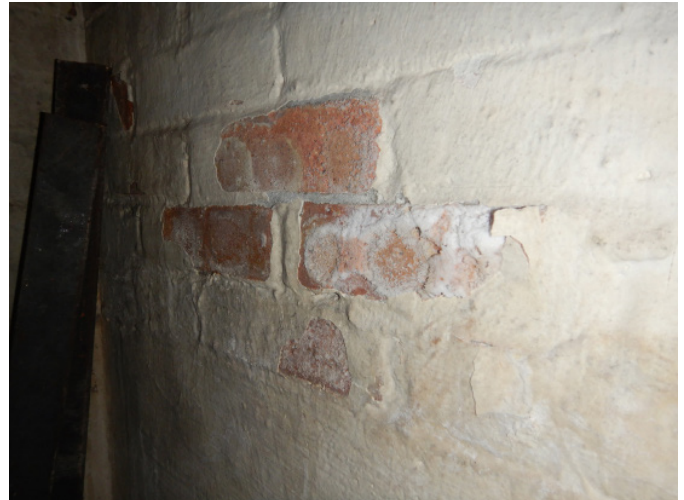
Figure 1D-42 Missing and peeling coating, efflorescence present on south brick masonry foundation wall.

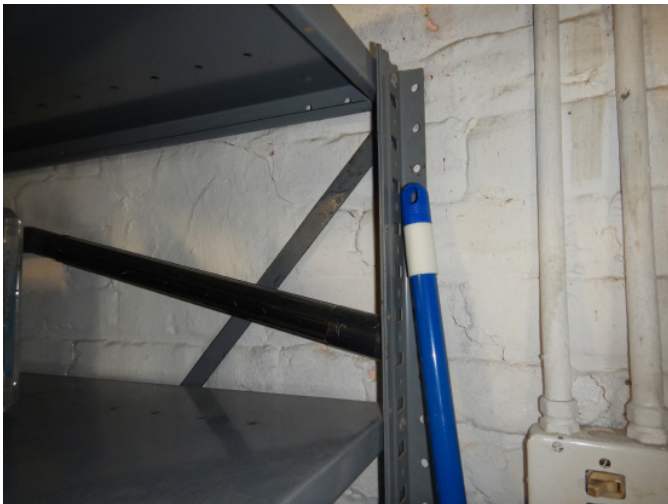
Figure 1D-44 Minor step cracking in brick masonry center bearing wall.

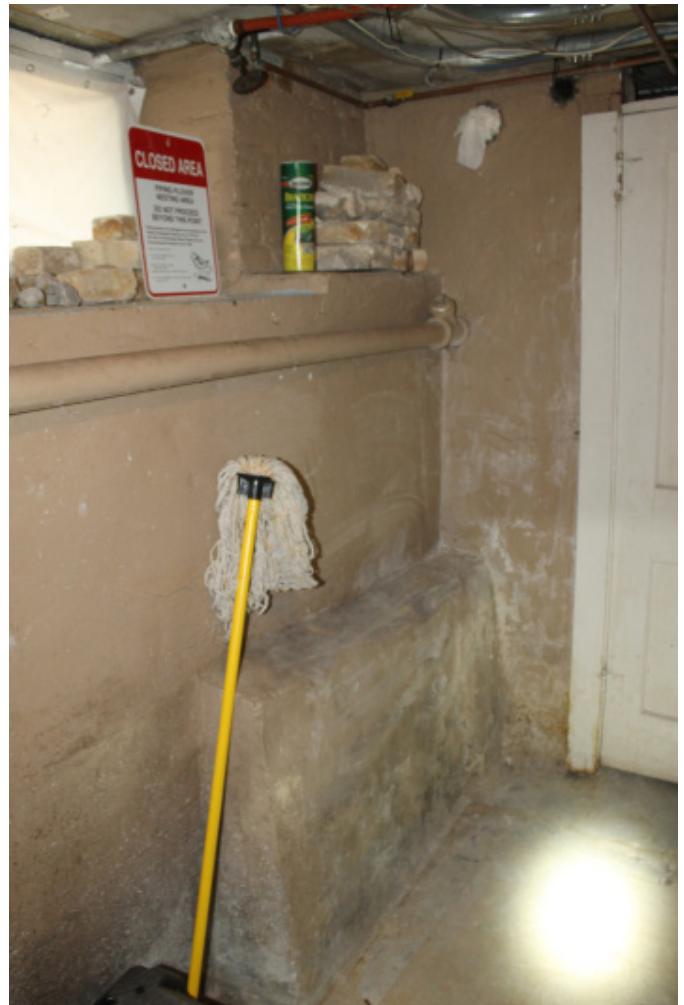
Figure 1D-45 Underpinning present in north brick masonry foundation wall.

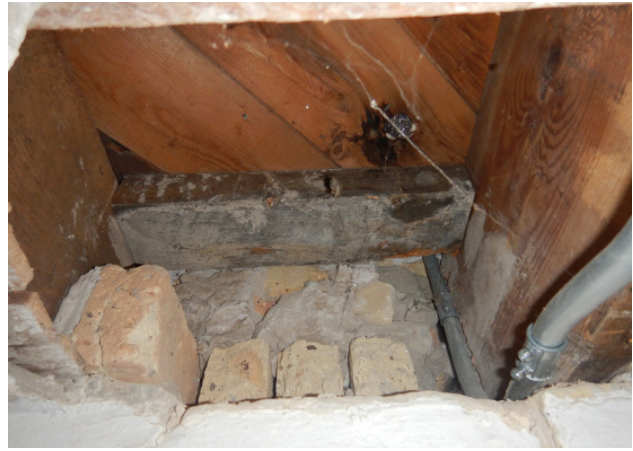
Figure 1D-46 Floor joists bearing at south brick basement wall; note diagonal subfloor and wood blocking between joists.

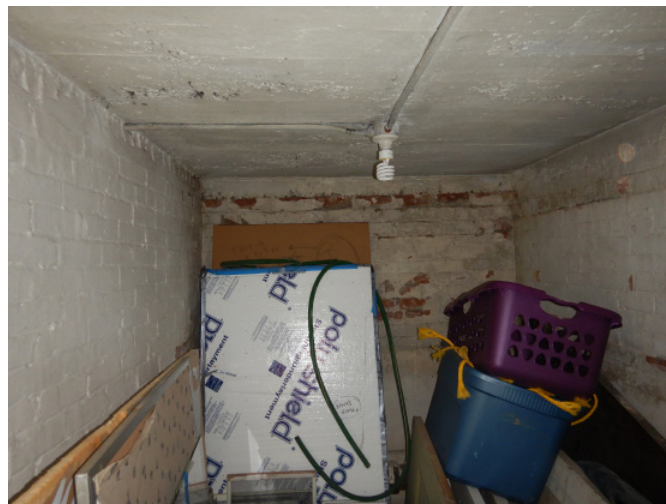
Figure 1D-50 Underside of concrete slab at southeast corner vestibule above; note condition of brick on east and south exterior walls of this basement level storage room.

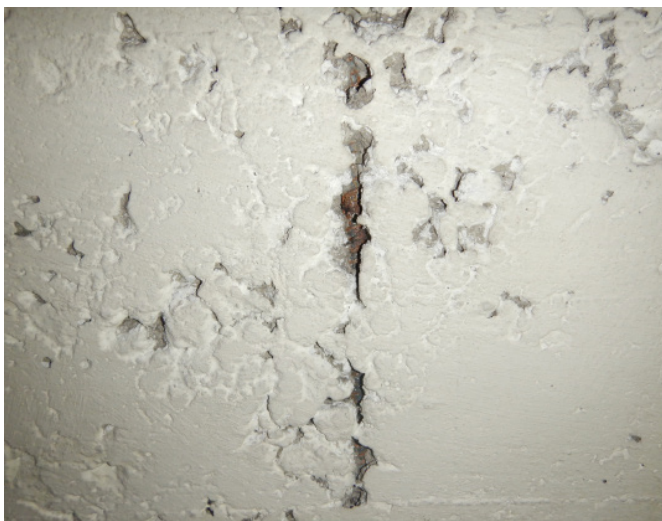
Figure 1D-51 Steel reinforcing visible where concrete was poorly consolidated during original construction.

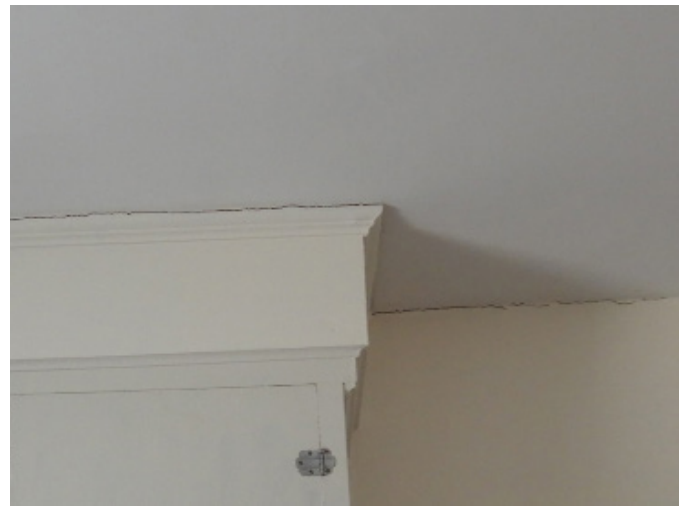
Figure 1D-52 Separation at ceiling and cupboard, and at ceiling and wall in first floor eastern kitchen space along east wall.

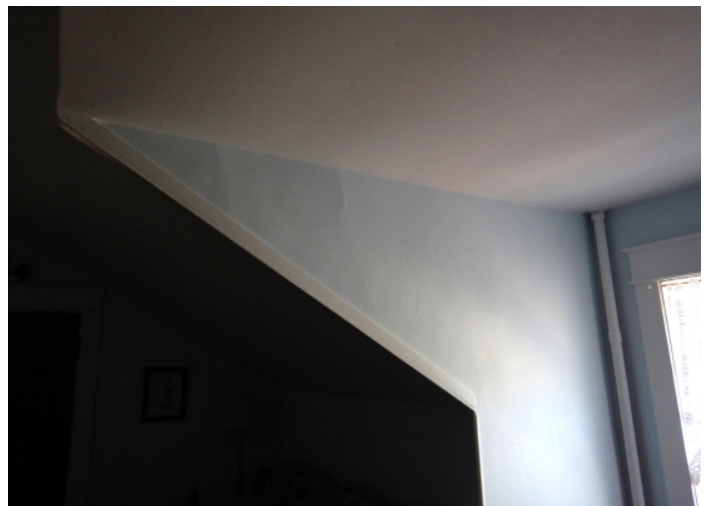
Figure 1D-53 Cracking in west wall of north dormer at second floor living area.

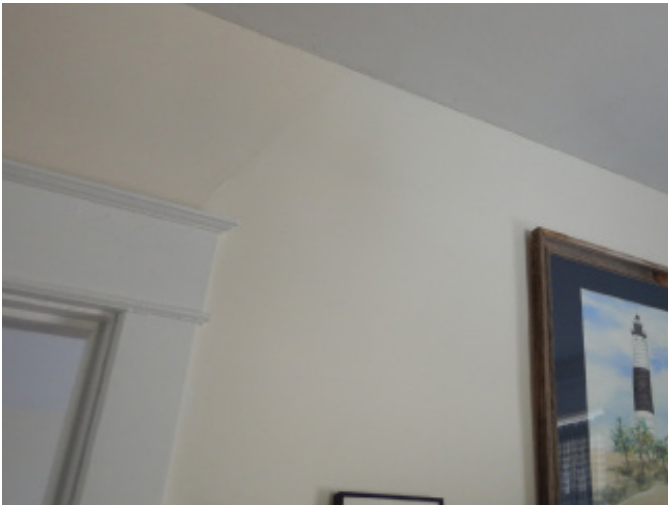
Figure 1D-54 Cracking in ceiling near center of room and extending up from corner of door.

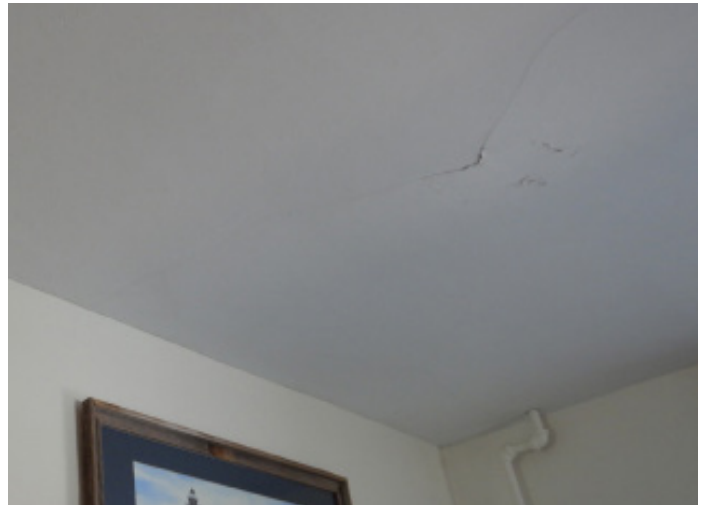
Figure 1D-55 Cracking in ceiling near center of room and extending up from corner of door.

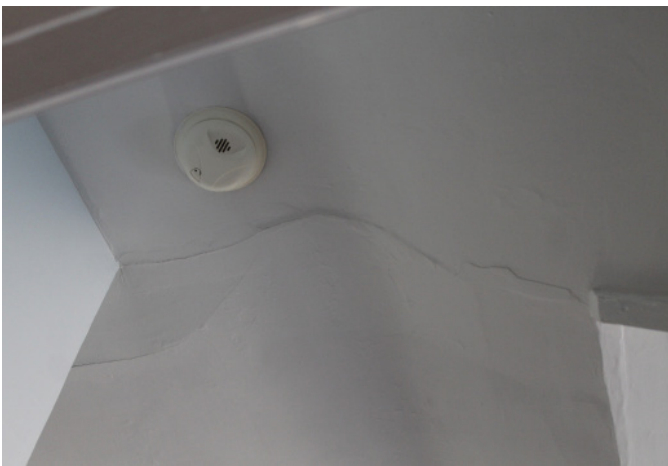
Figure 1D-56 Cracking between interior partition walls in ceiling.

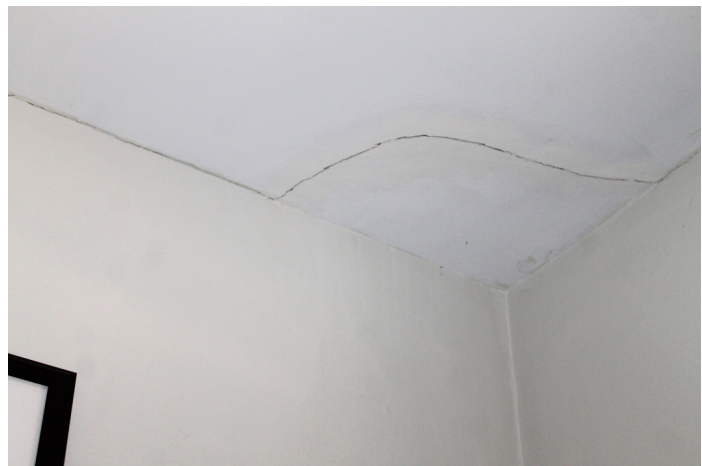
Figure 1D-57 Cracking reoccurred after previous repair attempt.

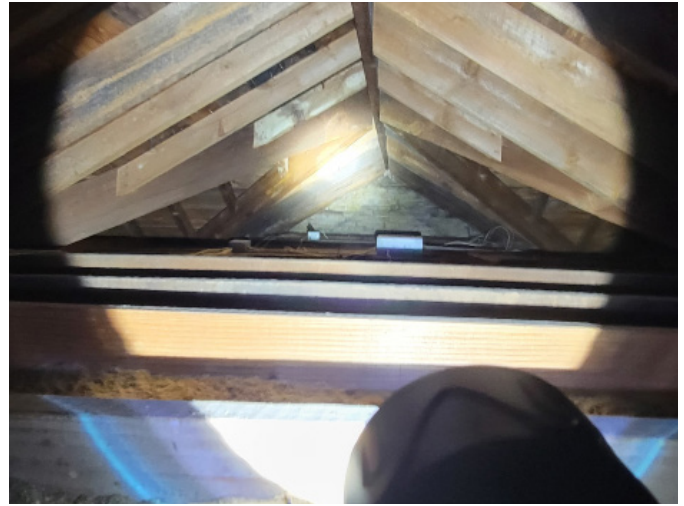
Figure 1D-59 Roof framing at ridge of east half of Keepers' Dwelling; note single nominal 2x members at dormer framing each side.

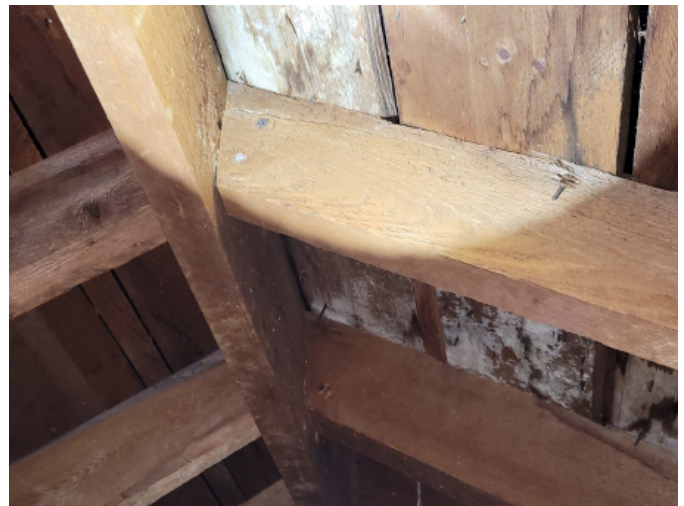
Figure 1D-60 Difference of color in skip-board sheathing at west half of roof; rafters are tight to ridge board.

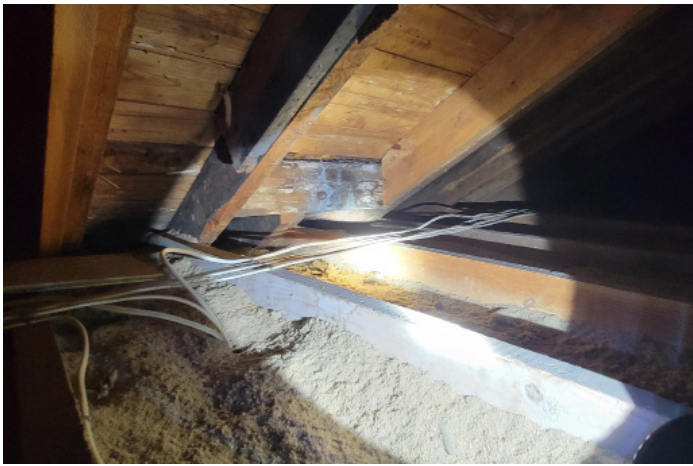
Figure 1D-62 Extensive water staining at south dormer framing at east half of roof.

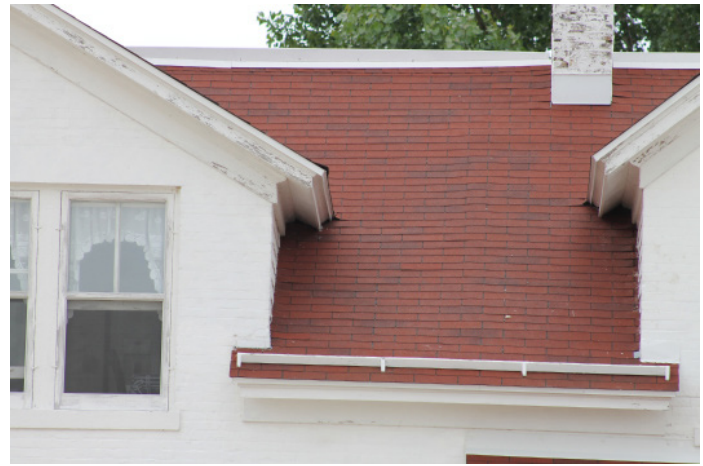
Figure 1D-63 Sloping of roof adjacent to center masonry demising wall at chimney on eastern portion of the Keepers' Dwelling.

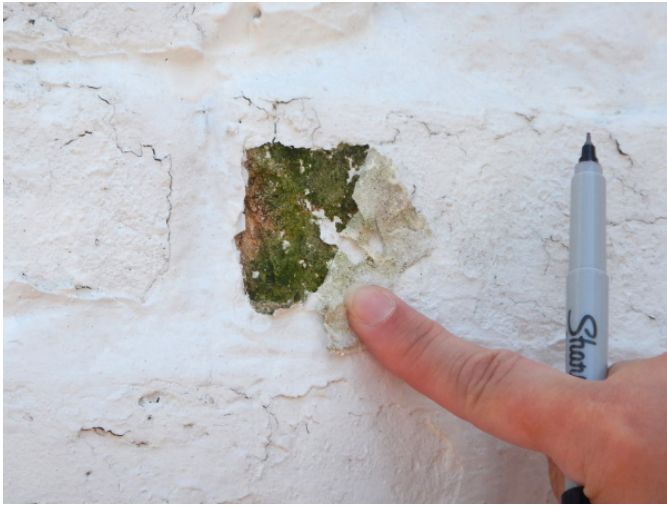
Figure 1D-64 Organic growth located between the brick masonry exterior face and the exterior coating.

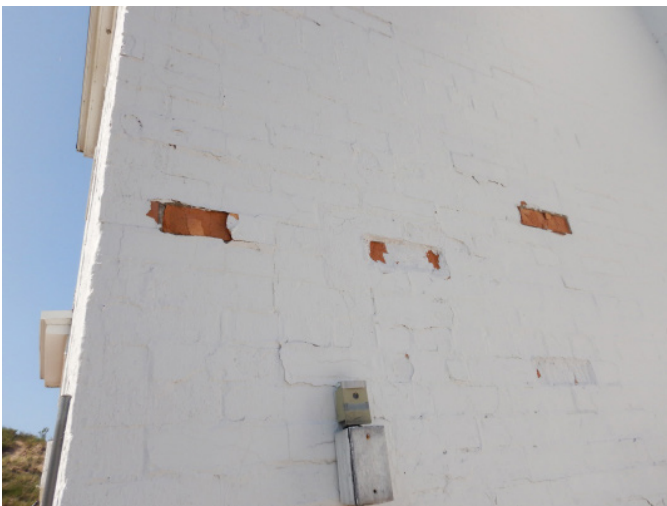
Figure 1D-65 Exposed red, spalled brick at east end of north façade where coating is missing.

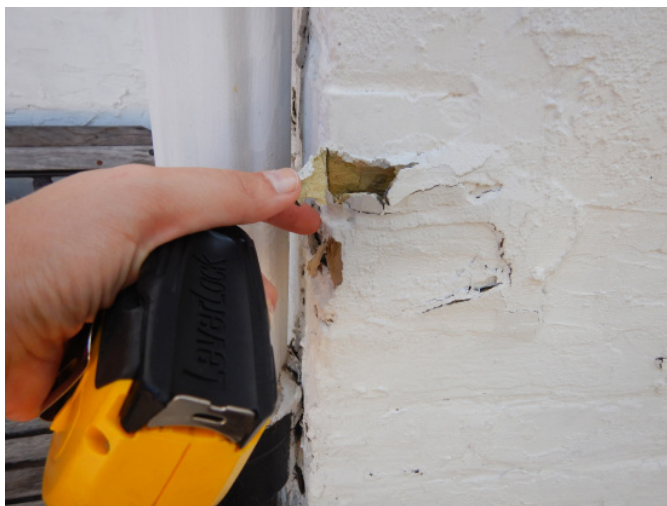
Figure 1D-66 Buff colored brick spalling where coating is peeling off of exterior surface of wall.

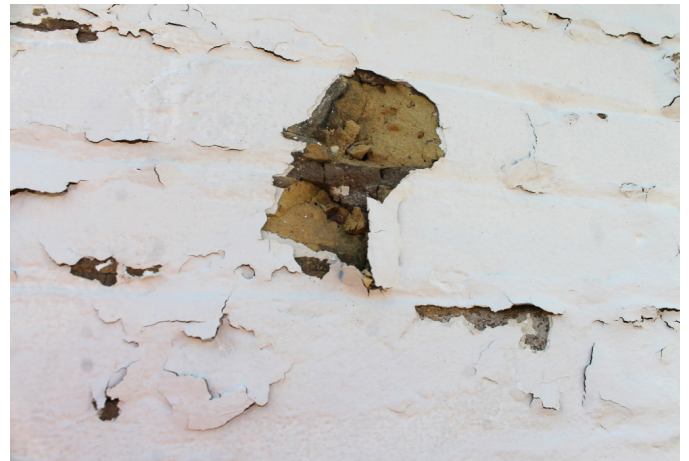
Figure 1D-67 Damaged buff colored brick behind coating which was peeling off of exterior surface of wall.

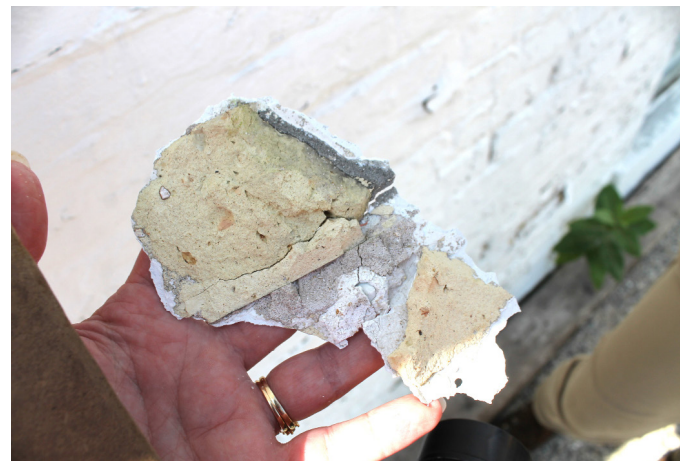
Figure 1D-68 Portions of buff colored brick bonded to coating from area shown in Figure 1D-67, note two different mortars also bonded to removed exterior coating.

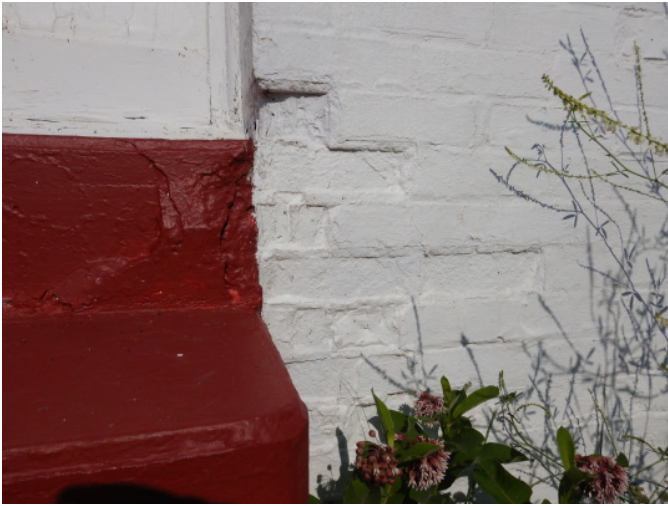
Figure 1D-69 Coating applied over spalled brick.

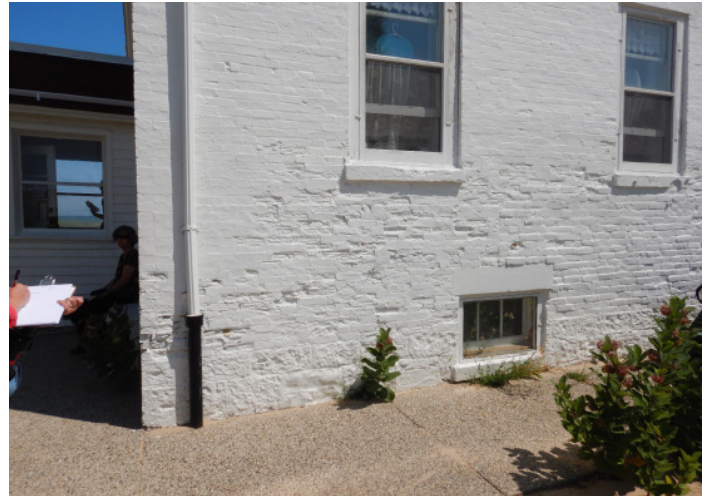
Figure 1D-70 Coating applied over spalled brick.

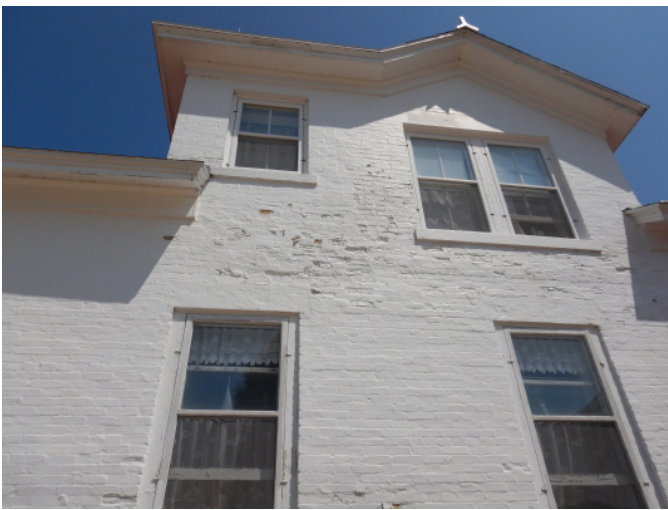
Figure 1D-71 Coating applied over spalled brick.

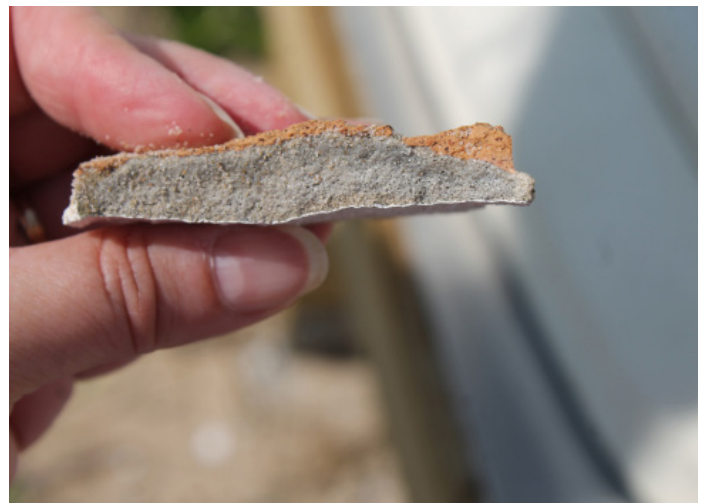
Figure 1D-72 Coating (on bottom surface of sample this photo) applied over cementitious fill over red brick (top surface of sample this photo).

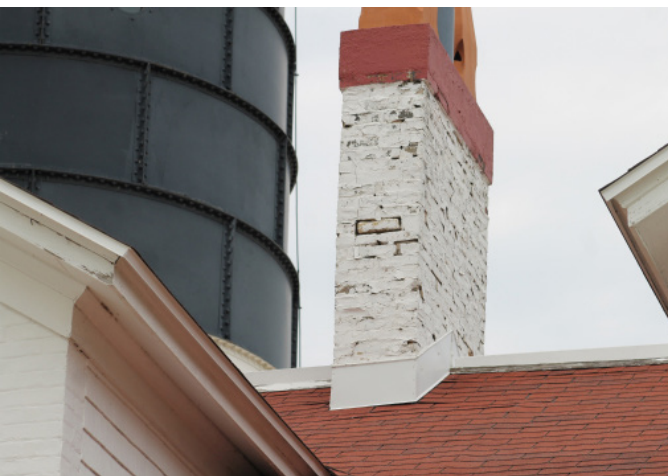
Figure 1D-73 Mortar around brick in chimney missing.

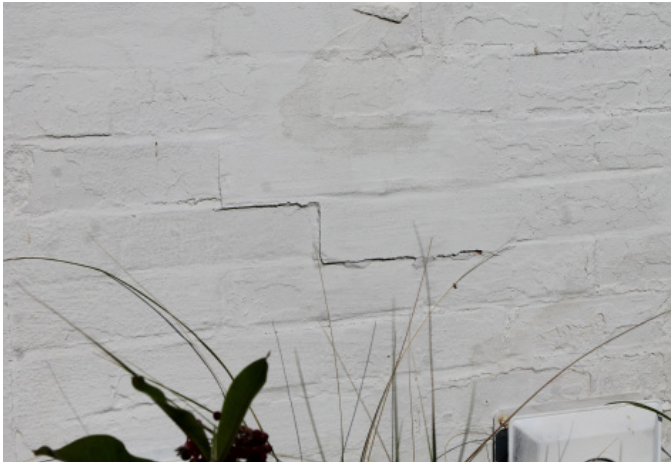
Figure 1D-74 Step cracking on east facade, north of basement windows.

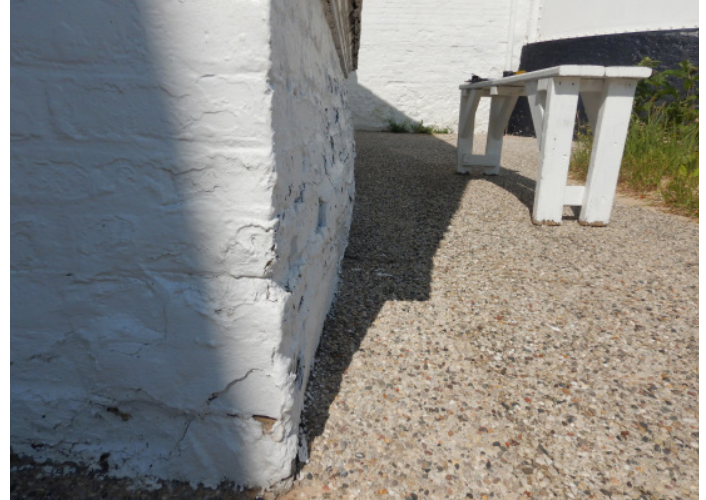
Figure 1D-77 Visibly displaced outward brick foundation wall of single-story projection on north facade.

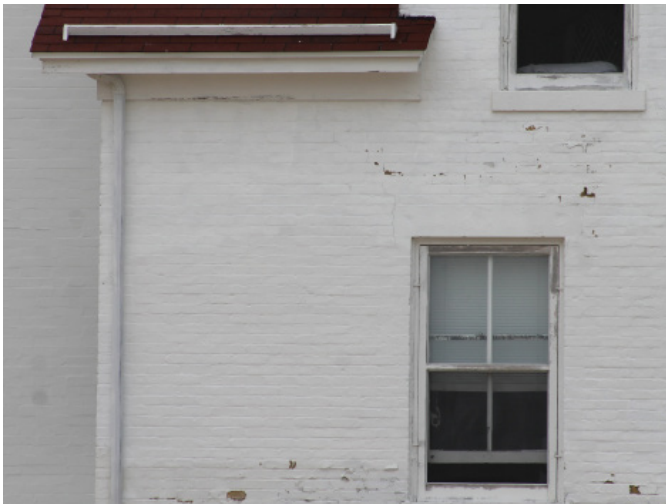
Figure 1D-75 Cracking extending between eastern corner of window and roof level at north facade.

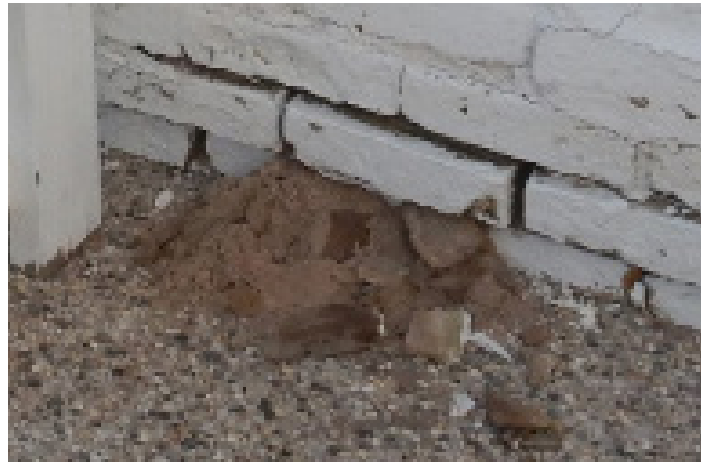
Figure 1D-78 Sand obtained from behind the loose brick when brick was removed.

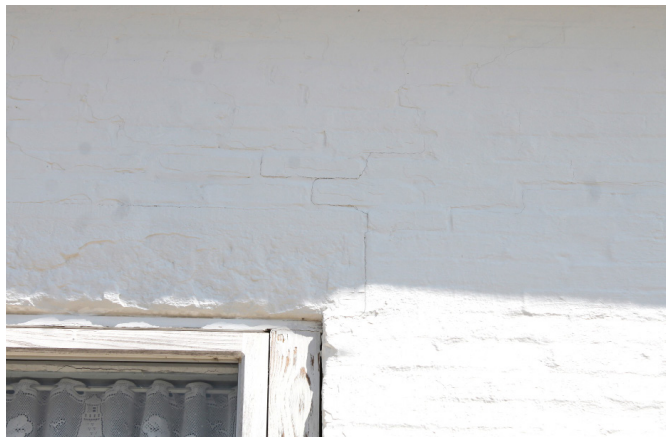
Figure 1D-76 Step cracking along edge of stone masonry lintel at the western end of the south facade.

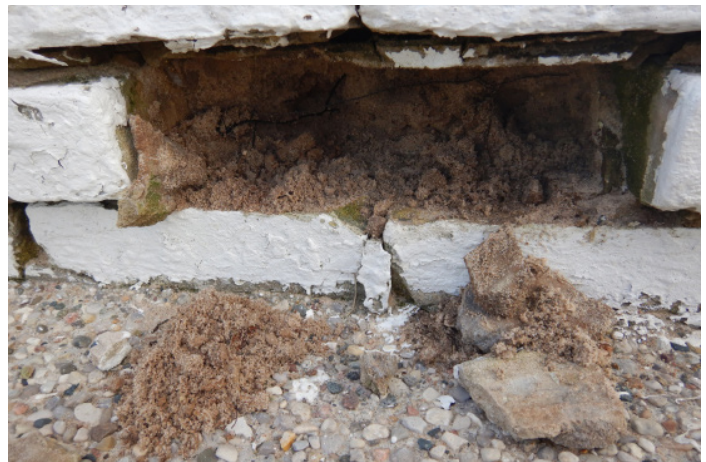
Figure 1D-79 Vegetation rooting in sand directly behind loose brick.

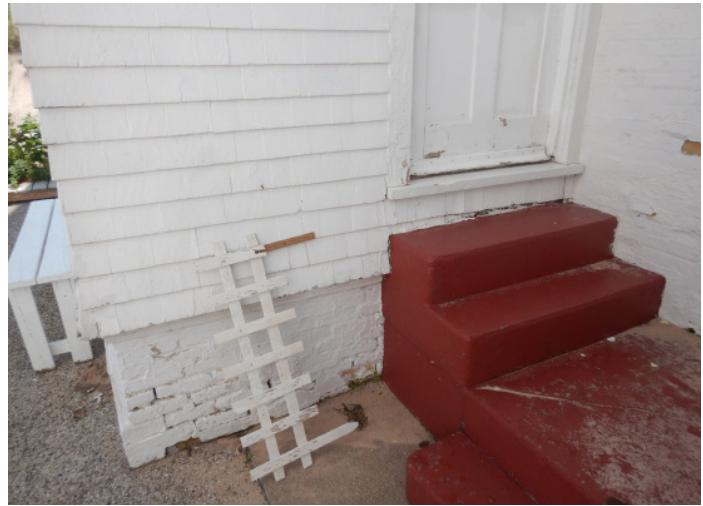
Figure 1D-80 North stairs up to first floor level of Keepers' Dwelling.

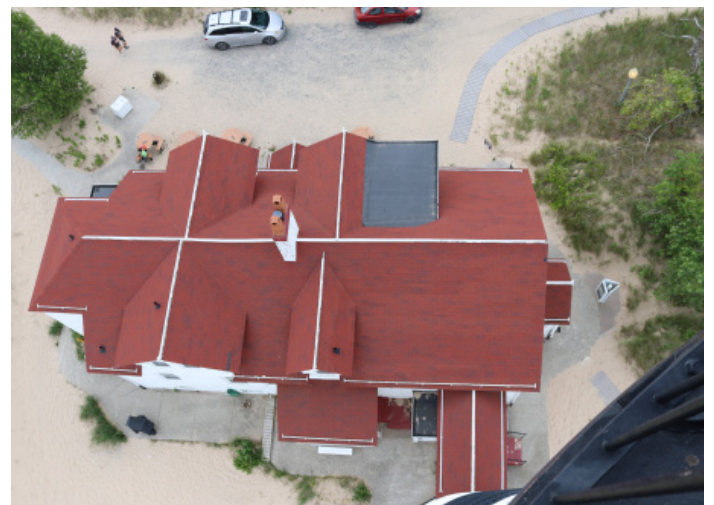
Figure 1D-83 Asphalt shingle roof of the Keepers' Dwelling and Passageway as seen from the Light Tower.

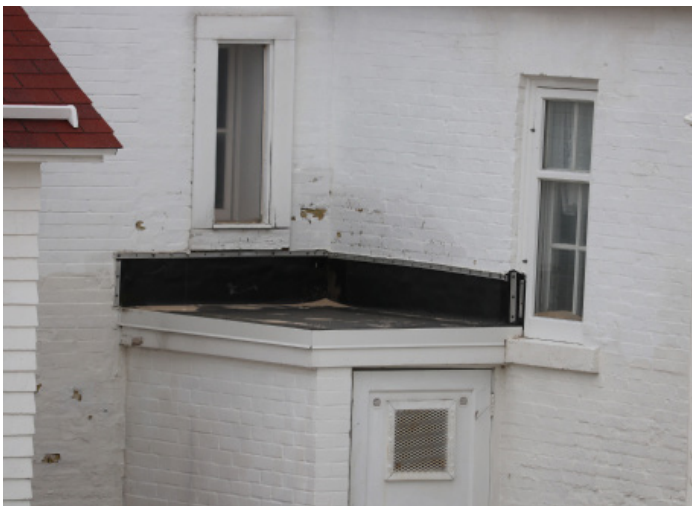
Figure 1D-86 EPDM roof on the Basement stair enclosure on the north side.

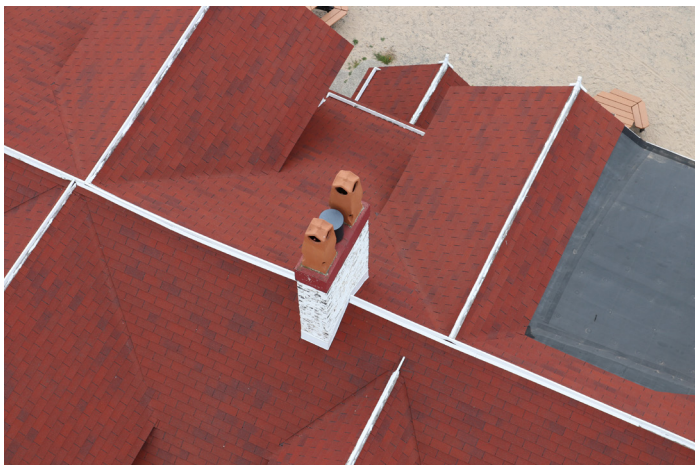
Figure 1D-90A View of chimney from the Light tower.

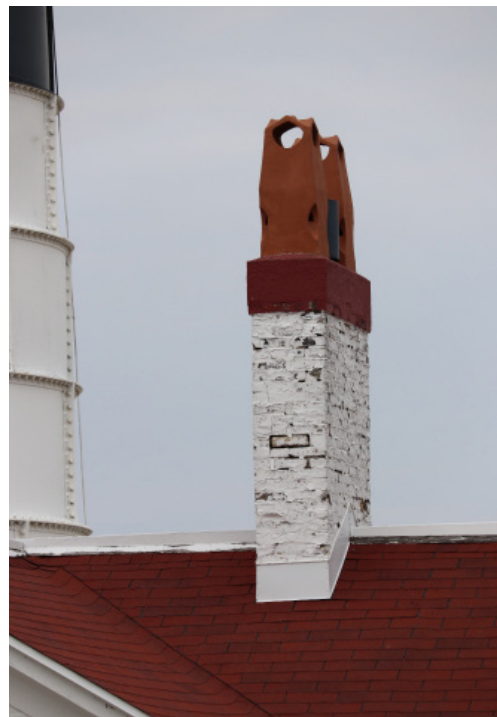
Figure 1D-89 Deteriorated brick and paint on the brick masonry chimney.

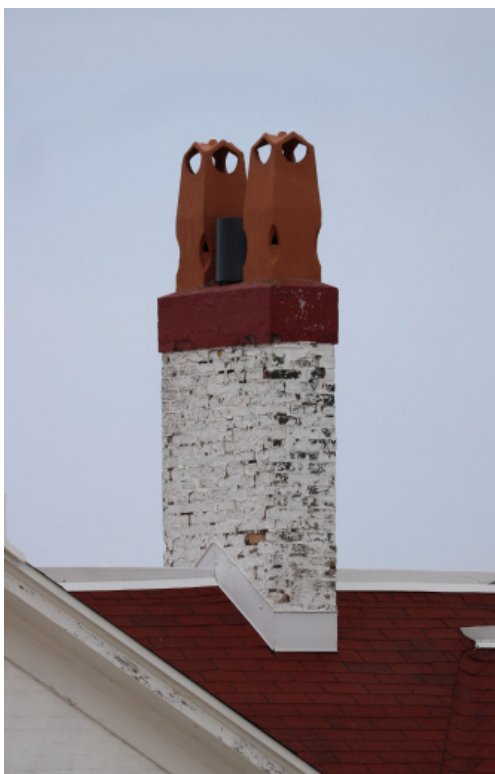
Figure 1D-90 Deteriorated brick and paint on the brick masonry chimney.

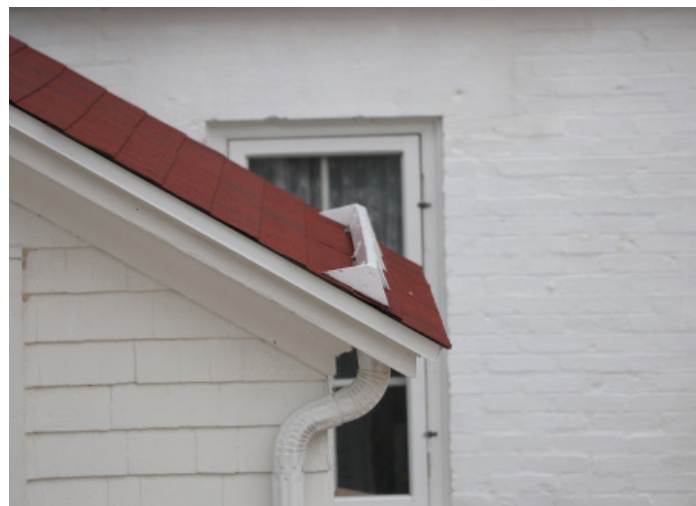
Figure 1D-91 Non-active metal gutter terminating in the soffit.

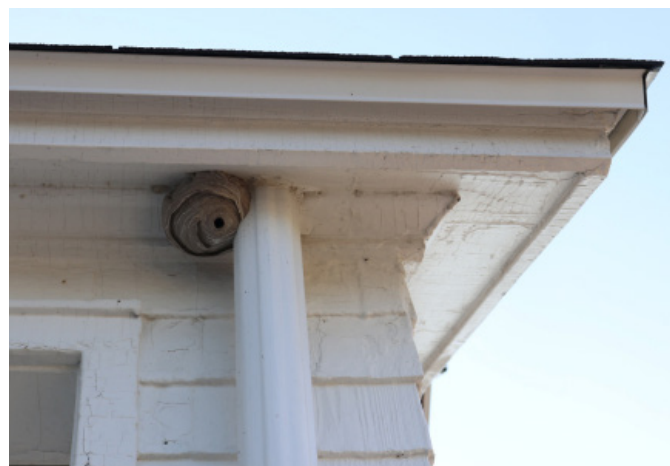
Figure 1D-92 Non-active metal gutter terminating in the soffit.

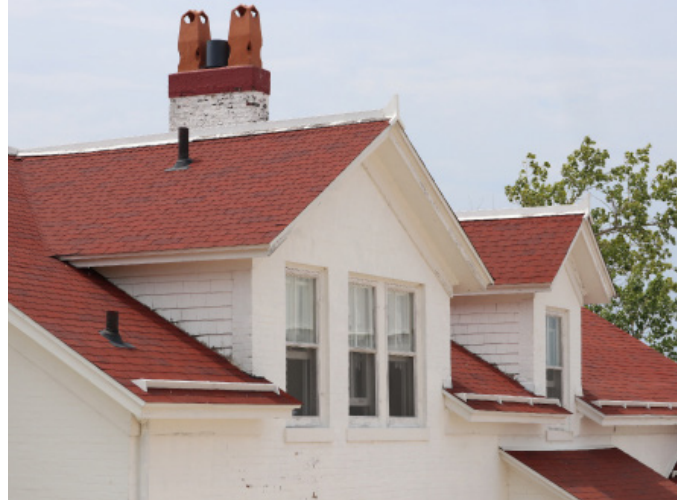
Figure 1D-94 Painted wood shingles on the sidewalls of the second floor dormers.

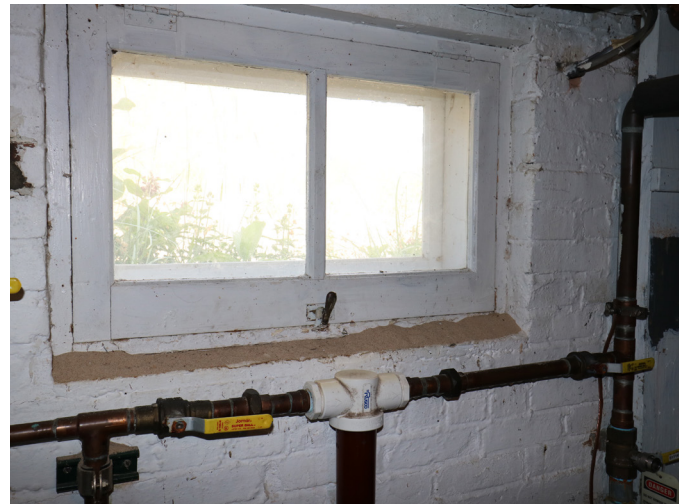
Figure 1D-97 Interior view of typical in-swinging, top hinged Basement window.
