TABLE OF CONTENTS

Management Summary

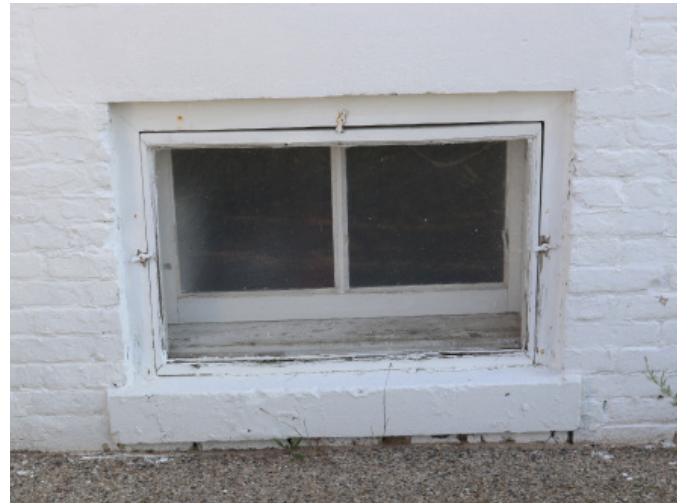
Figure 1D-98 Basement window and deteriorated storm sash on the north elevation.

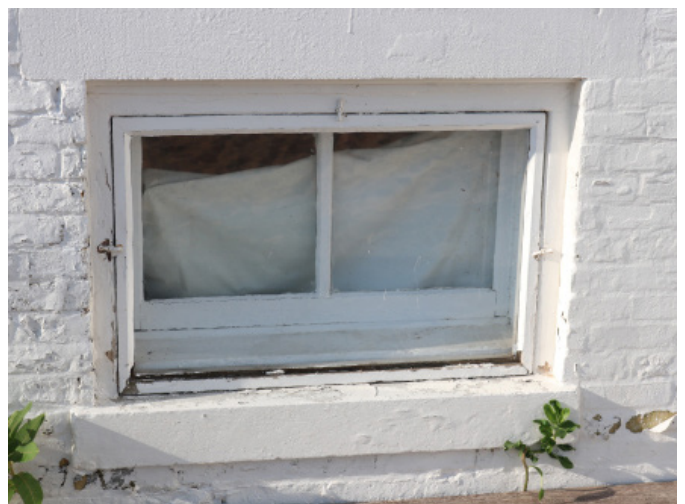
Figure 1D-99 Basement window and deteriorated storm sash on the south elevation.

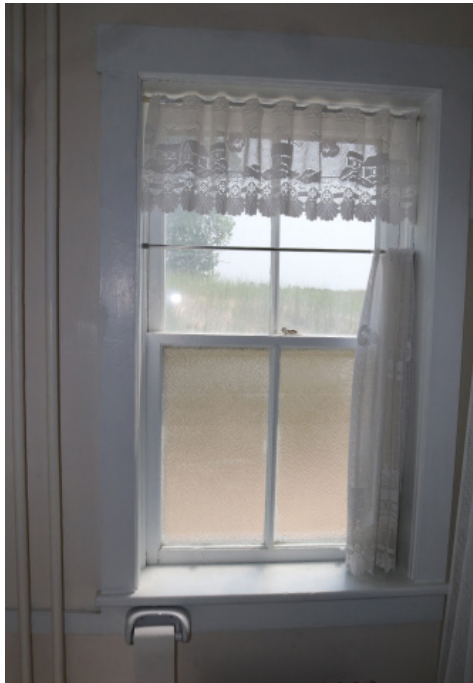
Figure 1D-100 Interior view of first floor Bathroom double hung window on the east elevation.

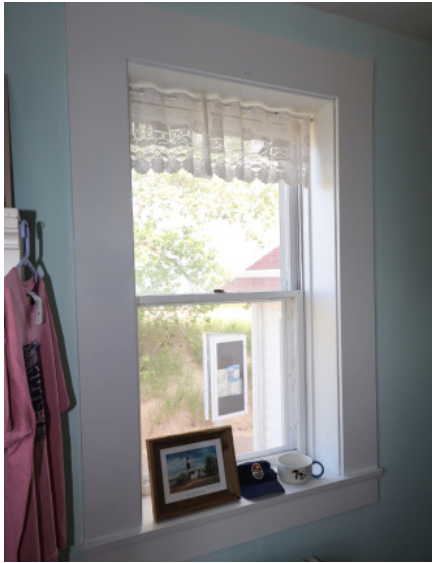
Figure 1D-104 First floor double hung window in the west part of the Keepers' Dwelling.

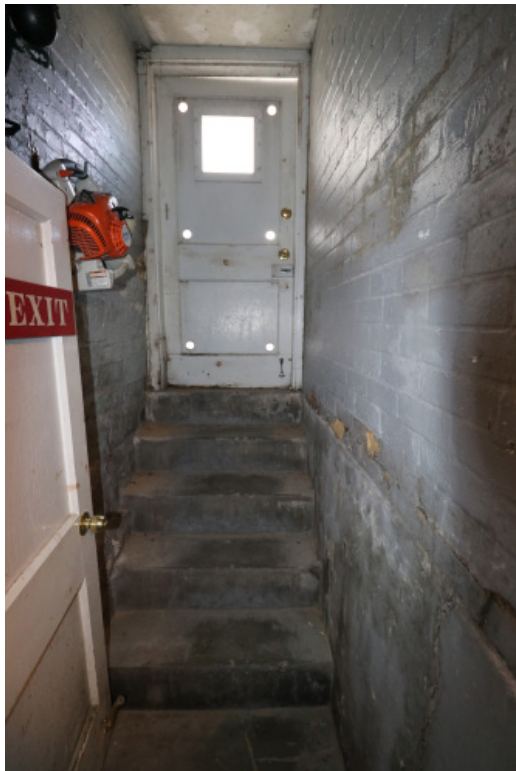
Figure 1D-115A Wood door at the Basement stairwell on the north elevation.

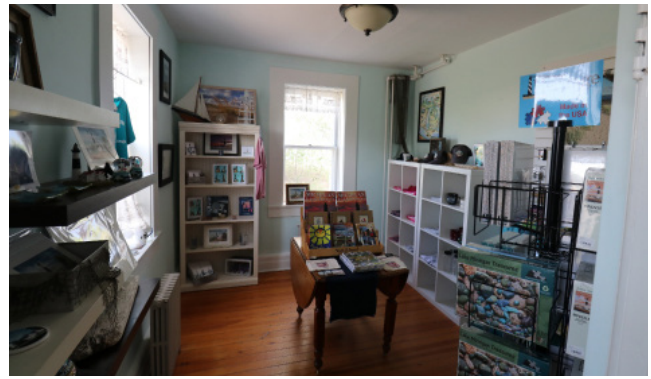
Figure 1D-137 Original Bedroom, now used as Gift Shop space.

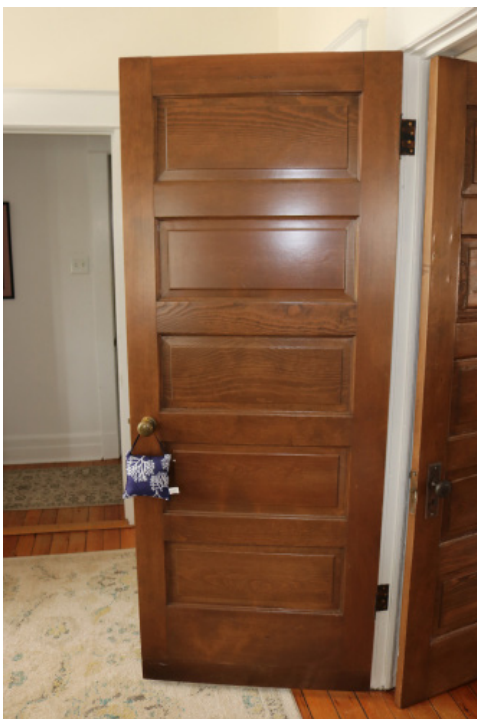
Figure 1D-170 Interior wood door between the Kitchen and Living Room in the first floor apartment.

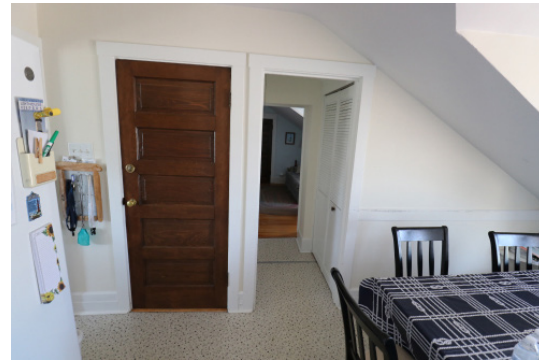
Figure 1D-172 Interior wood panel door and painted wood louver Pantry door in the second floor Hallway.

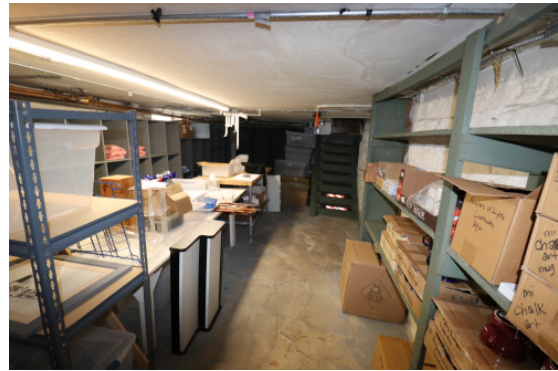
Figure 1D-185 Storage Room for Gift Shop inventory in the west part of the Basement, south side.

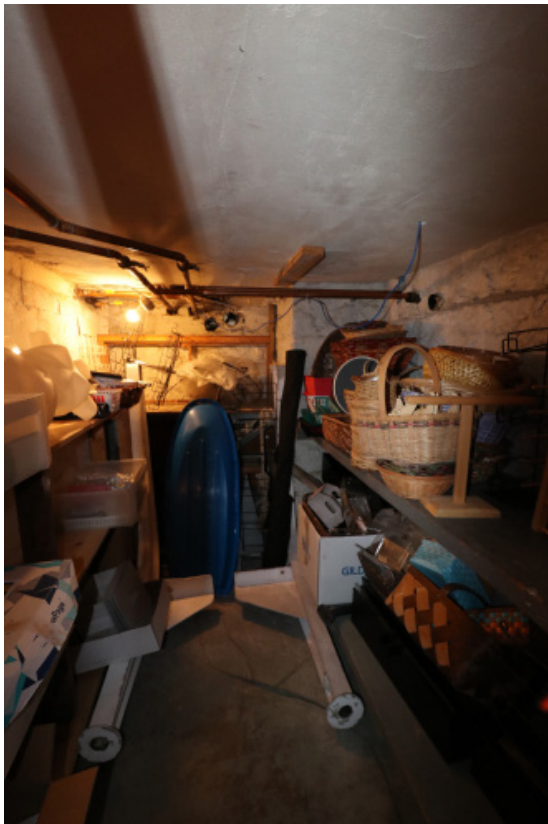
Figure 1D-190 Storage Room constructed of concrete masonry unit walls.

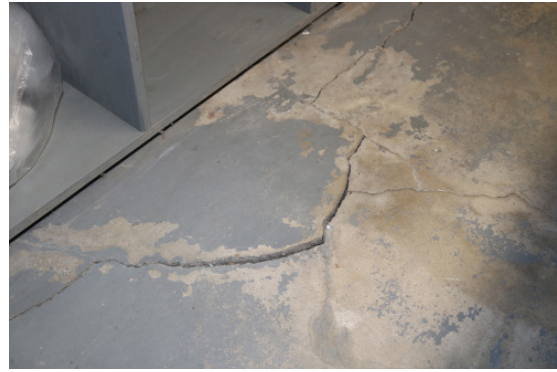
Figure 1D-191 Concrete floor slab cracking in the west part of the Basement.

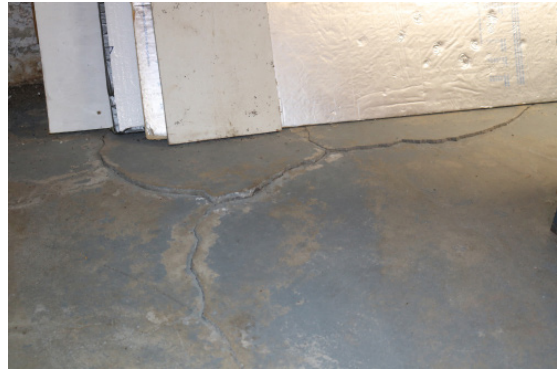
Figure 1D-192 Concrete floor slab cracking in the west part of the Basement.

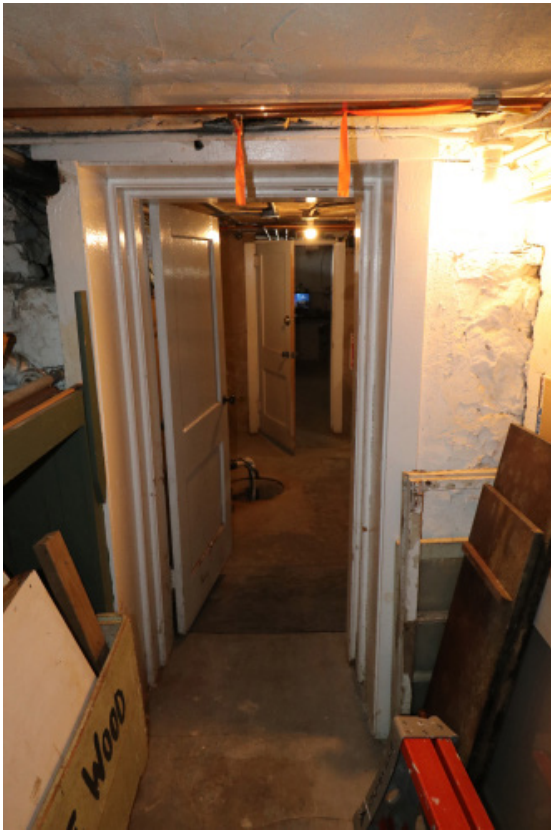
Figure 1D-193 Painted wood door in the Basement through the wall connecting the east and west parts.

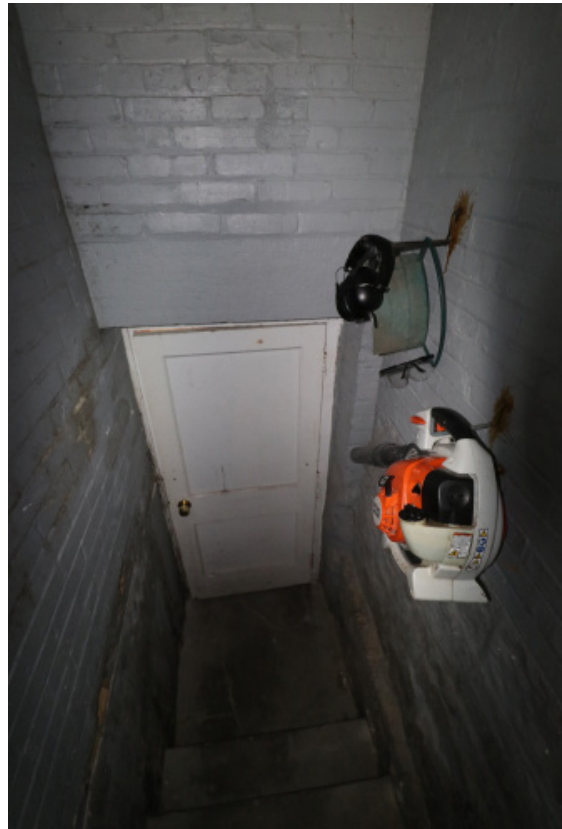
Figure 1D-194 Painted wood door at the entry to the north elevation exit stair.

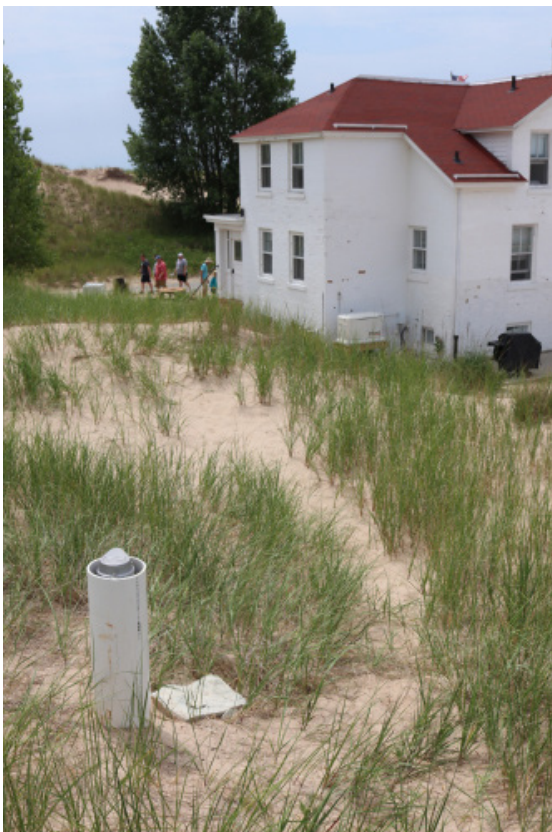
Figure 1D-195 Water well located off the northeast corner of the Keepers' Dwelling.

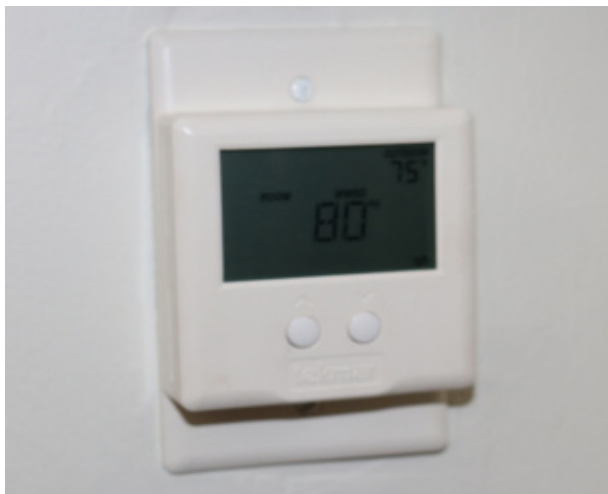
Figure 1D-209 Typical heating system thermostat control unit.

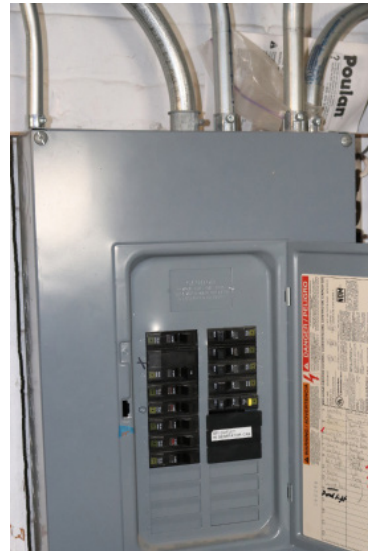
Figure 1D-210 Electric sub-panel located in the Basement.

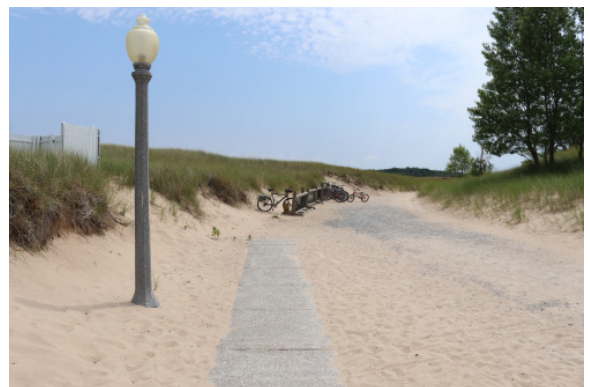
Figure 1D-219 Exterior pole mounted light fixture.

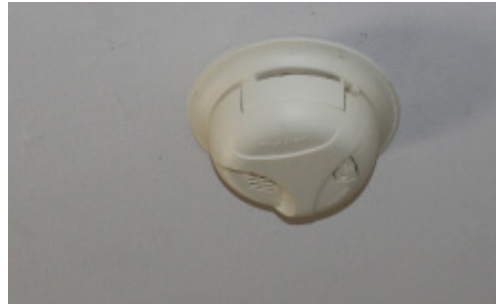
Figure 1D-220 Smoke detector/smoke alarm.

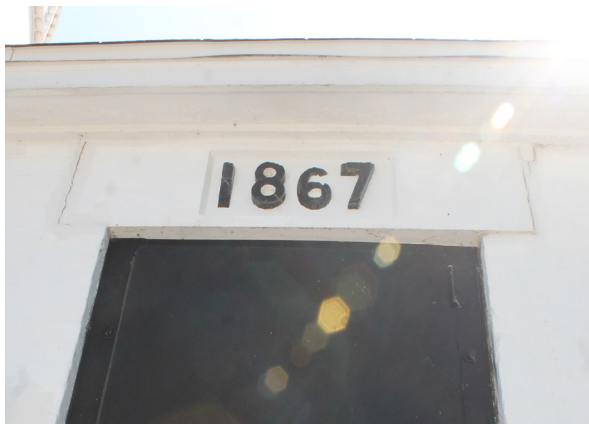
Figure 1D-223 No visible displacement of connector link roof structure, misalignment and cracking present on either side of stone masonry header.

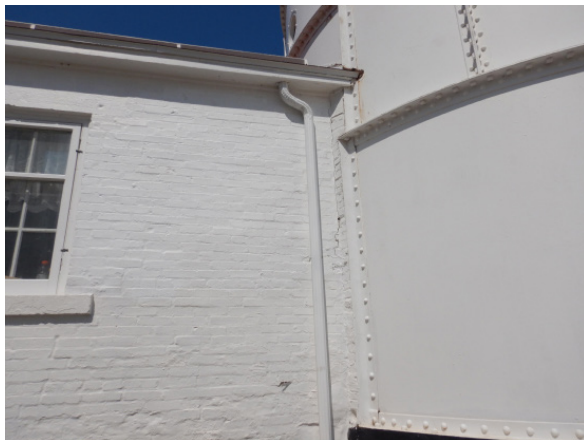
Figure 1D-224 Cracking present at north end of east wall at intersection of tower.

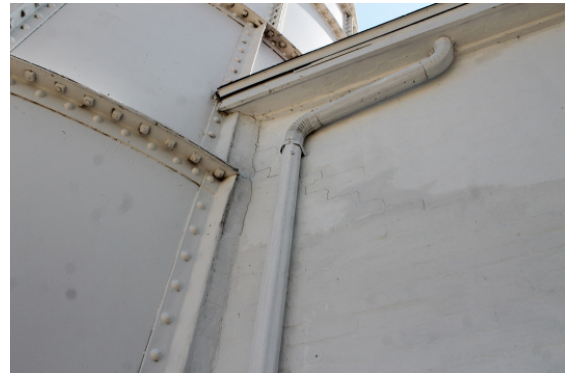
Figure 1D-225 Cracking present at north end of west wall at intersection of tower.

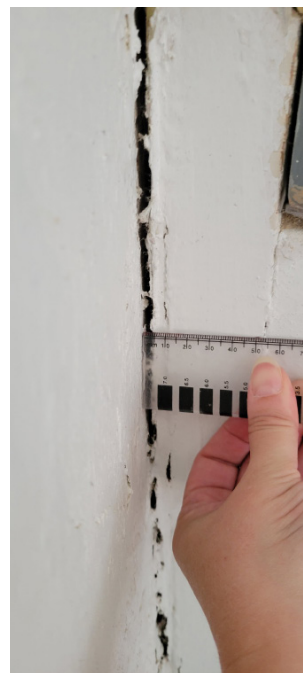
Figure 1D-226 Cracking present at north end of east wall at intersection of tower on interior.

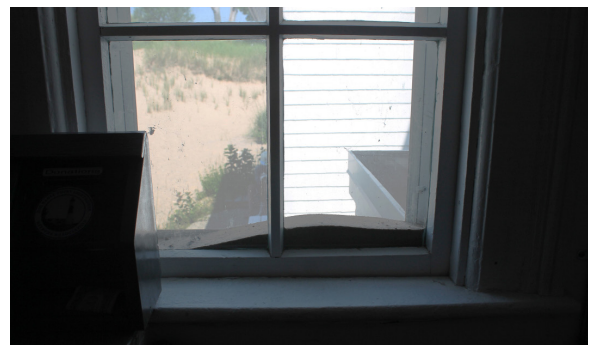
Figure 1D-227 Sand accumulation on sill of east window.

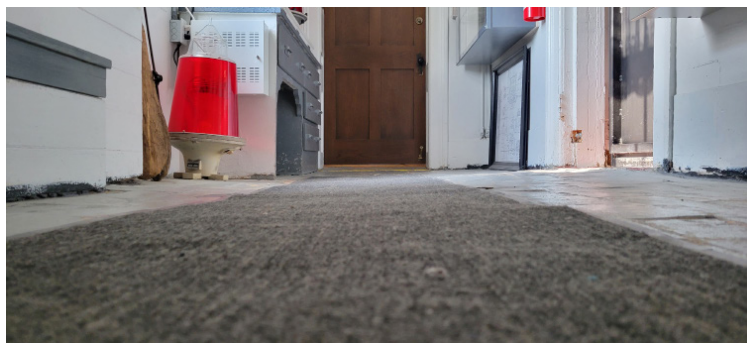
Figure 1D-228 Vertical displacement of paver floor.

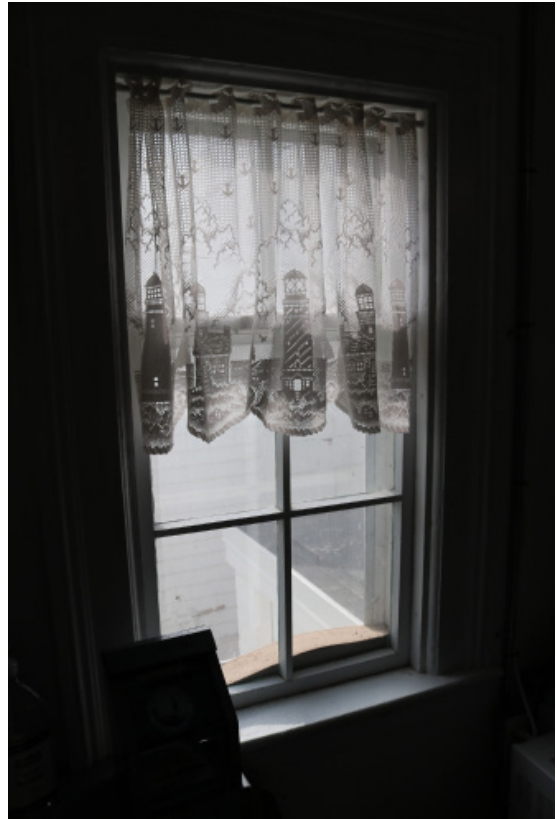
Figure 1D-232 Interior of Passageway double hung window.

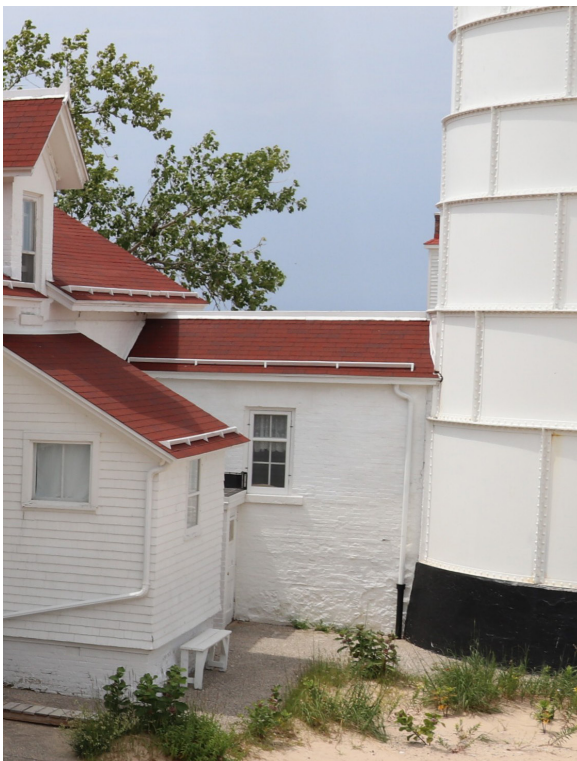
Figure 1D-231 East wall of the Passageway with single window.

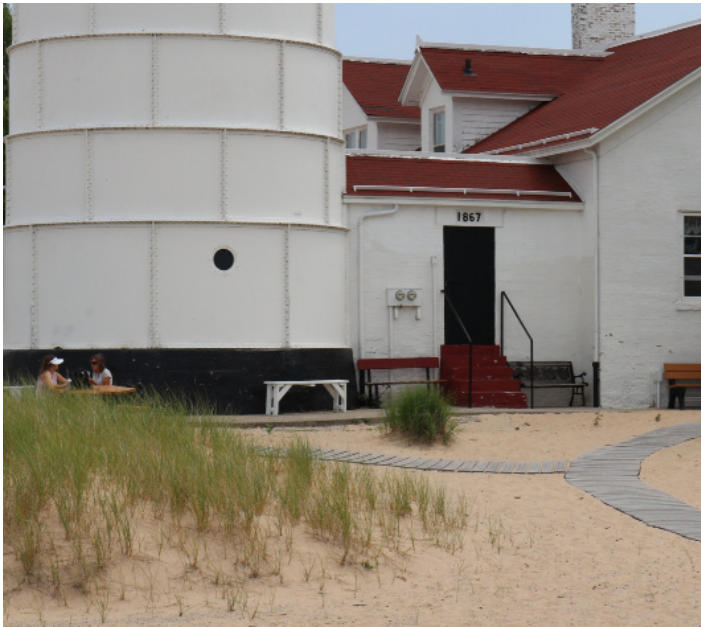
Figure 1D-233 Steel plate door on the west wall of the Passageway.

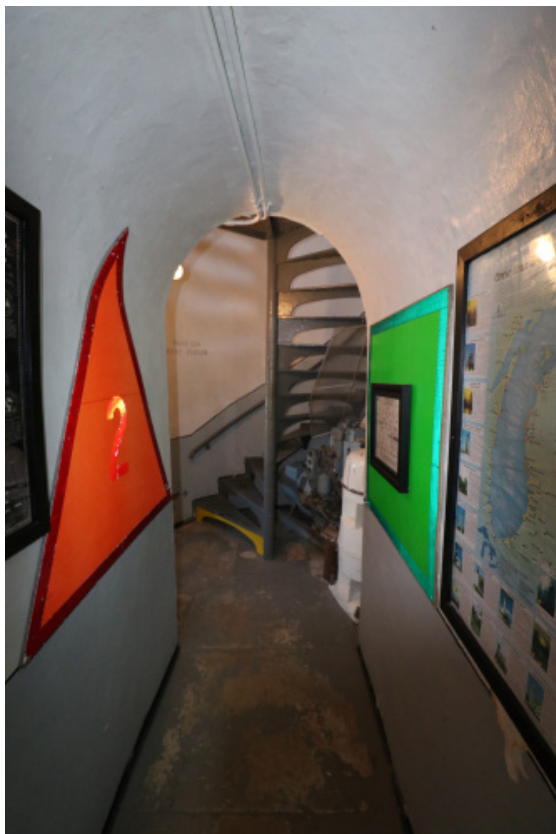
Figure 1D-238 Interior view of Passageway looking towards the circular stair of the Light Tower.

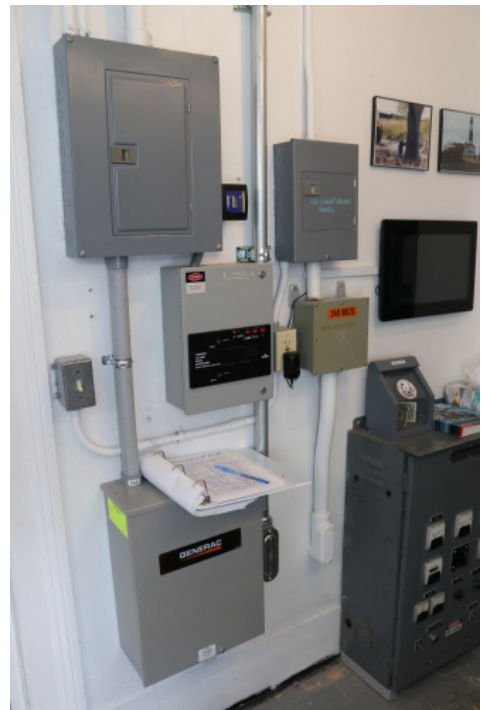
Figure 1D-241 Main electric panel and sub-panels on the west wall of the Passageway.

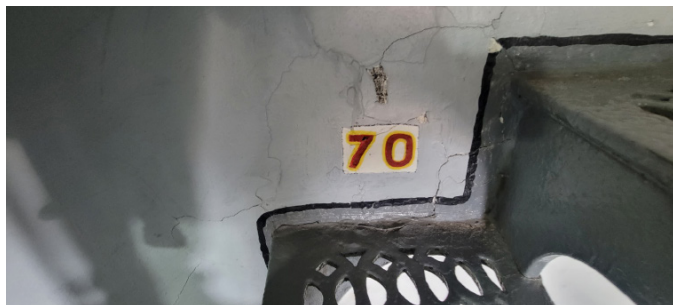
Figure 1D-247 Cracking in plaster at stair tread.

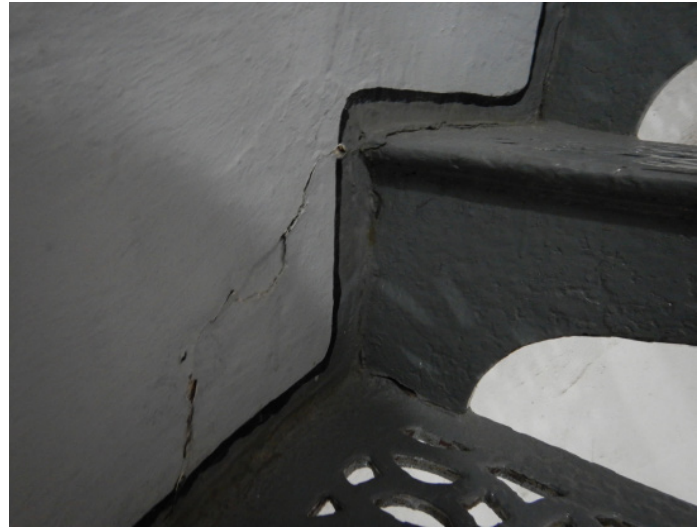
Figure 1D-248 Cracking in plaster at stair tread.

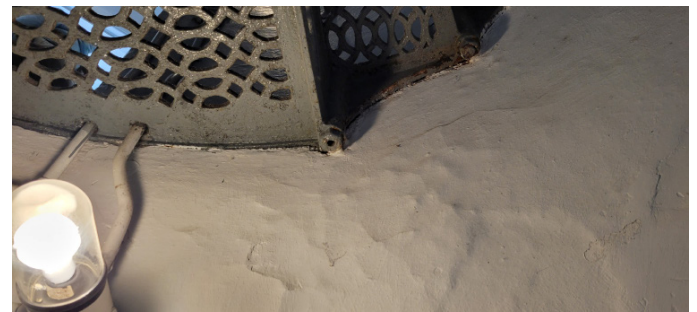
Figure 1D-249 Plaster distress below stairs; note bolt between treads does not extend down through assembly.

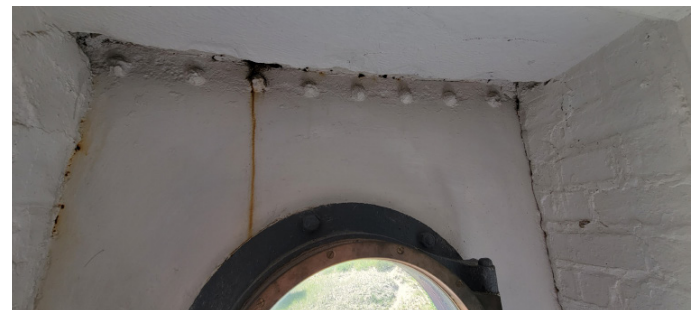
Figure 1D-250 Corrosion staining at window well at watch room floor level; note steel is tight to the brick masonry (no cementitious fill between the masonry and the steel plate this level).

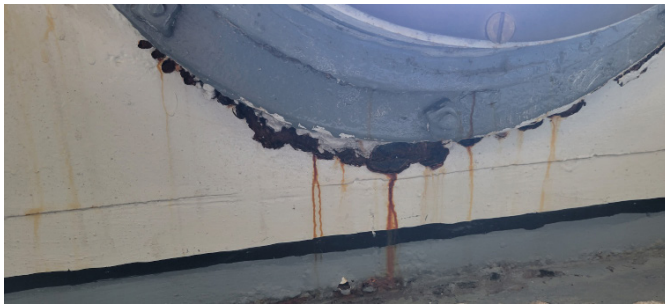
Figure 1D-251 Corrosion of steel plate below port hole window at watch room floor level.

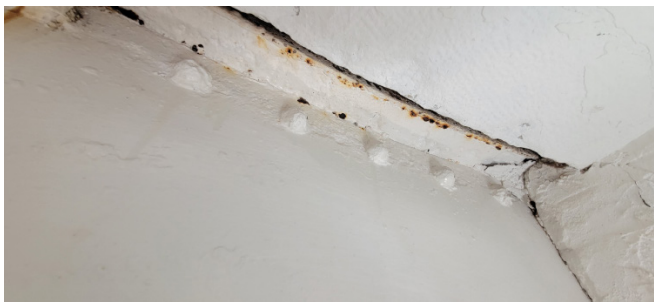
Figure 1D-252 Corrosion staining at window well at watch room floor level; note section loss of rivet heads on the right side of the photo.

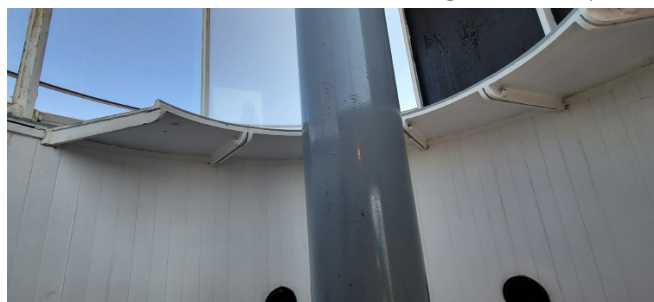
Figure 1D-253 Upper walkway of lantern room floor.

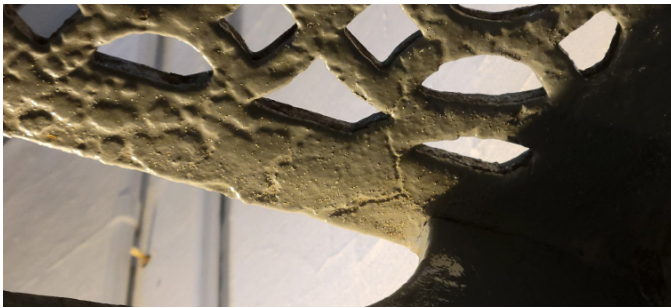
Figure 1D-257 Pitting of and potential cracking through the coated cast iron lattice stair tread.

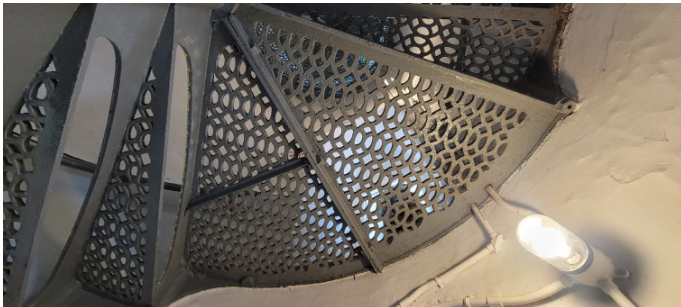
Figure 1D-258 Underside of lowest landing level (only two sections of the full circle, not a semi-circle like the other landings), note the left section is reinforced with a small metal angle at mid-length.

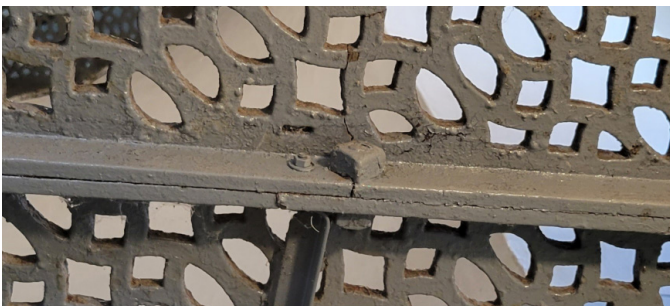
Figure 1D-259 Cracking at bolt location and added angle section connection in turned down edge of landing section members.

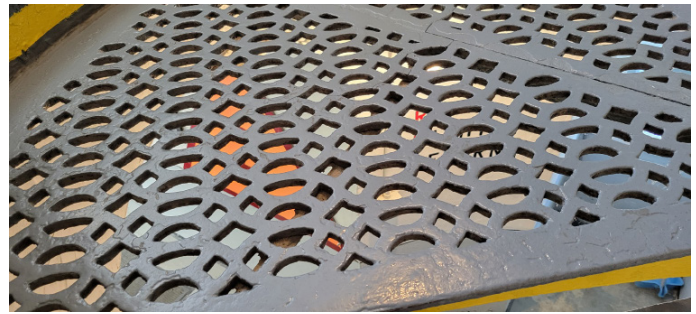
Figure 1D-260 Top surface of the same landing in Figure 1D-257, note reinforcing angle and cracking visible on top surface in lattice and turned down edge adjacent to other landing section.

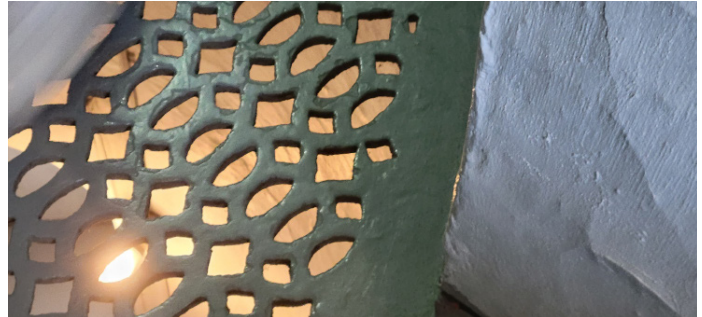
Figure 1D-261 Casting defect along edge of lattice work in tread.

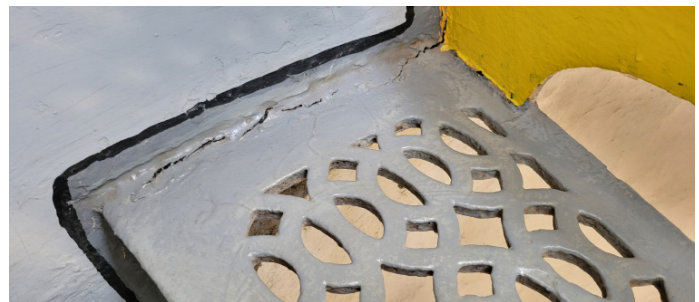
Figure 1D-262 Adhesive failure of sealant applied at wide edge of tread along interior wall.

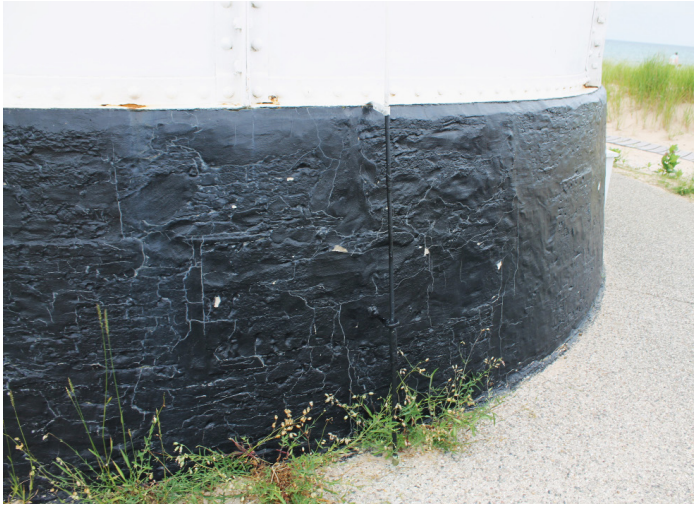
Figure 1D-263 Cracking in grid pattern through coating at base of tower; likely reflecting mortar joints of stone foundation.

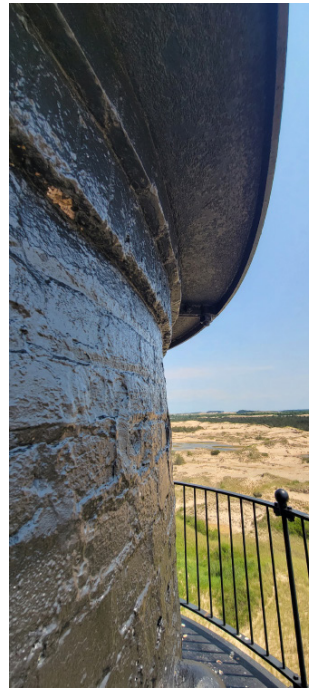
Figure 1D-264 Coated brick on exterior of tower above lantern floor balcony.

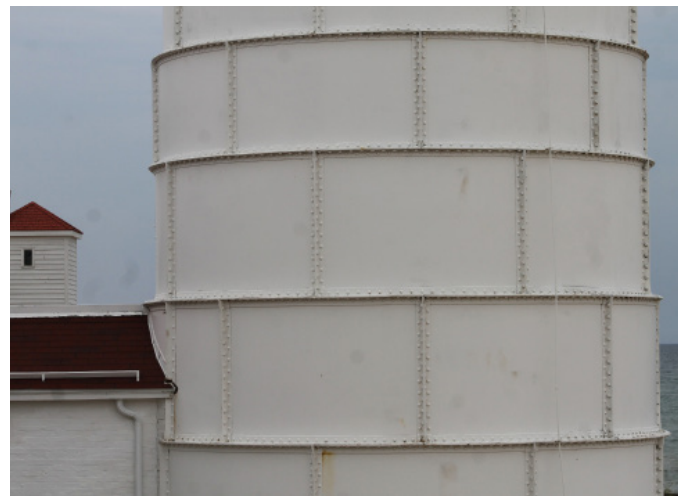
Figure 1D-265 General condition of east portion of tower metal cladding, note staggered alignment of vertical edges of plates creating an enlarged “running bond pattern” of the cladding.

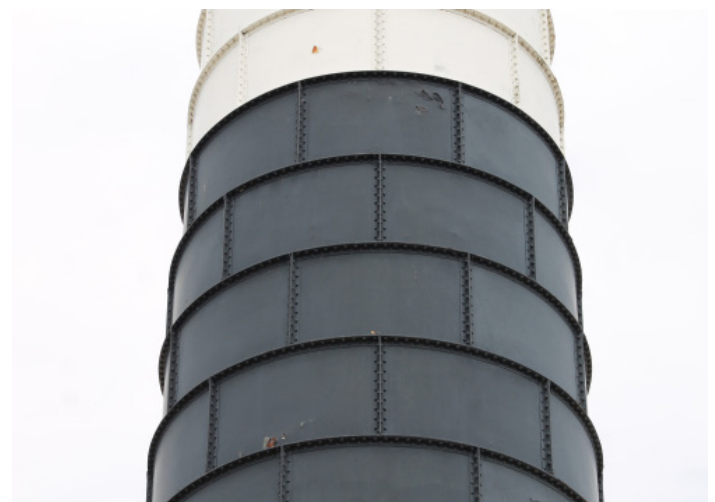
Figure 1D-266 Isolated areas of missing or peeling coating from metal cladding.

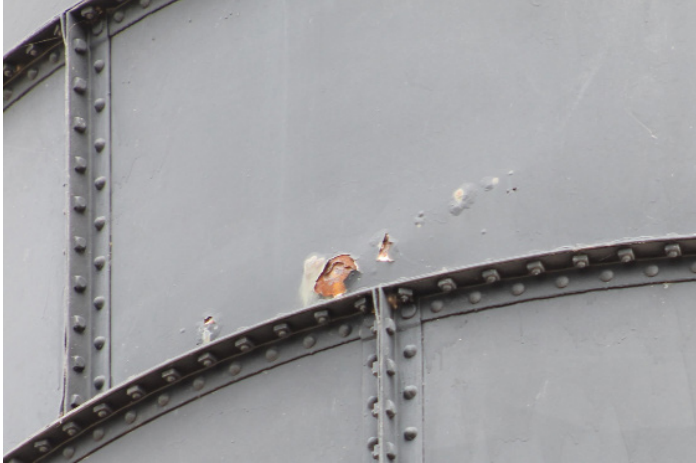
Figure 1D-267 Closer view of corrosion of metal cladding where coating is missing.

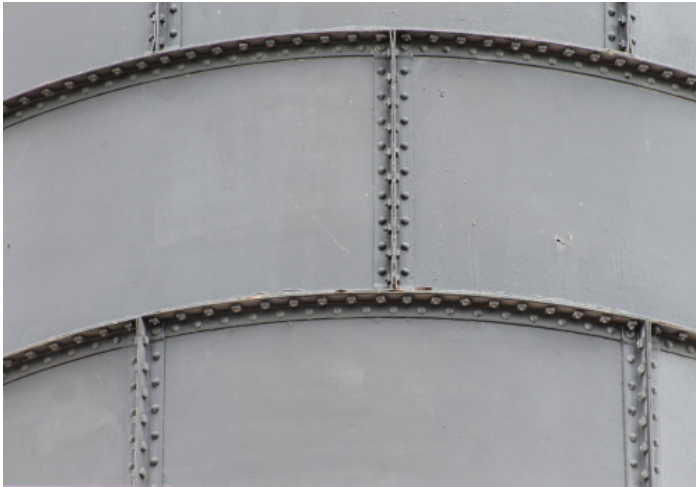
Figure 1D-268 Vertical angles deformed at ends likely due to "rust jacking" forces separating the angle sections.

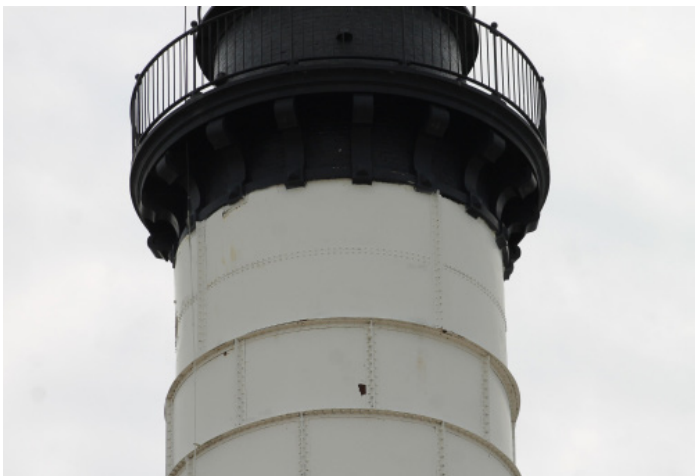
Figure 1D-269 Differences in detailing of metal cladding at top of tower to typical sections below.

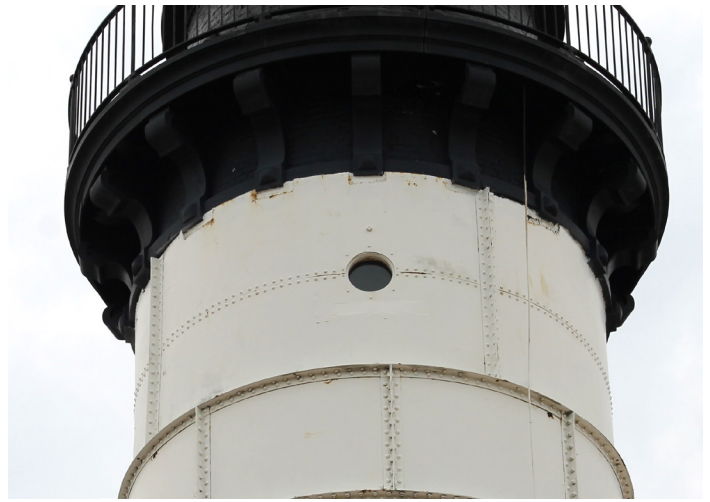
Figure 1D-270 Corrosion and potential displacement present at lantern balcony bracket locations at top of upper level metal cladding.

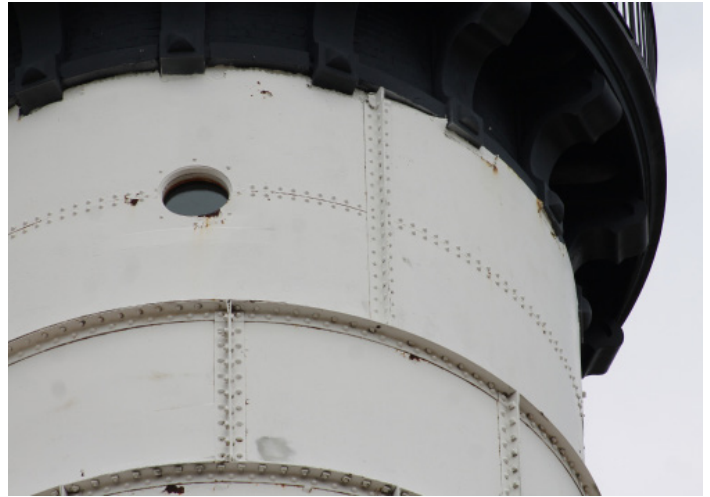
Figure 1D-271 Fastener misalignment in horizontal leg where upper cladding meets lower cladding around perimeter of tower.

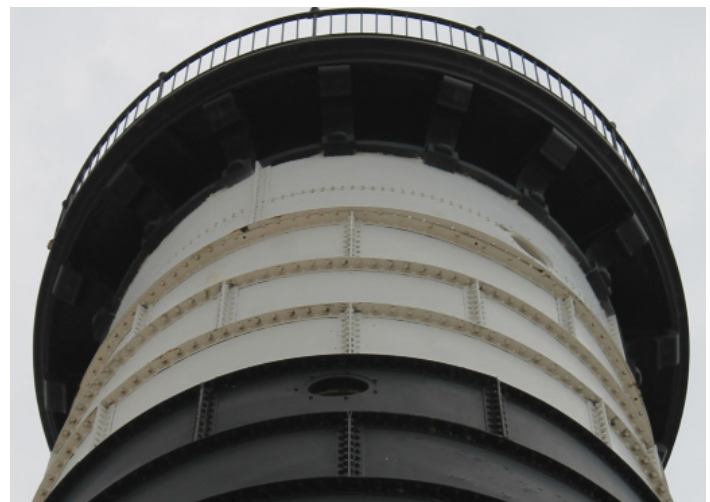
Figure 1D-272 Daylight observed through fastener holes in horizontal leg of angles where upper cladding meets lower cladding around perimeter of tower.

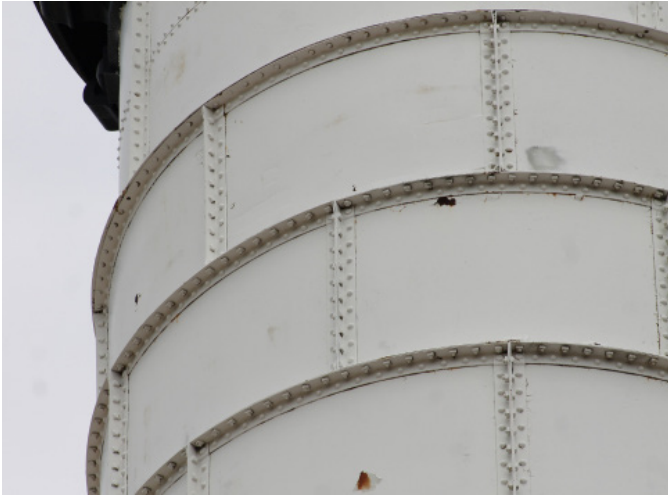
Figure 1D-273 Fastener misalignment in horizontal leg where upper cladding meets lower cladding around perimeter of tower.

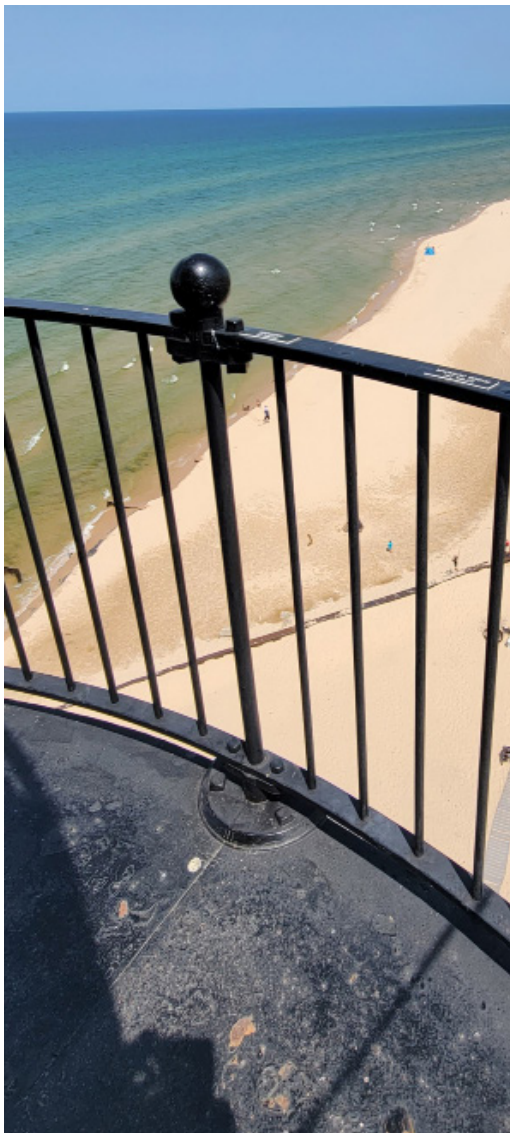
Figure 1D-274 Exterior metal railing at the Watch Deck level.

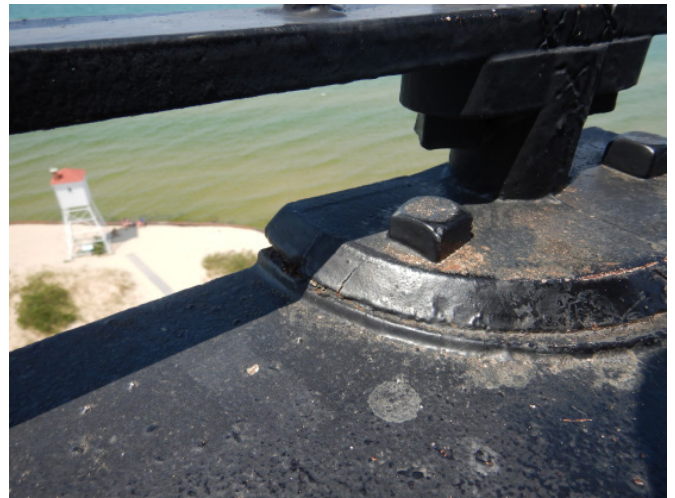
Figure 1D-275 Cracked base plate at bolt location at rail post at exterior balcony at lantern level.

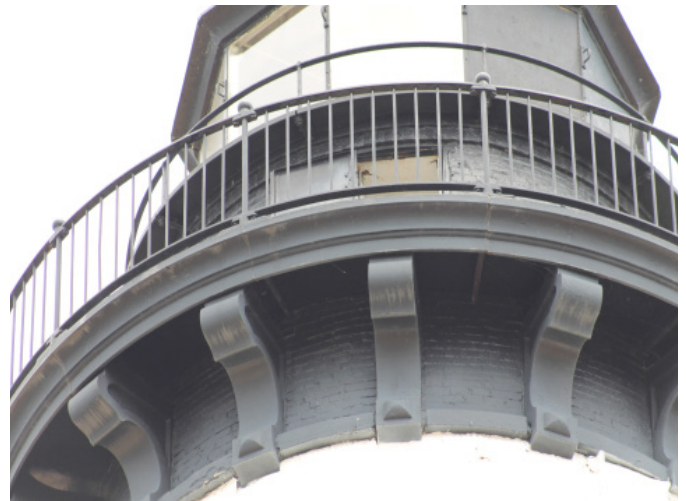
Figure 1D-276 Rail posts do not align with brackets below lantern balcony floor level.

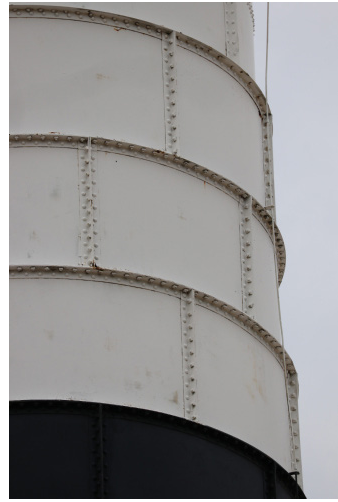
Figure 1D-277 Metal cladding on the Light Tower with "white" and "black" paint patterns.

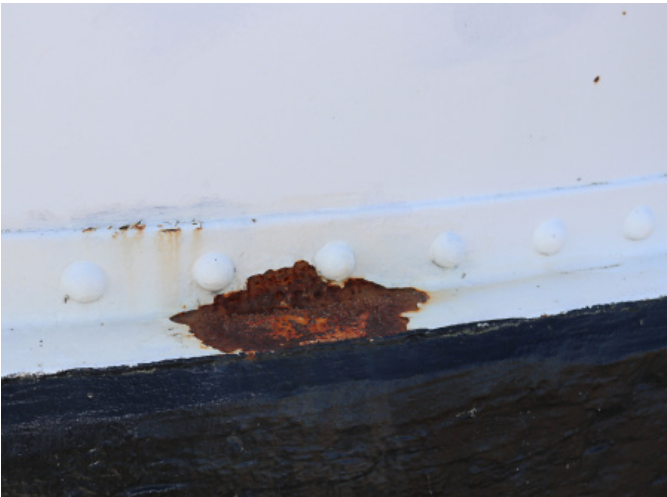
Figure 1D-278 Deteriorated paint finish and corrosion of steel.

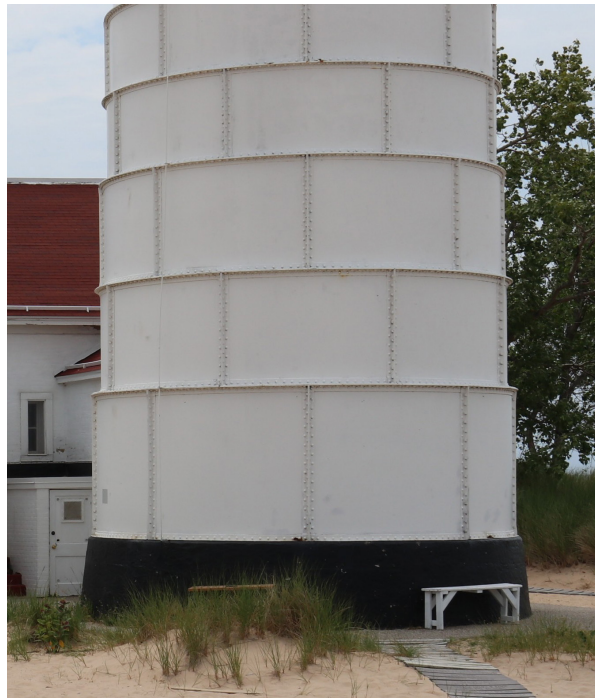
Figure 1D-279 Painted "black" stone masonry base of the Light Tower.

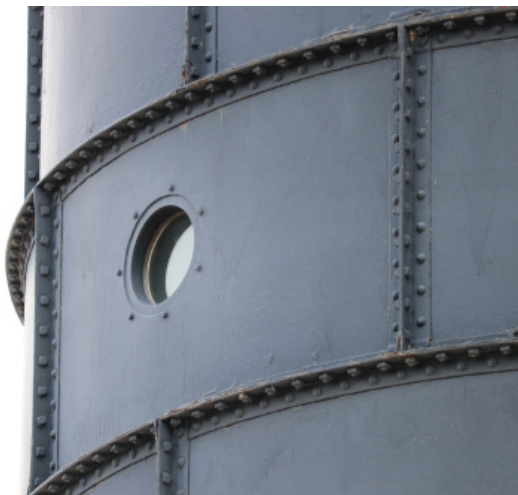
Figure 1D-280 "Porthole" style window in the metal cladding surface of the Light Tower.

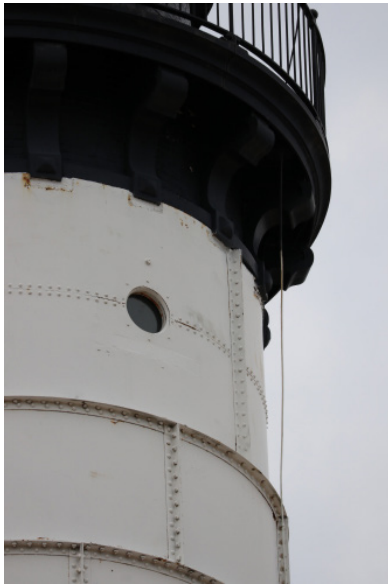
Figure 1D-281 “Porthole” style window in the metal cladding surface of the Light Tower.

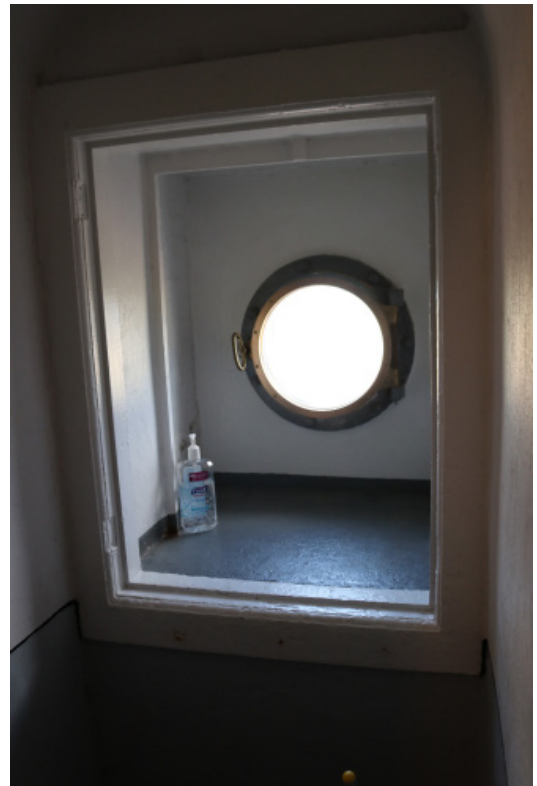
Figure 1D-282 Interior view of Porthole window and non-extant original rectangular tower window.

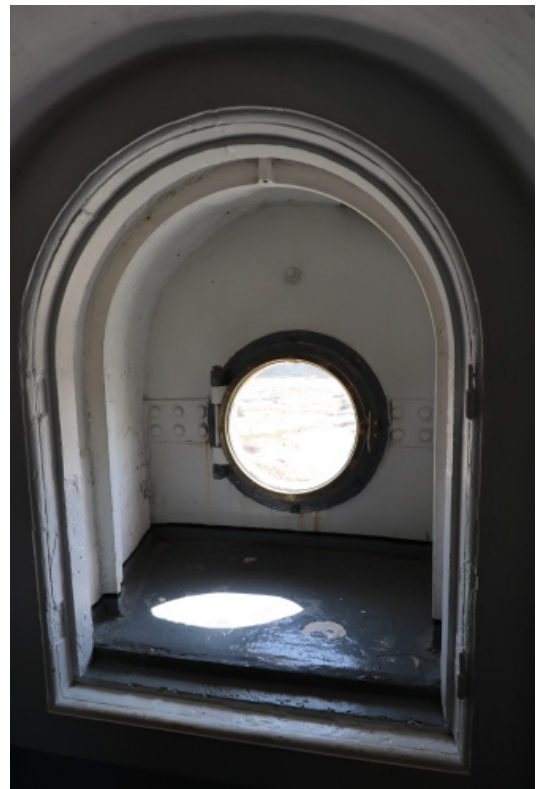
Figure 1D-283 Interior view of Porthole window and non-extant original arch top tower window.

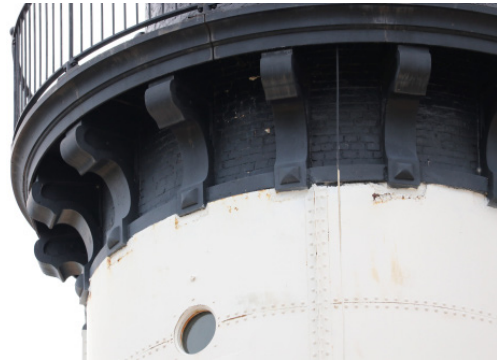
Figure 1D-286 Upper section of the Light Tower with metal corbels, painted brick between the corbels and Watch Deck.

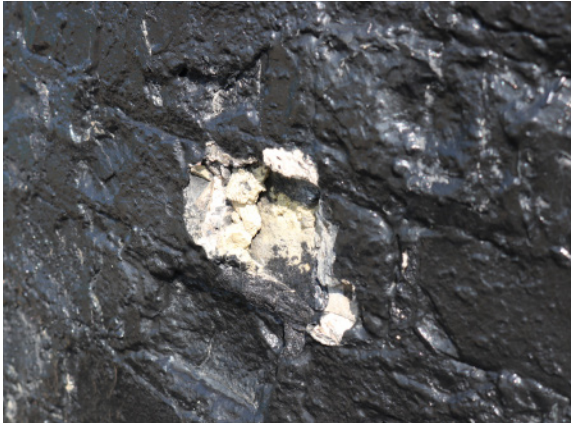
Figure 1D-288 Deteriorated paint surface and damaged brick on the exterior brick masonry wall at the Watch Deck.

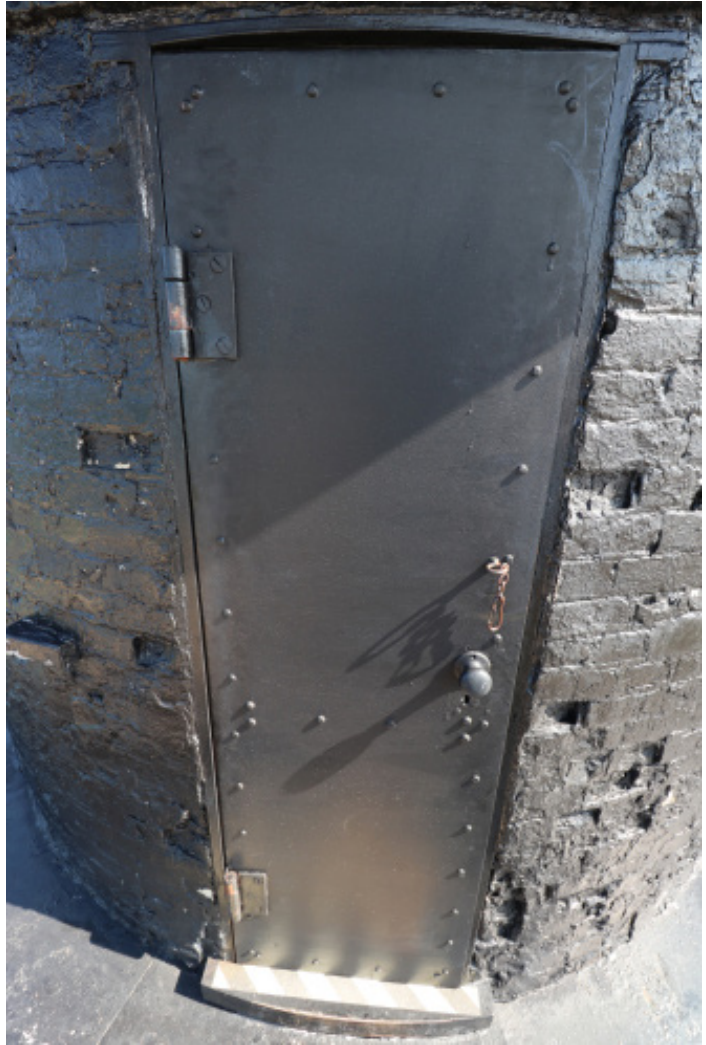
Figure 1D-289 Exterior steel plate door providing access from the Watch Room to the exterior Watch Deck.

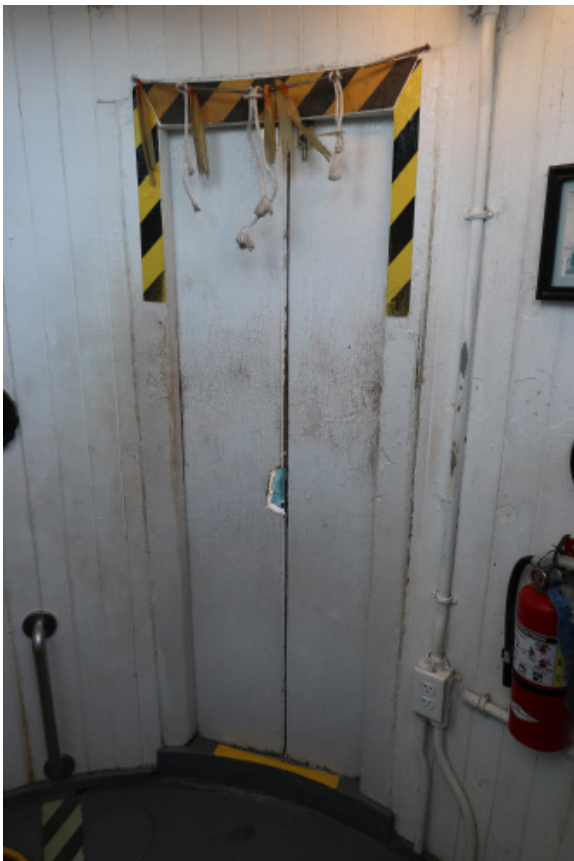
Figure 1D-294 Inner face of the pair of inner wood doors at the Watch Room.

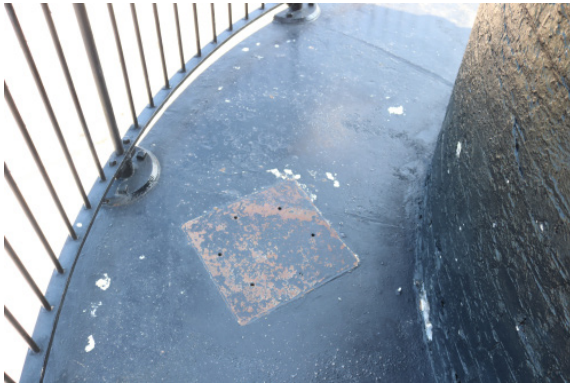
Figure 1D-295 Cast iron floor of the Watch Deck.

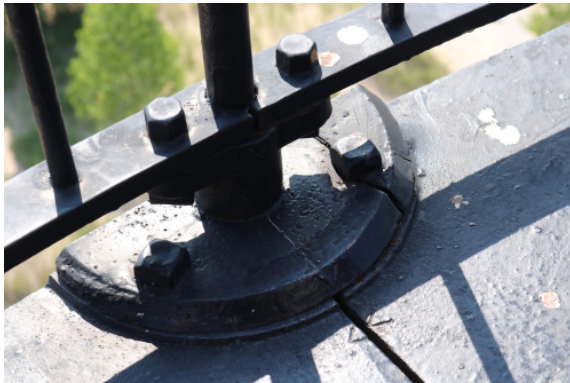
Figure 1D-297 Cracked railing base plate.
