TABLE OF CONTENTS

Management Summary

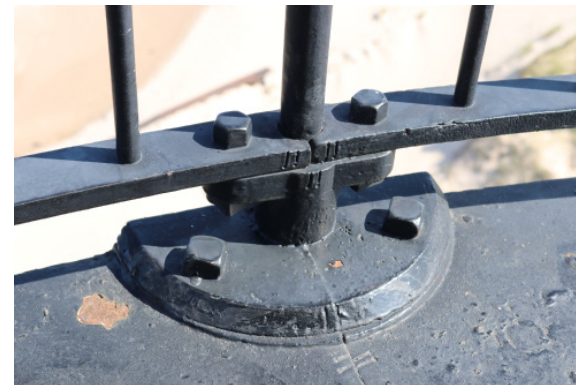
Figure 1D-299 Bracket and bottom rail.

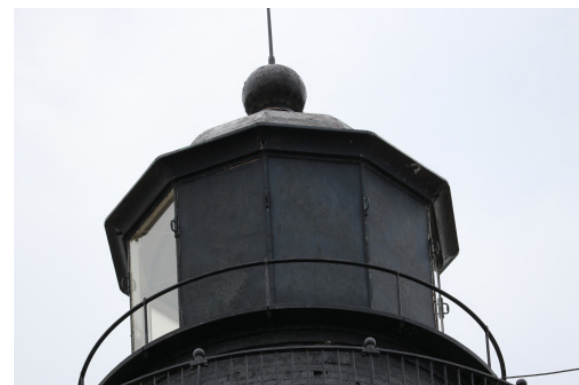
Figure 1D-301 Ten-sided Lantern.

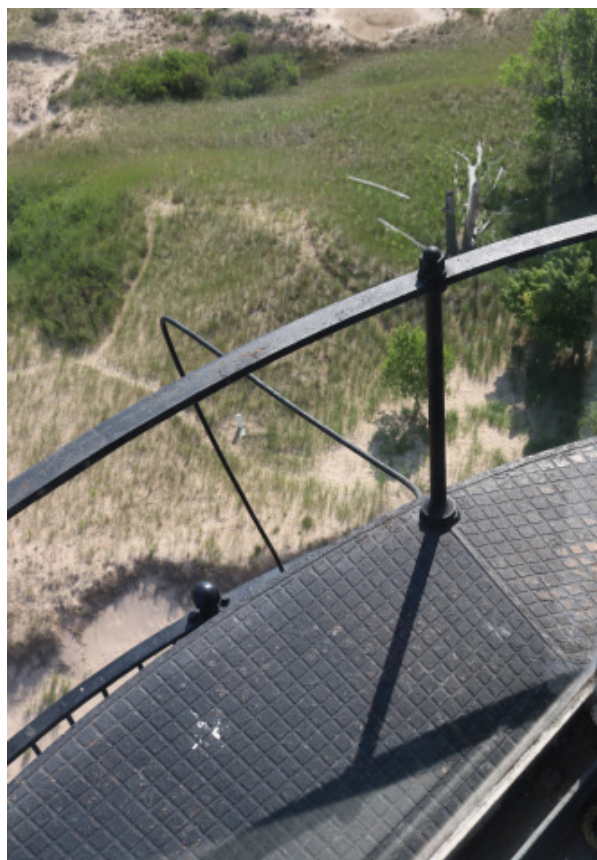
Figure 1D-302 Metal railing around the perimeter of the Lantern Deck.

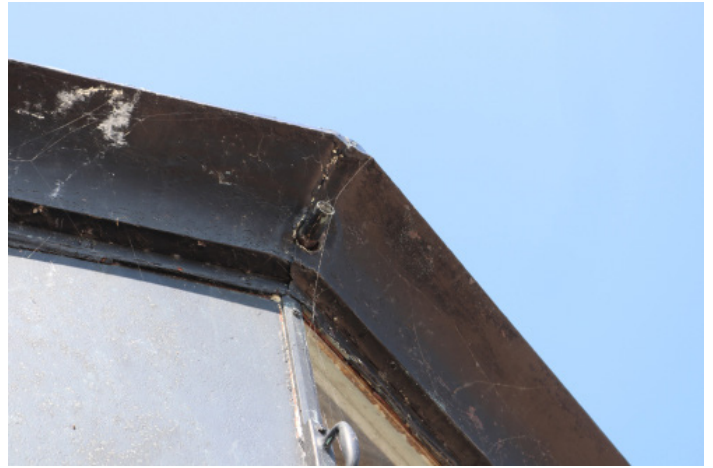
Figure 1D-305 Gutter drainage tube and cracking at cornice joint.

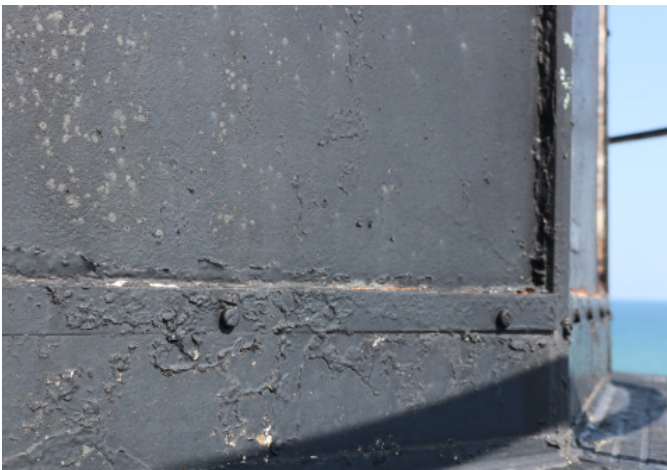
Figure 1D-306 Base of Lantern with deteriorated paint finish.

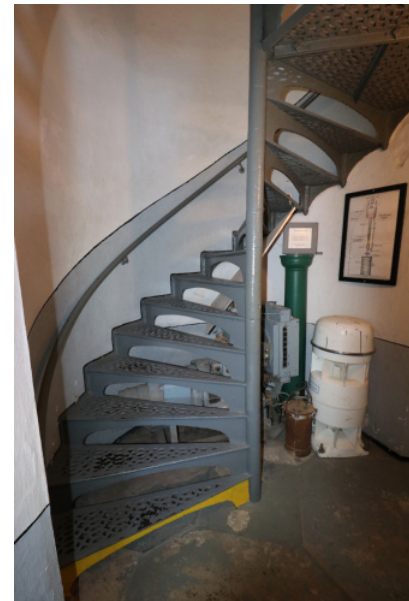
Figure 1D-307 Circular stair at the main floor level in the Light Tower.

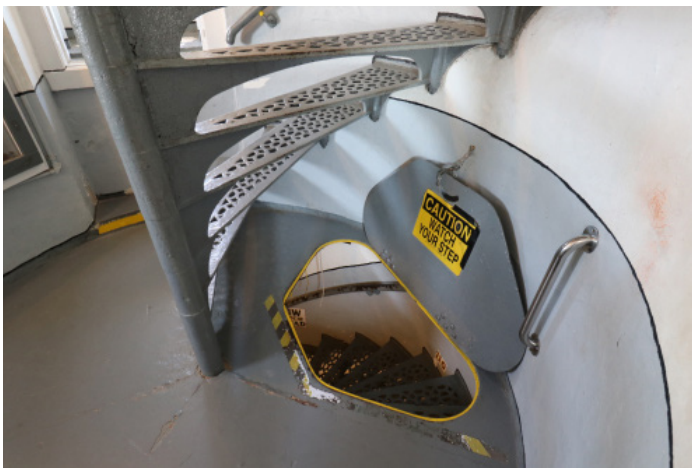
Figure 1D-312 Metal floor hatch at the fourth landing level. Note stainless steel grab bar.

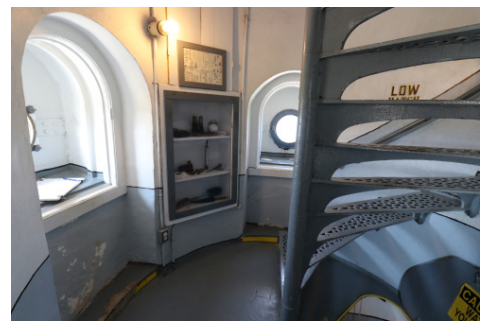
Figure 1D-313 Built in wood shelves at the fourth landing level.

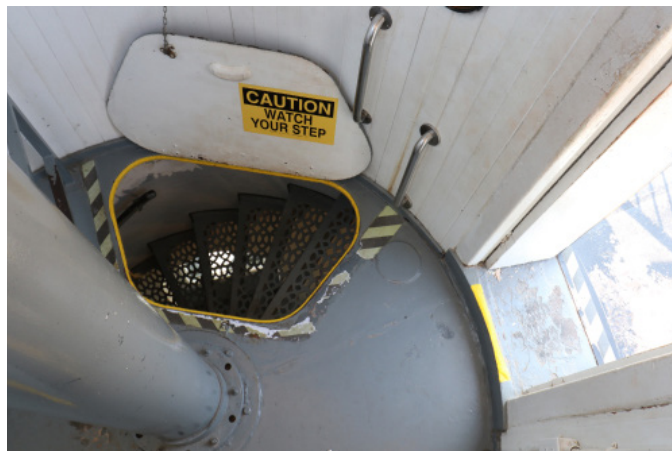
Figure 1D-314 Metal floor hatch at the Watch Room. Note stainless steel grab bars.

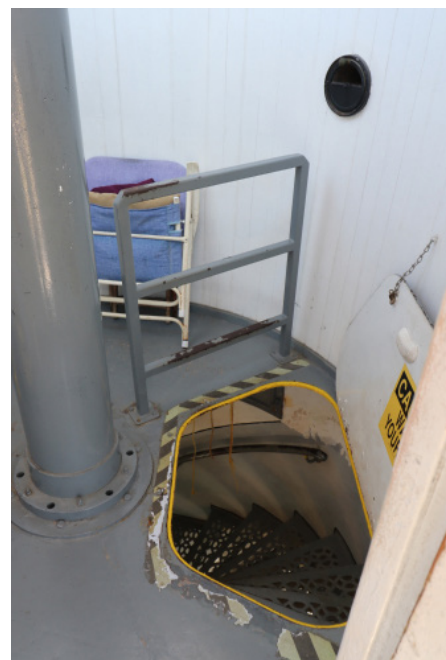
Figure 1D-315 Metal guardrail and navigation light pedestal protecting the floor hatch opening.

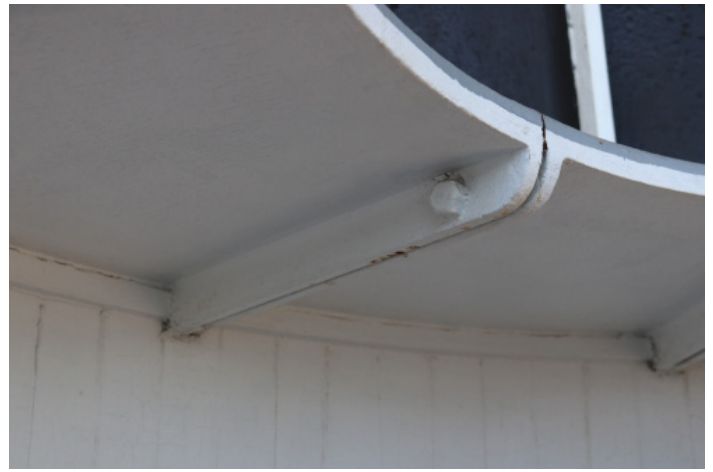
Figure 1D-317 Painted wood trim at the top of the wood paneling and the cast iron floor deck of the Lantern.

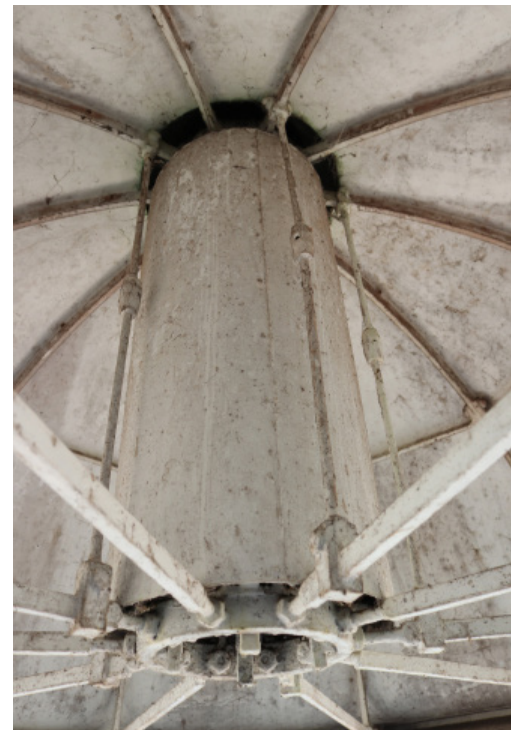
Figure 1D-328 Lantern chimney.

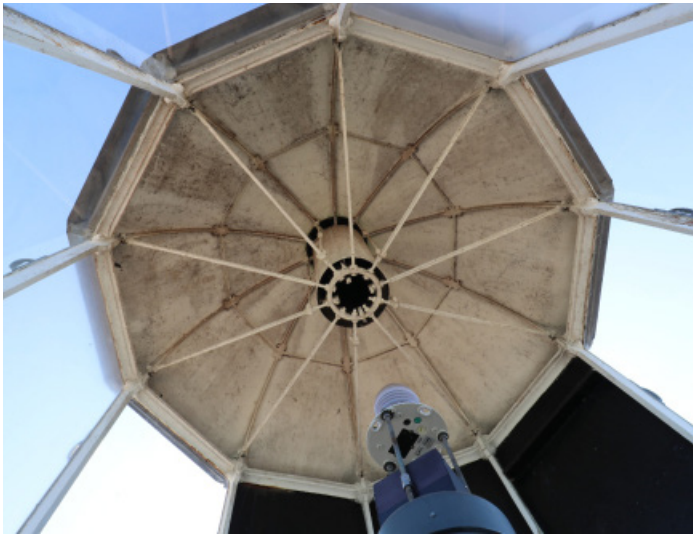
Figure 1D-329 View of Lantern ceiling and roof structure.

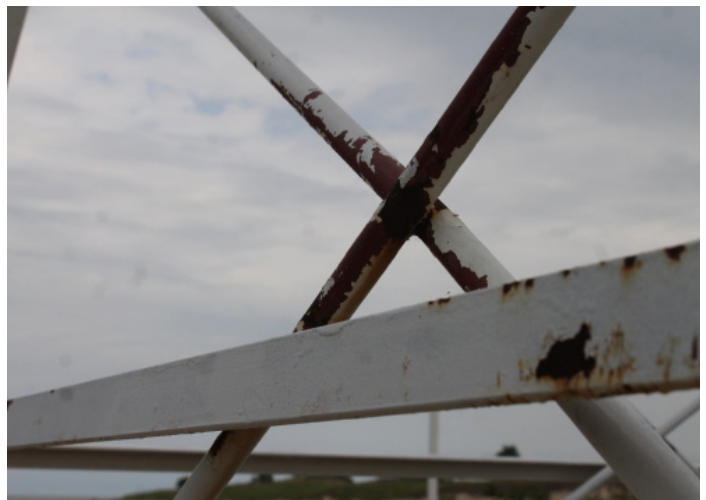
Figure 1D-335 Worn coatings and spotted corrosion of the steel tower frame.

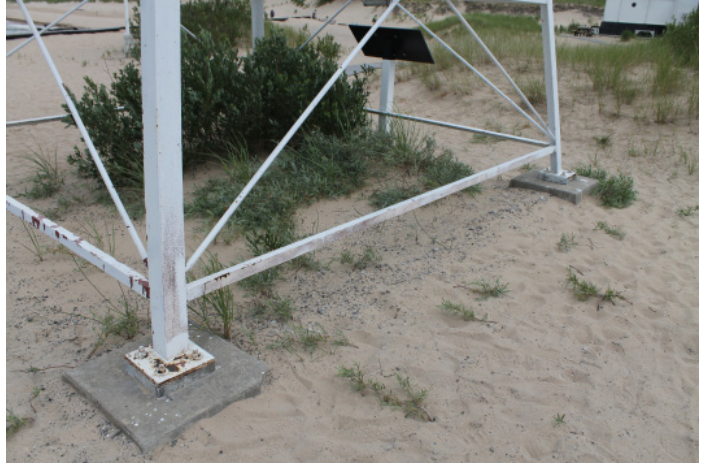
Figure 1D-337 Southern concrete foundations; note corner is spalled from southwest (left) foundation.

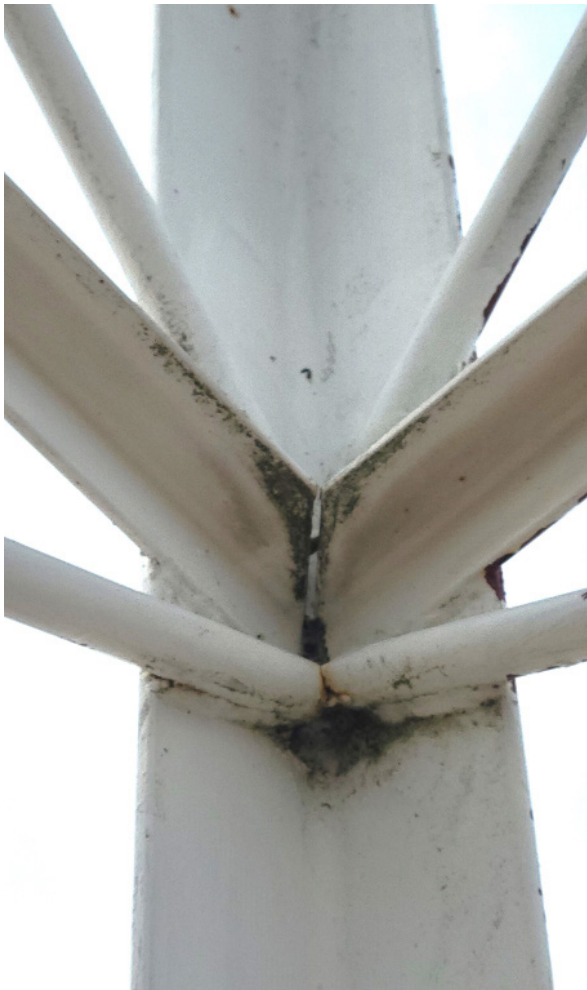
Figure 1D-336 Welded connections of steel bar cross bracing and third set of horizontal angle members located above grade at corner angle column of fog signal tower.

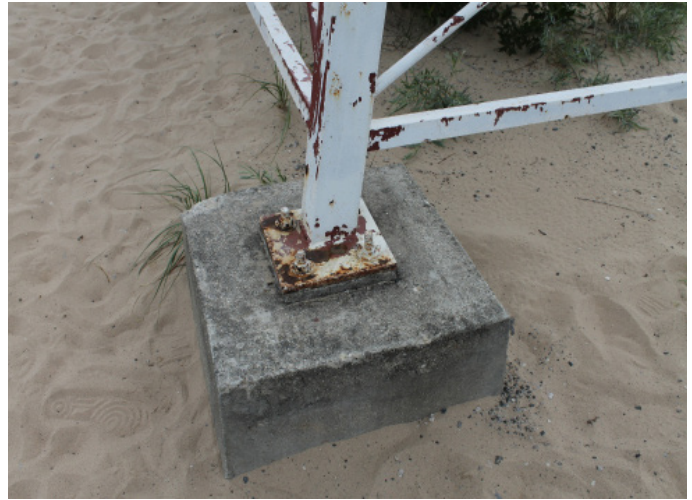
Figure 1D-338 Northwest concrete foundation, top of corner is spalled.

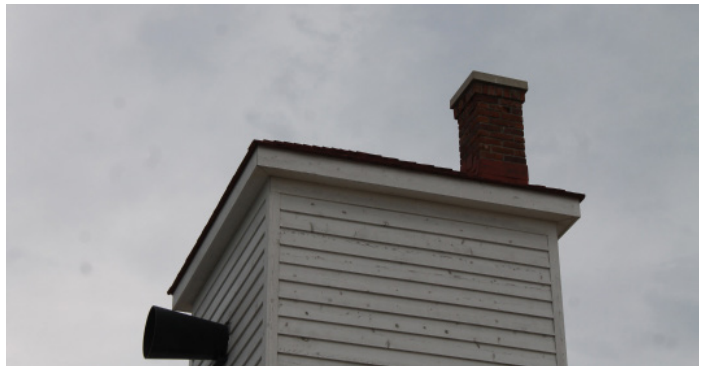
Figure 1D-339 Stepped sheet metal flashing at intersection of masonry chimney and roof of fog signal building.

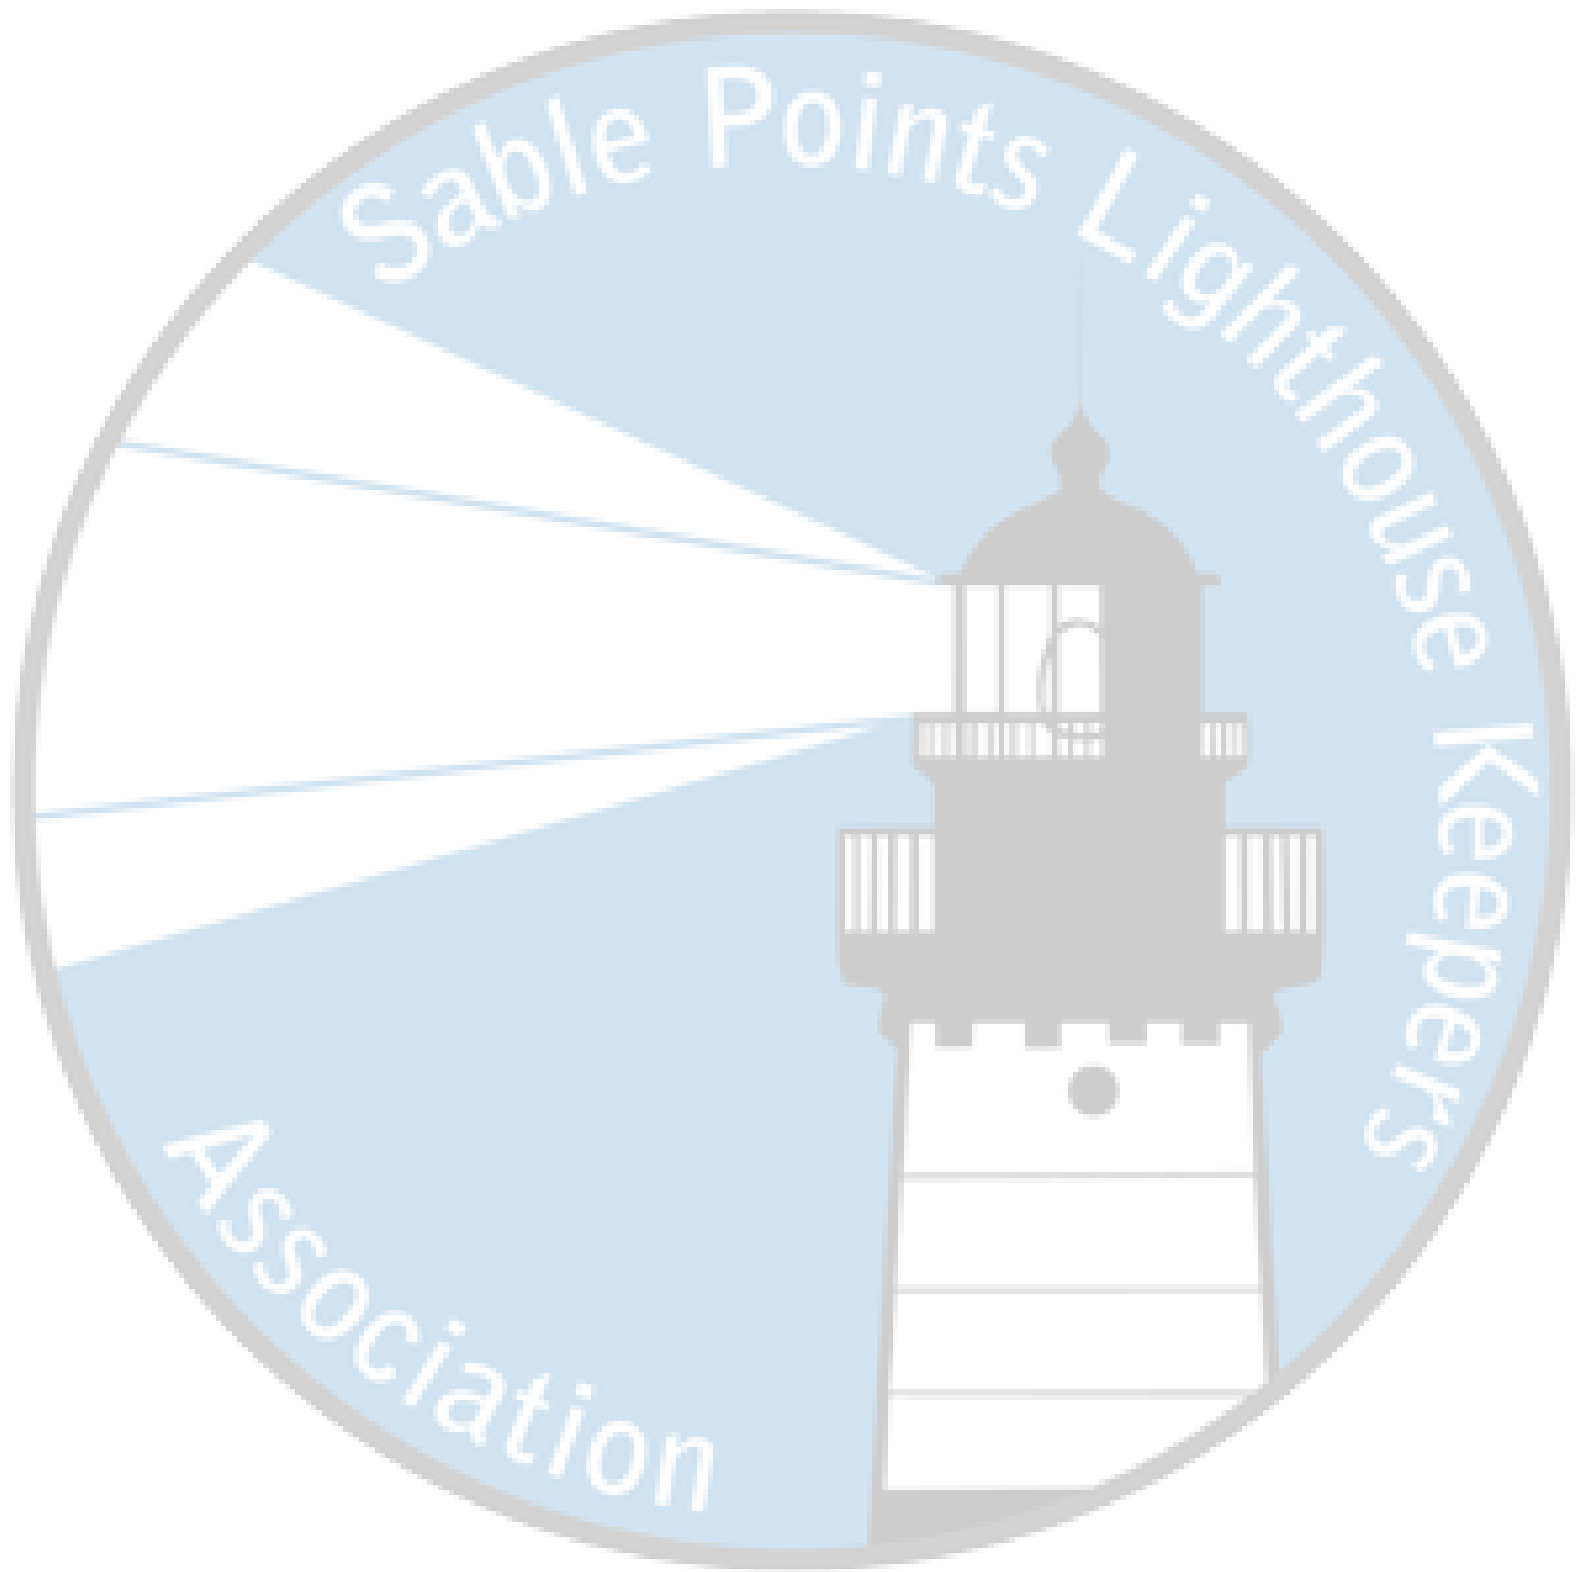
PART II: TREATMENT + USE
