HISTORIC STRUCTURES REPORT
for
LITTLE SABLE POINT LIGHT STATION
(PETITE POINTE au SABLE)
Golden Township (Oceana County), Michigan

Prepared by:
Sanders & Czapski Associates, PLLC
109 S. Front Street
Suite #210
Marquette, Michigan 49855

FINAL REPORT
July 15, 2015

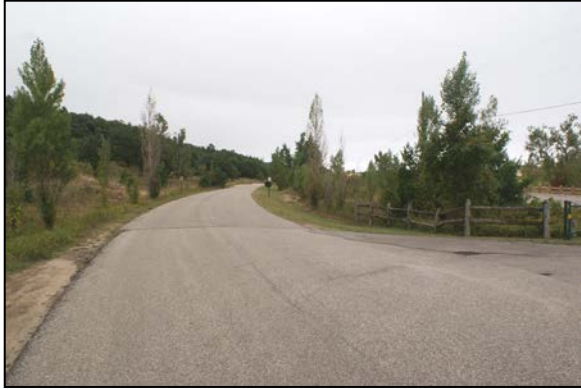
PHOTO III-A-2

The approach to the light station is along a paved asphalt road known as Lighthouse Drive, as seen in Photos III-A-2 and III-A-3. A driveway off Lighthouse Drive provides entry to a large public parking lot for visitors accessing the sand dunes and beach as well as the Little Sable Point Light Tower. The driveway, Photo III-A-4, passes a small state park contact station, Photo III-A-5, where staff is occasionally stationed to verify state park permits as required for entry. Adjacent to the contact station are two vault toilet buildings for public use. The vault toilets, as seen in Photos III-A-6 and III-A-7, are barrier free accessible. The magnificent light tower rises above the dunes and is clearly seen from this parking lot entry point, Photo III-A-8.

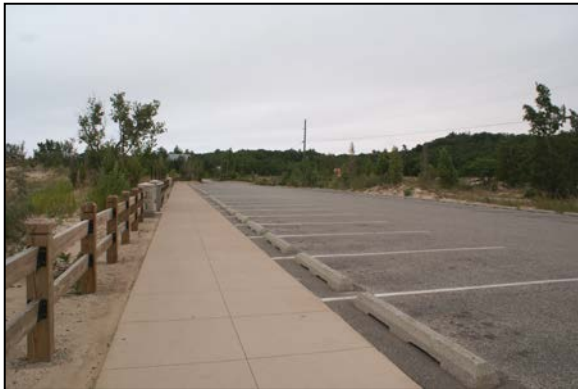
PHOTO III-A-9

The large asphalt paved parking lot, Photos III-A-9 and III-A-10, provides convenient parking for lighthouse visitors. A wood rail fence with stone posts marks the edge of the concrete sidewalk that runs the length of the parking lot. Barrier free parking spaces are located adjacent to the concrete sidewalk that leads to the light tower. Refer to Photo III-A-11. Additional views of the parking lot and the circular turn-around drive at the south end of the lot are shown in Photos III-A-12 and III-A-13. The concrete sidewalk, 7'-2" wide, provides a solid, barrier free accessible walkway through the sand dunes to the light tower. This sidewalk, installed in 2006, is in very good condition as seen in Photos III-A-14, III-A-15, III-A-16 and III-A-17. Park staff and lighthouse volunteers keep drifting sand from the concrete walk for the safety of visitors.

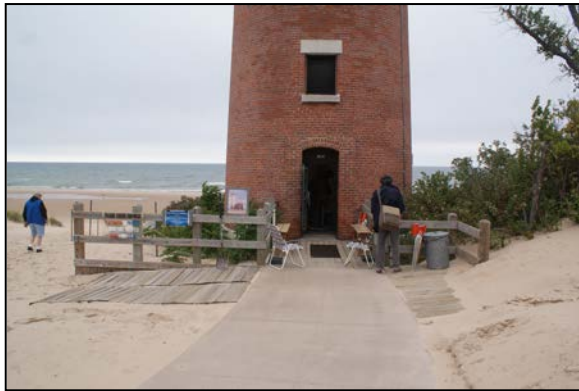
PHOTO III-A-18

The concrete sidewalk terminates at a small wood deck structure at the base of the light tower. The deck, approximately 7'-2" x 9'-10" in size as seen in Photo III-A-18, provides an area for lighthouse volunteers to greet visitors, as well as a solid platform surface for entry into the tower. A 5'-0" x 2'-0" metal grate built into the deck allows for removal of sand. Wood rails surround two sides of the deck and also provide a place for signage, as seen in Photo III-A-19. A wood ramp, Photo III-A-18 and III-A-20, at the east end of the deck transitions from the sidewalk to the sandy site, providing easy access for visitors walking around the light tower or accessing the beach.

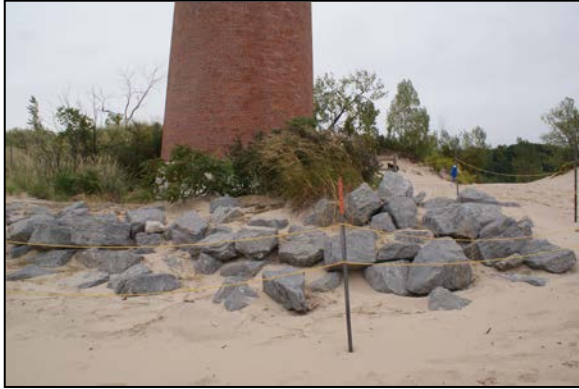
PHOTO III-A-21

The site around the light tower consists of sand, small vegetation, stone rip-rap, and some remnants of concrete slabs placed around the tower base. Refer to Photos III-A-21, III-A-22 and III-A-23. The top of a small 1'-1" wide concrete retaining wall located on the west side of the tower is also seen in Photo III-A-22. Other sloped sections of concrete are poured against the tower, as seen in Photo III-A-24. The grade of the site drops off on the west side of the site facing the lake and undoubtedly the earlier elements, such as the concrete slabs and retaining wall, and the more recent stone rip-rap have been placed to protect the base of the light tower from high water levels. In the recent past Lake Michigan, along with the other Great Lakes, have been in a period of record low water levels. On the date of this inspection, the water's edge was approximately 250 feet from the west face of the light tower. The base of the sand dune, indicative of the high water line, was approximately 100 feet from the tower. Although lake levels and erosion are not currently a problem, it can be expected that water levels will rise at some point in the future and once again pose a threat to the tower. Views of the light tower, beach and dunes are shown in Photos III-A-25 and III-A-26.

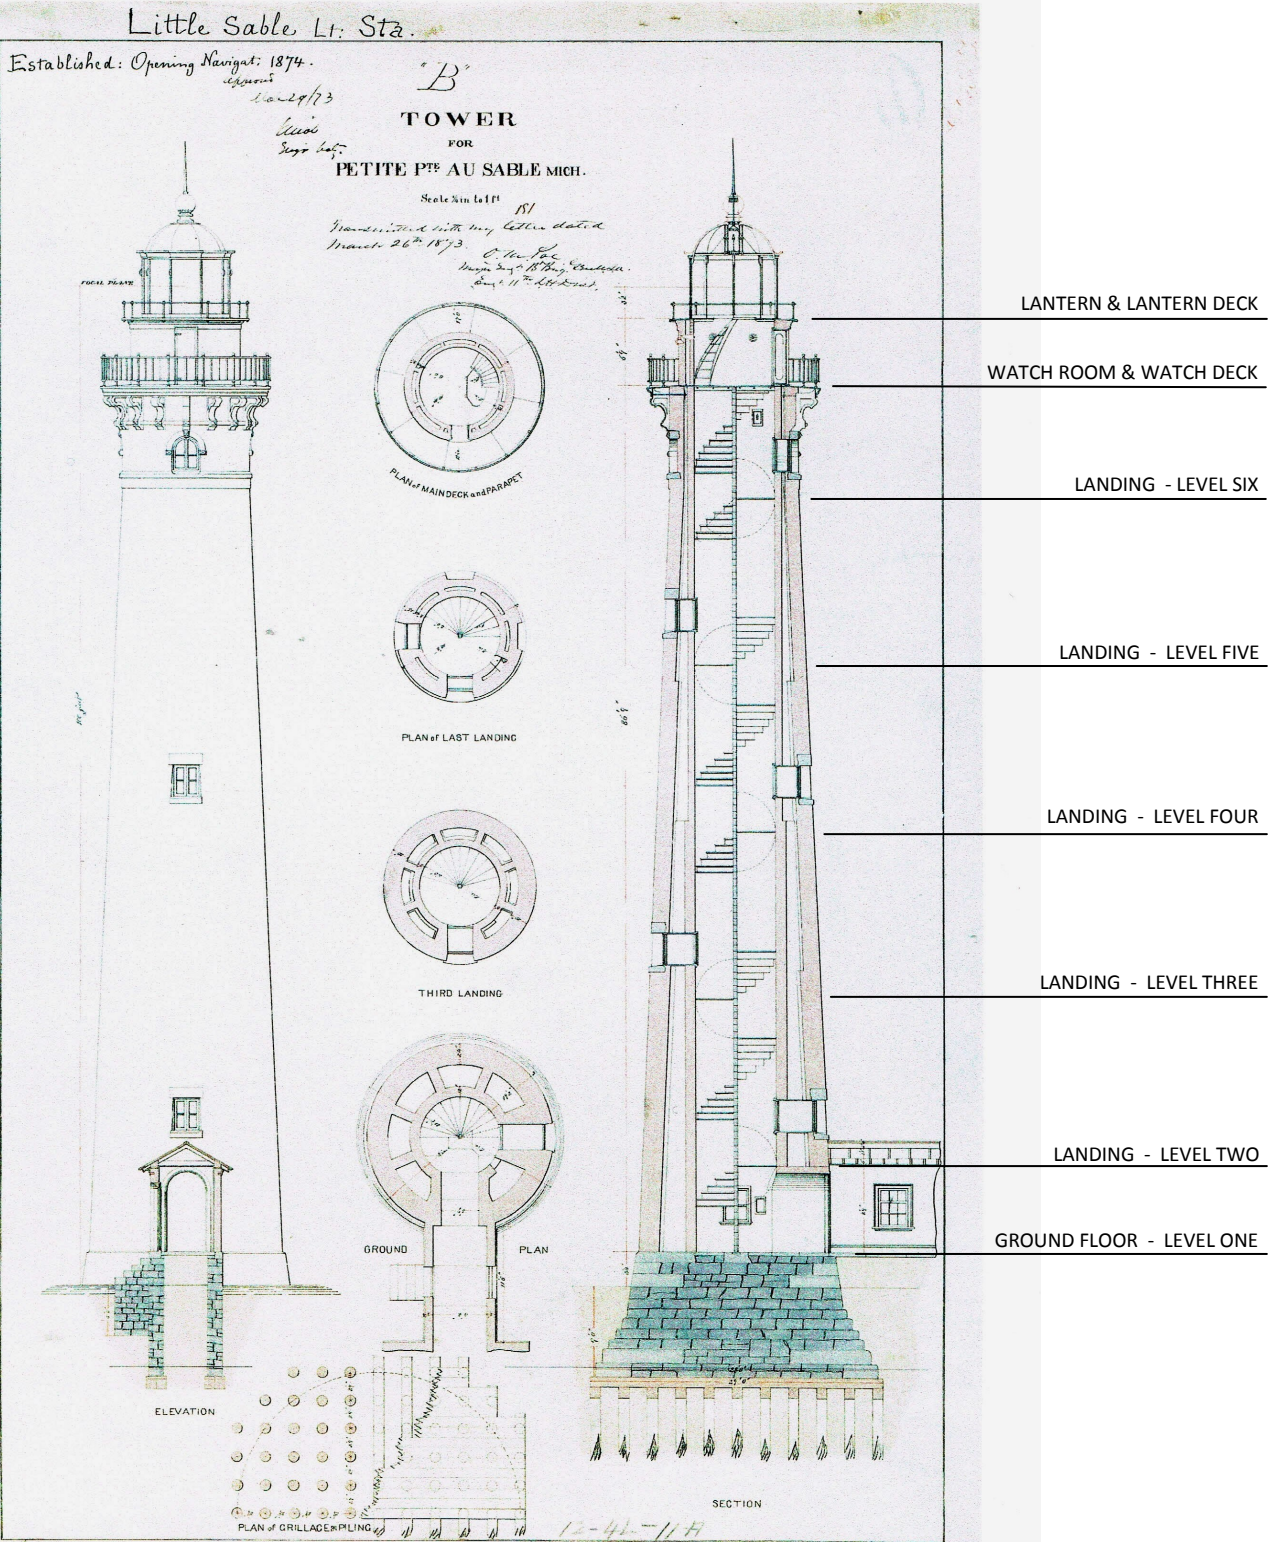
FIGURE ONE

The dwelling, and passageway that connected the dwelling to the tower, are no longer extant. Figure One, a copy of an original drawing of the Light Tower, indicates the various levels and spaces in the tower referred to in this report.

DIAGRAM OF THE LIGHT TOWER AT LITTLE SABLE POINT LIGHT STATION

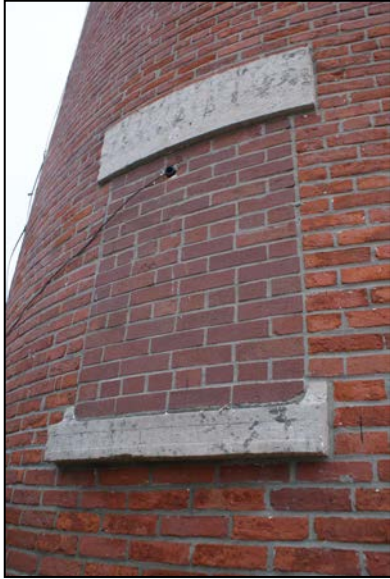
PHOTO III-B-16

The exterior of the Little Sable Point Light Station light tower is unpainted brick and stone which is in excellent condition as discussed in the previous section. Cut stone lintels and sills are located at all window openings. At one former window location on the north side that has been bricked in, the lintel and sill remain exposed. Refer to Photo III-B-16. These stone elements are in good condition. Near the top of the tower the smooth brick surface transitions to brick corbelling and a cut stone band below four arch top windows. Metal corbels provide a decorative element below the watch deck. These elements are shown in Photo III-B-17. A second band of cut stone is located at the lower end of the metal corbels. All metal elements and the paint finish appear in good condition. Decorative cut stone arches cap the window openings at this level.

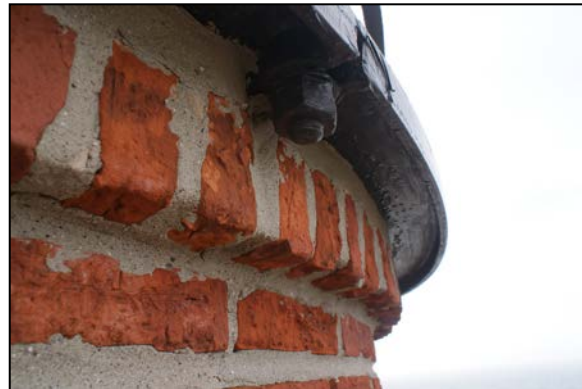
PHOTO III-B-19

The exterior tower walls at the Watch Deck level are also brick masonry, as seen in Photo III-B-18. The upper most brick course is corbelled where it transitions to the underside of the metal lantern deck, as seen in Photo III-B-19. The brick and mortar joints are in very good condition at this upper level with some minor areas of deterioration near the deck surface, shown in Photo III-B-20, and some cracking above the door, Photo III-B-21. Five metal vents, Photo III-B-22, are set in the masonry at this level.

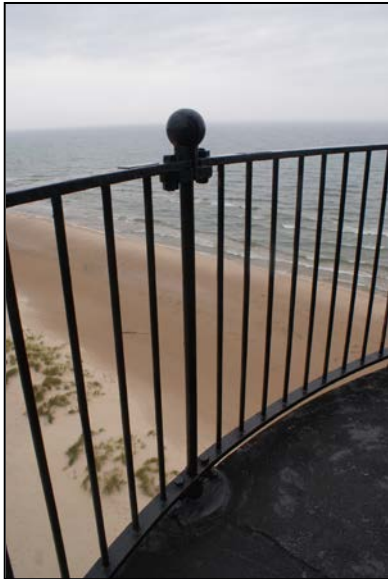
PHOTO III-B-23

The exterior Watch Deck surface is 3'-0" wide and surrounded by a 3'-4" high metal guardrail. The guardrail has two horizontal bars measuring 2 1/8" x 3/4" with vertical 5/8" diameter bars spaced 5" on center. Twelve 1 1/4" diameter metal posts capped with a 3 1/4" diameter ball are equally spaced around the perimeter. The guardrail is shown in Photo III-B-23. All guardrail components are in good condition. The paint finish is also in good condition. The exterior metal floor surface of the Watch Deck is painted with a textured paint. Except for one crack, as seen in Photo III-B-24, the metal deck is in good condition. The paint finish is also in good condition.

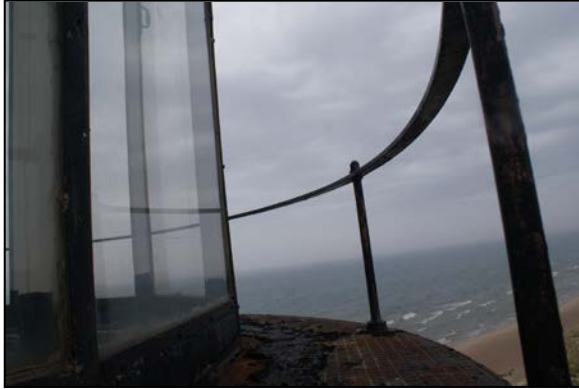
PHOTO III-B-25

The exterior Lantern Deck is located 6'-6" above the Watch Deck surface and provides a narrow, 1'-6 1/2" wide, walkway around the ten-sided lantern. A simple 1'-7" high guardrail with a single horizontal metal bar, 1 1/2" x 1/2" in size, surrounds the deck, as seen in Photos III-B-25 and III-B-26. Ten 1 1/8" diameter metal posts are located around the perimeter in alignment with the corners of the lantern. Refer to Photo III-B-27. All guardrail components are in good condition, however, the paint finish is in poor condition. The Lantern Deck floor surface is a checkered metal pattern, as seen in Photos III-B-28 and III-B-29. All metal surfaces are in good condition, however, the paint finish is in very poor condition.

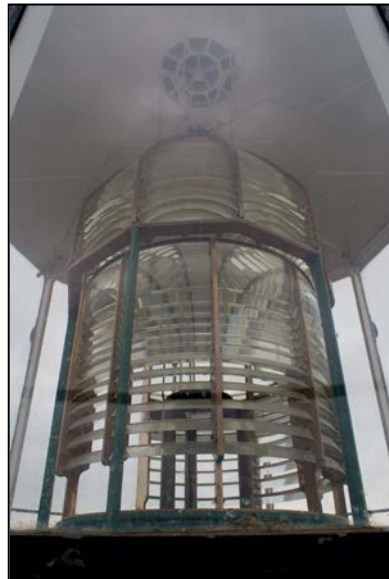
PHOTO III-B-31

The ten-sided lantern, Photo III-B-30, has large glass panels measuring 2'-8 ½" wide x 5'-10" high. All glass panels are in good condition providing protection for the Fresnel Lens, Photo III-B-31. Vertical glazing bars include safety handles, as seen in Photo III-B-32. All exterior glazing bars are in good condition, however, as with other exterior lantern components, the paint finish is in poor condition. The metal roof of the lantern is capped with a ventilation ball and lightning rod. The lantern roof has built-in gutters with drainage tubes that penetrate the simple metal cornice. These are also seen in Photo III-B-32. All metal components are in good condition, however, the paint finish is in poor condition.

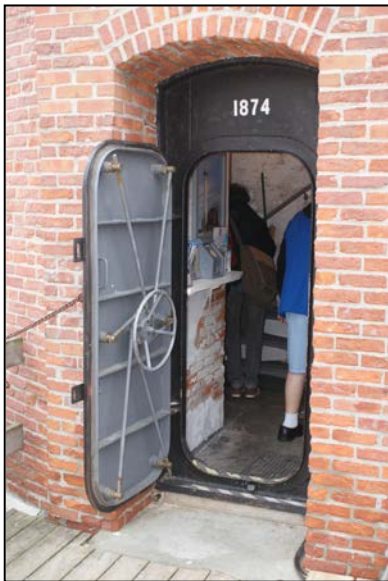
PHOTO III-B-33

A single entry door is located at the base of the light tower in a recessed masonry opening. The door is a 2'-2" x 5'-6" gasketed, water-tight metal door, as seen in Photos III-B-33 and III-B-34. This style of door has a continuous frame at the bottom of the opening, Photo III-B-35, requiring extra caution when stepping through. The door hardware consists of a padlock hasp and hinges on the exterior and a multi-point lock mechanism on the interior. All door components are in good condition and good operating order. The paint finish on the door and frame is in good condition. The numerals "1874" are painted on the metal wall surface above the door.

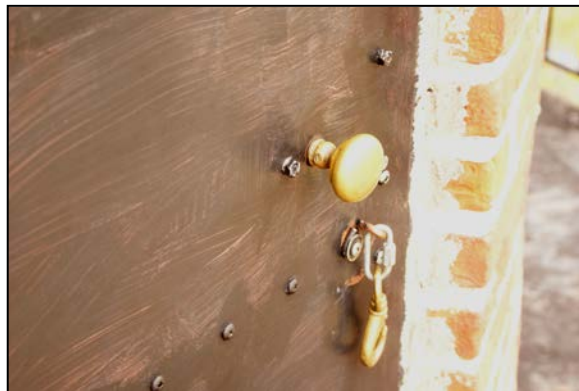
PHOTO III-B-40

At the Watch Room level there is a small door opening with inner and outer doors that provides access to the exterior Watch Deck. On the inside there is a pair of outward swinging wood doors with a paint finish that each measure 0'-10 ¼" wide x 5'-4" high x 1 ¼" thick. Each door has two inset panels, as seen in Photo III-B-36. Door hardware on these doors includes hinges, pull handles and surface mounted flush bolts at the top. There is no hardware on the exterior face of these doors, as seen in Photo III-B-37. The doors and paint finish are in good condition. The outer door is an outward swinging metal plate door that measures 1'-9" wide x 5'-6 ½" high. This door is shown in Photo III-B-38. Door hardware includes hinges, knob and hold-open. The hinges, as seen in Photo III-B-39, are in poor condition. The knob and hold-open, used to secure the door to the masonry wall in an open position, shown in Photo III-B-40, are in good condition. The door is in good condition and the paint finish is in good condition.

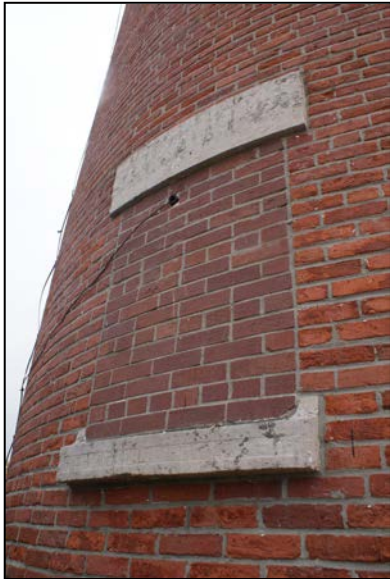
PHOTO III-B-41

There are a number of windows and former window openings along the length of the light tower. At the tower entry level, referred to as Level One in this report, there is one former window opening that has been bricked in on the north side of the tower, as seen in Photo III-B-41, with the cut stone lintel and sill exposed. The inner wall surface at this former opening is plastered solid. It is not known if any window frame or sash components remain buried within the wall. A small electrical grounding cable passes through the masonry at this former window location.

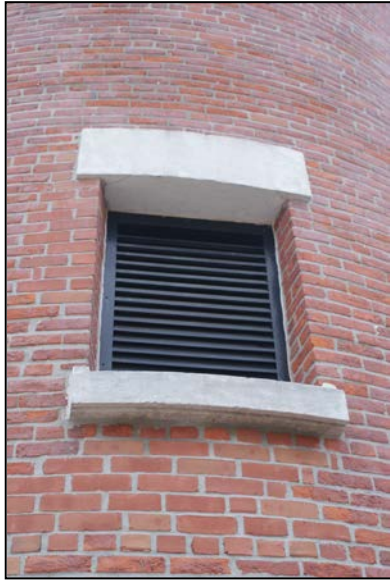
PHOTO III-B-43

At Level Two of the tower directly above the entry door, Photo III-B-42, there is another former window opening that has been modified. At this masonry opening, which measures 2'-8" wide x 3'-6" high, the former wood window sash have been removed and replaced with a modern fixed metal ventilation louver, as seen in Photo III-B-43. This metal louver, with 5" metal blades, is covered with a removable metal insect screen on the interior face, as seen in Photo III-B-44, and allows for continuous ventilation in the tower. Some wood trim and window frame components remain on the interior. The metal louver is in good condition.

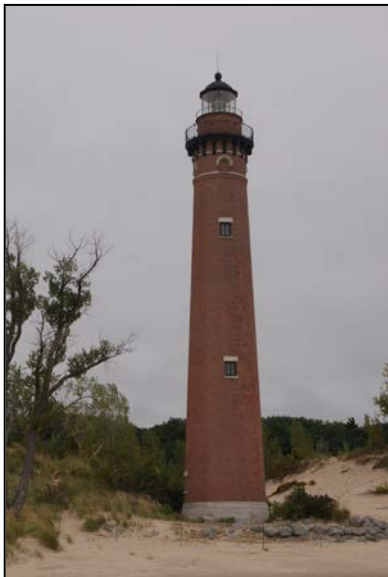
PHOTO III-B-45

Three rectangular window openings with wood windows are located on the tower, two facing west at Levels Three and Five, as seen in Photo III-B-45, and one facing east at Level Four. All masonry openings have the cut stone lintel and sill exposed on the exterior. All wood windows have a pair of outward swinging side hinged sash with two 10" x 16" glass lights in each sash, as seen in Photo III-B-46. Each sash measures 1'-2" wide x 3'-2" high. The pair of inside inward swinging sash matches the style and dimensions of the outer sash. An inside view of the window at Level Three is shown in Photo III-B-47 and a view of the window at Level Four is shown in Photo III-B-48. Hardware includes one pair of hinges on each sash and a surface mounted flush bolt at the bottom of one sash. A wood astragal forms the seal between each sash in a pair. All wood trim, frame and sash appear in good condition. The paint finish is in fair condition with some deteriorated areas. Some glazing material in various locations is also deteriorated but in overall fair condition.

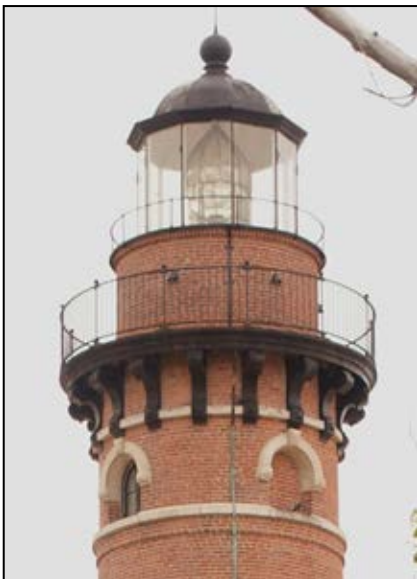
PHOTO III-B-49

At Level Six there are two arch top wood windows, although there are four arched masonry openings at this level. All four masonry openings have cut stone sills and cut stone arched lintels. Arched openings on the north and west are infilled with brick as seen in Photo III-B-49. Similar to the other windows, the two windows at this level have pairs of inner and outer sash. Each sash measures 1'-2" wide x 3'-2" high and has a quarter circle arch. Outside sash are side hinged outward swinging and inside sash are side hinged inner swinging. An inside view is seen in Photo III-B-50. Hardware includes one pair of hinges on each sash and a surface mounted flush bolt at the bottom of one sash. A wood astragal forms the seal between each sash in a pair. As with the lower windows, all wood trim, frame and sash components appear in good condition. The paint finish is in fair condition with some deteriorated areas and some glazing material is deteriorated, but in fair overall condition.

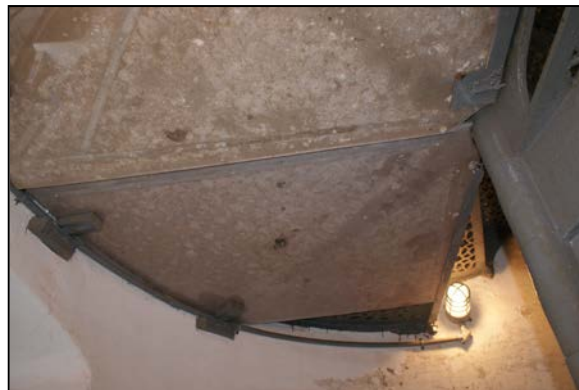
PHOTO III-B-62

Approximately 9'-9" above the ground floor level is the first of five landings that are part of the circular metal stair assembly. Removable plywood panels, as seen in Photo III-B-62, are fastened to the underside of the landing to catch falling sand from visitors walking up the tower. All components of the metal stair appear in sound condition. There are some locations throughout where the paint finish is in poor condition and some rust is present. The paint finish is in generally good condition.

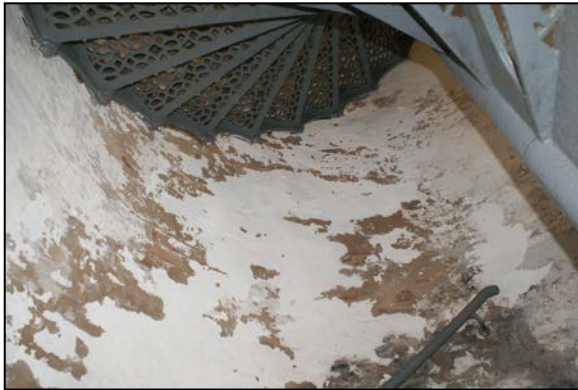
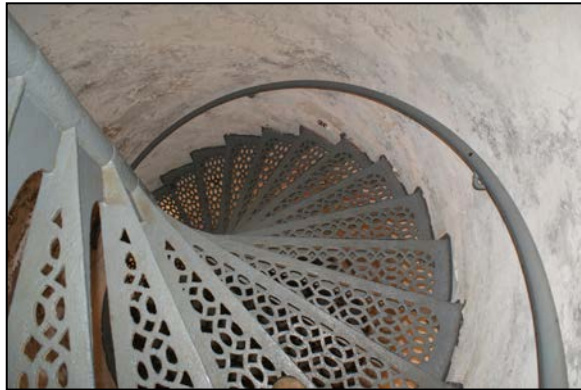
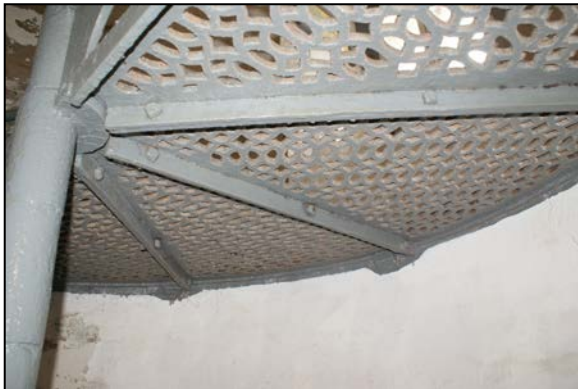
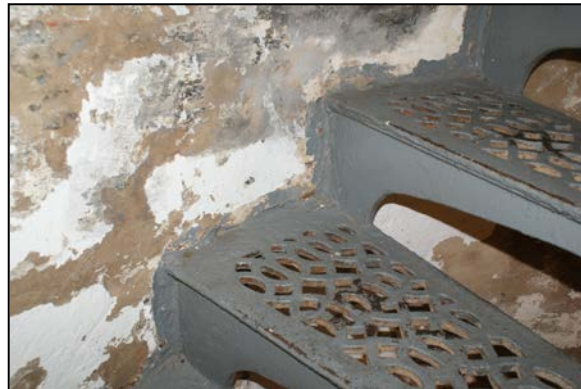
Conditions are similar throughout all levels of the tower with plaster walls and the circular metal stair. Plaster and paint finish on the walls is in poor condition in many areas. Views of the interior tower are shown in Photos III-B-63, III-B-64, III-B-65 and III-B-66. The vertical rise between the landings at Levels Two through Six is a consistent 16'-9 1/2". A 1 5/8" diameter metal pipe handrail follows the curvature of the stair and terminates at each landing, as seen in Photo III-B-67. The metal handrail is mounted to the masonry wall with metal brackets, Photo III-B-68, and is solid throughout. The paint finish on the handrail is deteriorated in some areas, as seen in Photo III-B-69.

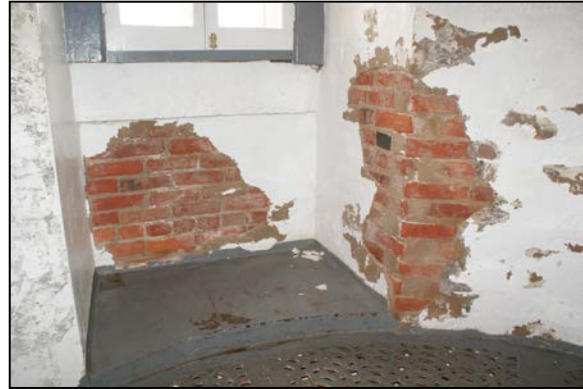
PHOTO III-B-73

As seen in many of the previous photos, there is damaged wall plaster and paint throughout the tower. There is some severe plaster deterioration at the window recess at Level Four, as seen in Photos III-B-72 and III-B-73. At Level Three a masonry crack is located at the apex of the arch above the window recess, as seen in Photo III-B-74.

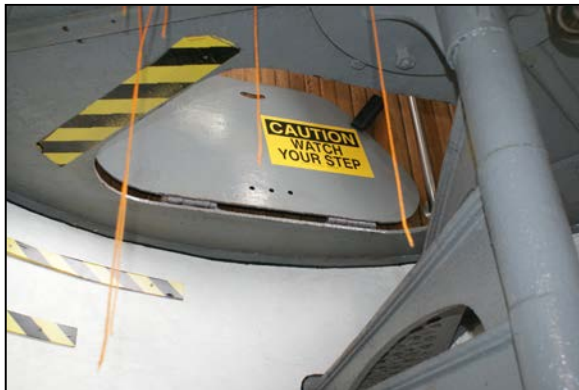
PHOTO III-B-92

A continuation of the circular metal stair provides access to the Watch Room. Entry to the Watch Room is through a 2'-2" wide floor hatch, as seen in Photos III-B-92 and III-B-93. Finishes in the Watch Room include a solid metal floor with a paint finish and 2 ¼" wide vertical wood paneling with a natural finish. The wood paneling and finish are in good condition. The underside of the metal floor panels of the Lantern form a partial ceiling for the room, as seen in Photo III-B-94. The underside of this deck has a paint finish that is in good condition. A very unique feature and focal point of this room is the base support and rotational mechanism of the Third Order Fresnel Lens. Refer to Photos III-B-95 and III-B-96.

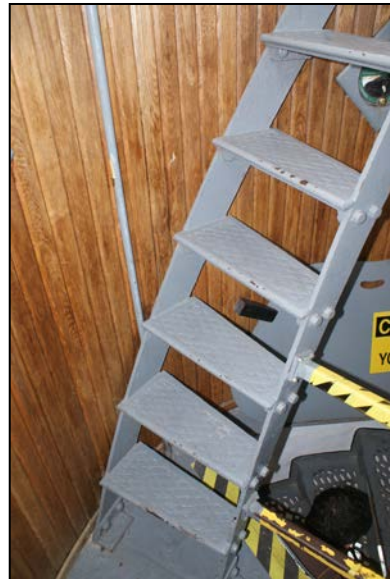
PHOTO III-B-97

A curved ship's ladder style stair, Photos III-B-97 and III-B-98, provides access from the Watch Room to the Lantern. Security bars, controlled by the U. S. Coast Guard, are placed over the Lantern floor opening, preventing the public from accessing this area of the tower. A small wood bench, wall mounted cabinets with artifacts and photos are also placed in the Watch Room, as seen in Photos III-B-99 and III-B-100. Five vents are located in the wall, with metal frames and rotating covers on the interior, Photo III-B-101, and metal bell shaped covers set in the masonry, Photo III-B-102, on the exterior. All vents are in good condition and operating order.

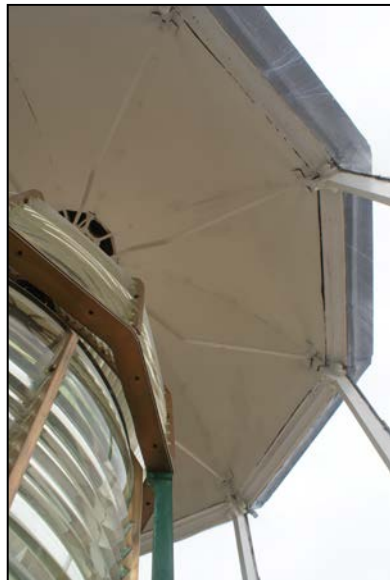
PHOTO III-B-107

The Third Order Fresnel Lens, Photo III-B-103, is housed in a ten-sided lantern with glass panels measuring 2'-8 1/2" wide x 5'-10" high. The 2'-0" wide interior lantern floor deck is located 6'-10 1/4" above the Watch Room floor and surrounds the navigation light. An interior view of the glazing is shown in Photo III-B-104. The lower edge of the glass, condensation gutter and checkered floor deck are shown in Photo III-B-105. All components are in good condition, however, paint finish is in poor condition on most surfaces, as seen in Photo III-B-106. Some "J" hooks remain at the bottom edge of the ceiling, once used to support curtains that protected the lens. The Lantern ceiling is metal with a paint finish, all of which are in good condition, as seen in Photo III-B-107. The ventilation opening at the top appears unrestricted.

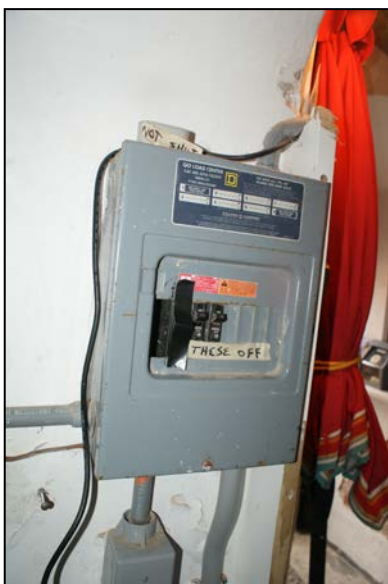
PHOTO III-B-108

Underground electrical service extends to the Light Tower from overhead power lines along the east edge of the parking lot. A 100 Amp, 120/240 volt, single phase service panel is located in the small room at ground level. Refer to Photo III-B-108. Surface mounted PVC conduit, lighting, switches and duplex receptacles are located throughout the tower. Typical utility type incandescent lights are shown in Photos III-B-109, III-B-110 and III-B-111. Duplex receptacles are seen in Photo III-B-90 and III-B-110. A simple intercom system, Photo III-B-112, allows communication between volunteer staff in the tower and at the ground level.

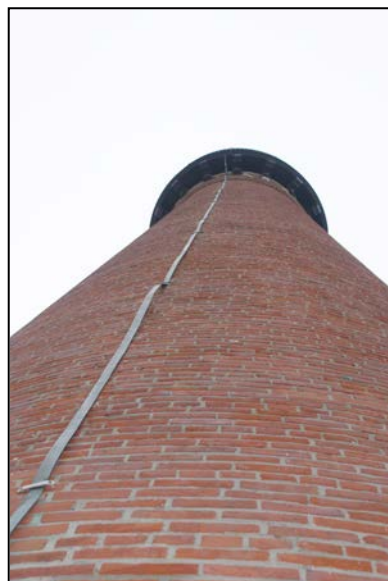
PHOTO III-B-114

A lightning grounding bar runs from the Lantern down the exterior face of the tower on the north wall. Refer to Photos III-B-113, III-B-114 and III-B-115. This grounding bar appears in good condition, however, the continuity is not known.
